REC 18 2021

BOARD OF RECREATION AND PARK COMMISSIONERS

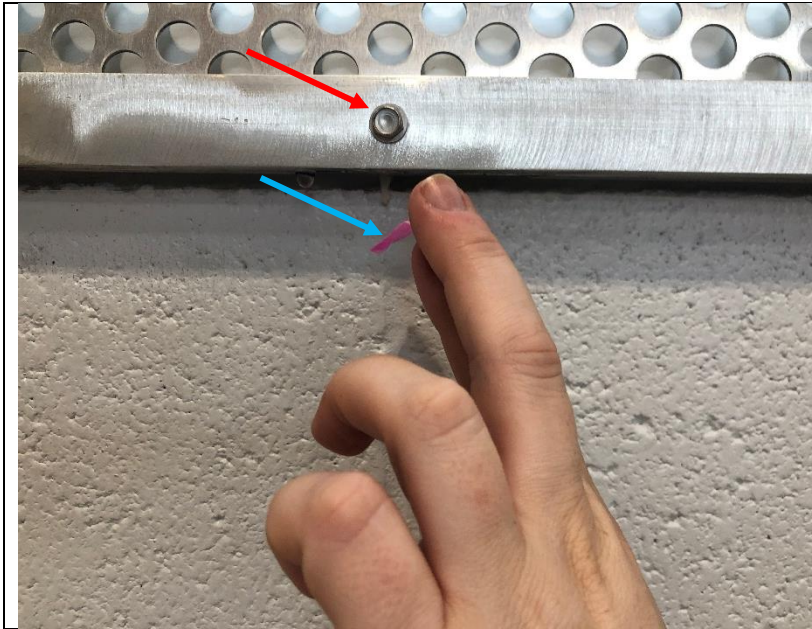
Photo 28:
Perforated aluminum panels appear to have been attached to the window frames and sill track with fasteners (red arrow).
Some of the fastener penetrations leaked during water testing (blue arrow).

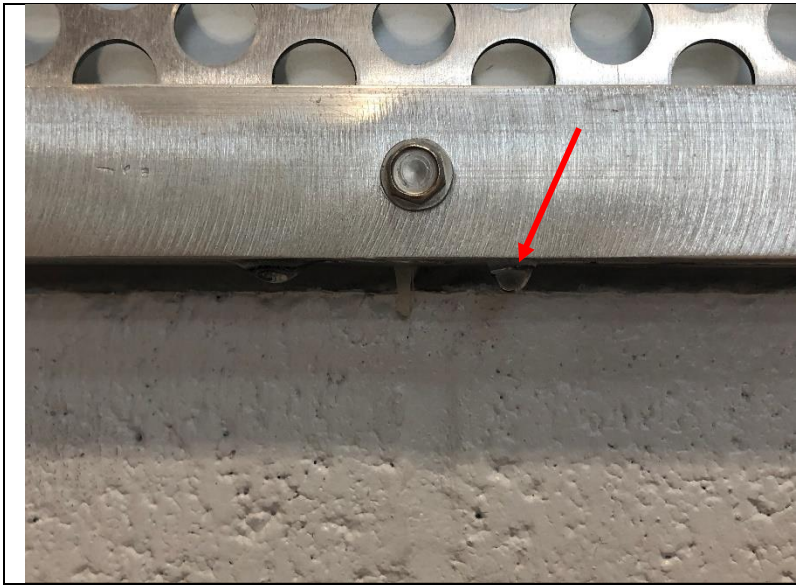
Photo 29:
One of the perforated aluminum panel mounting fastener locations leaking during water testing.

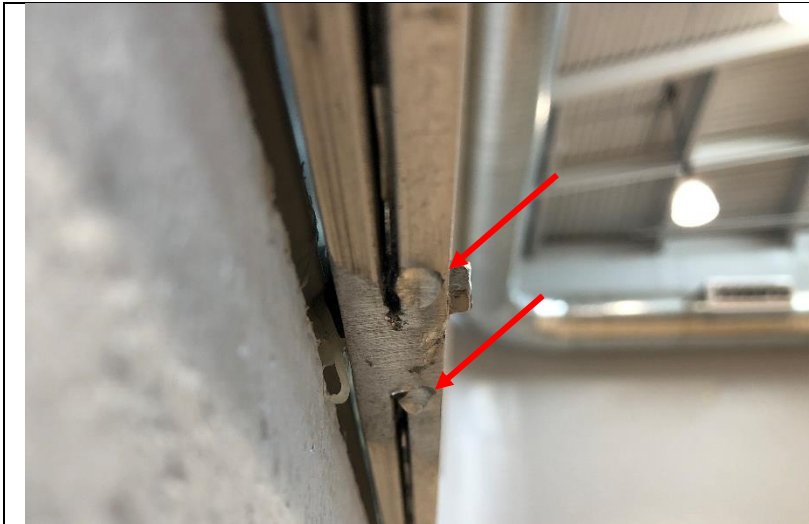
Photo 30:
A view from below of one of the perforated aluminum panel mounting fastener locations leaking during water testing.

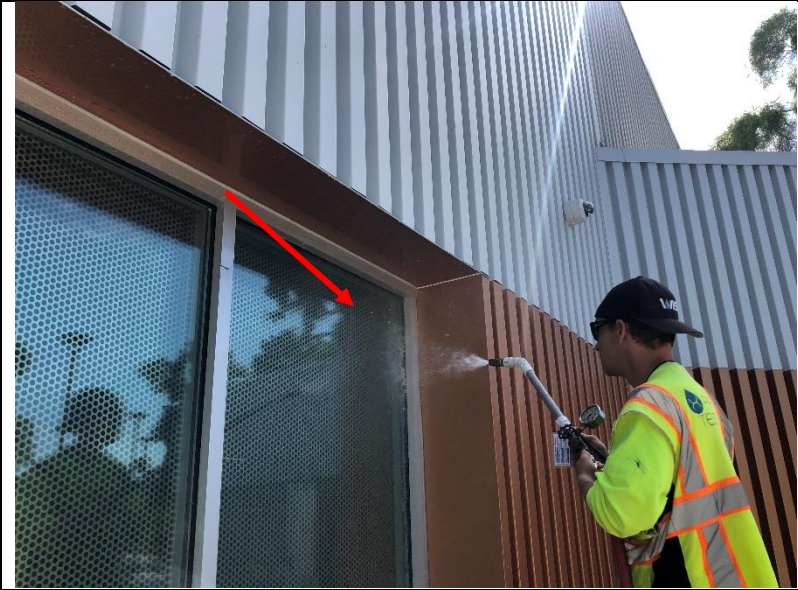
Photo 31:
Diagnostic testing at the windows on the south elevation of the indoor basketball court.

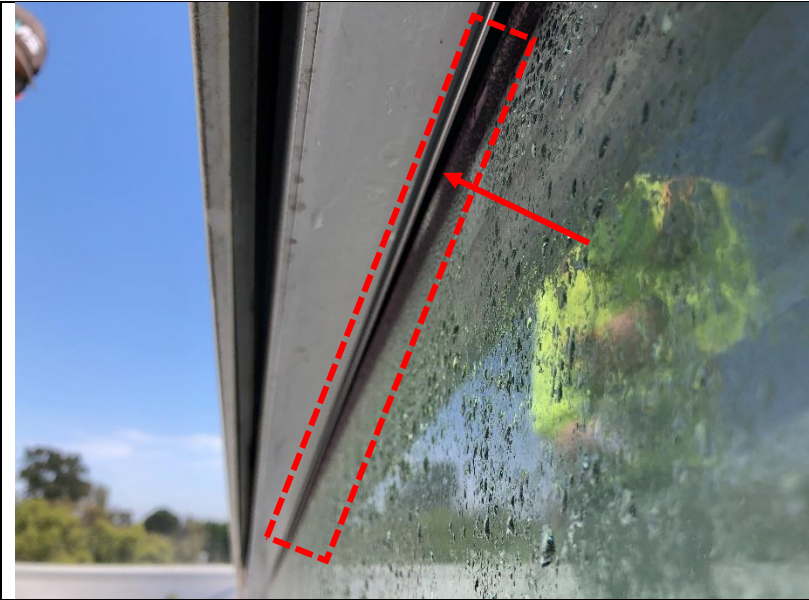
Photo 37:
A gasket at the head of one glazing units above the basketball court was missing.

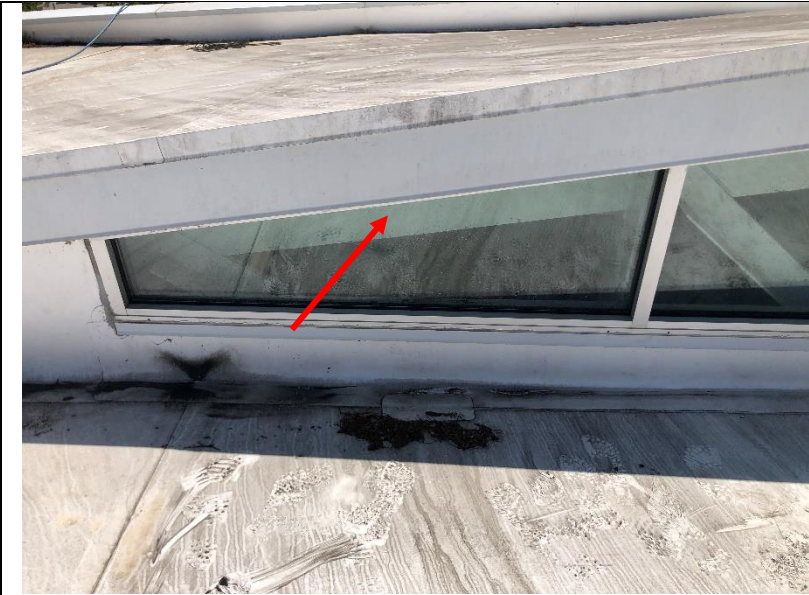
Photo 38:
A window with a missing glazing gasket at the head of the window.

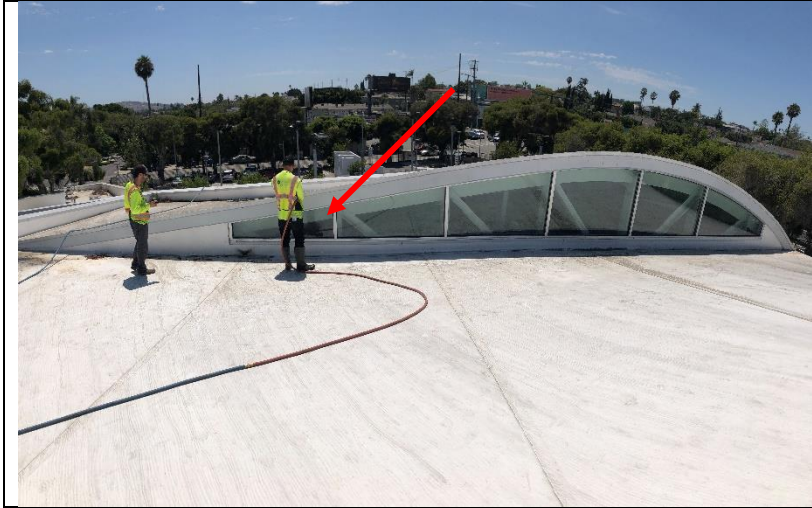
Photo 39:
An overview of a window with a missing glazing gasket at the head of the window.

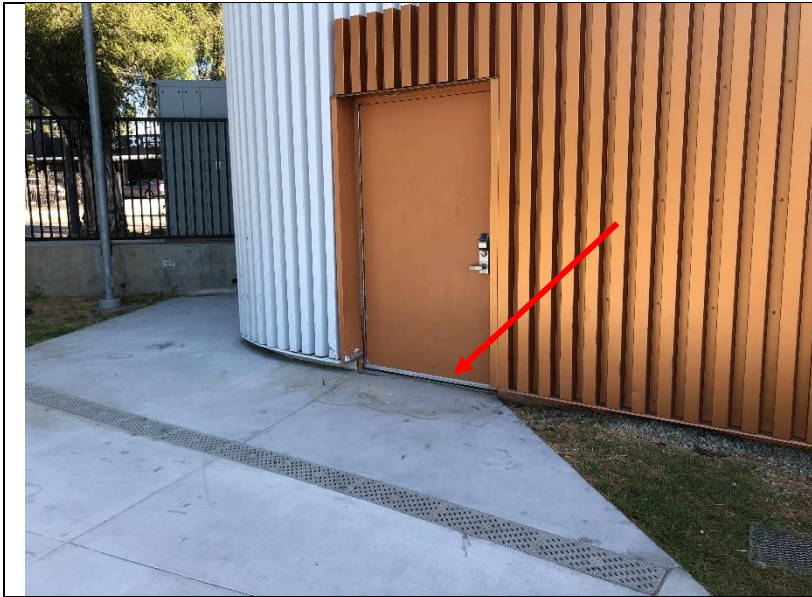
Photo 40:
Approved drawings call for a sill pan to be installed under all door thresholds.

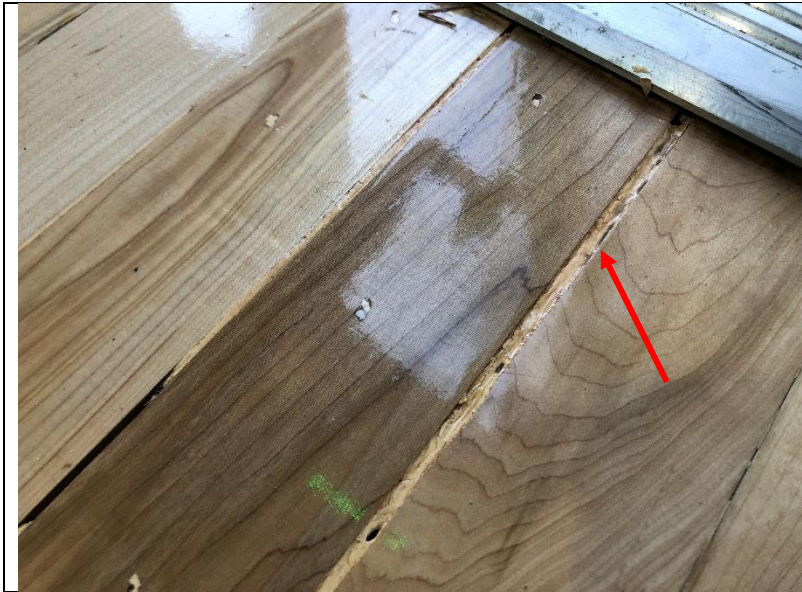
Photo 44:
Water damage to the flooring adjacent to the entrance on the south elevation of the indoor basketball court.

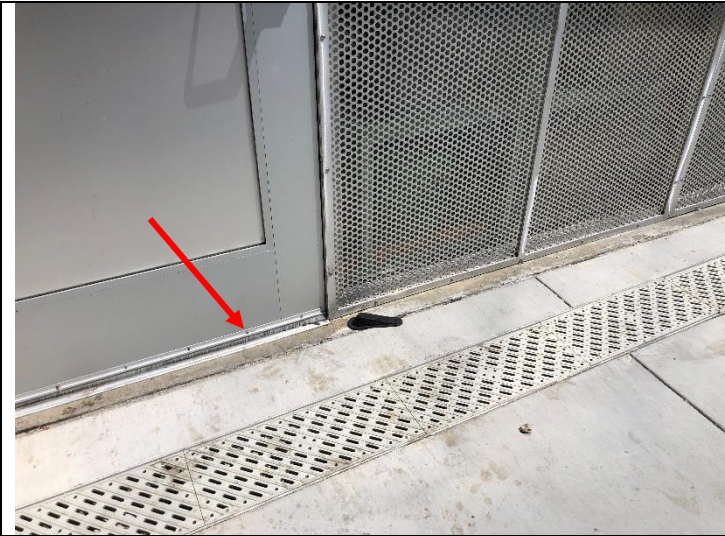
Photo 45:
Approved drawings call for a sill pan to be installed under all door thresholds.

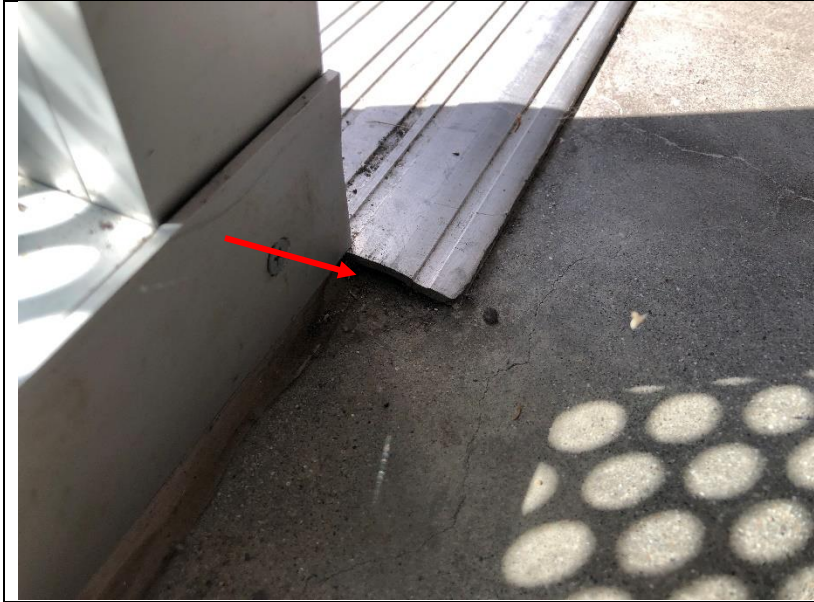
Photo 47:
Approved drawings call for a sill pan to be installed under all door thresholds.
Sill pans were not observed at any of the door thresholds.

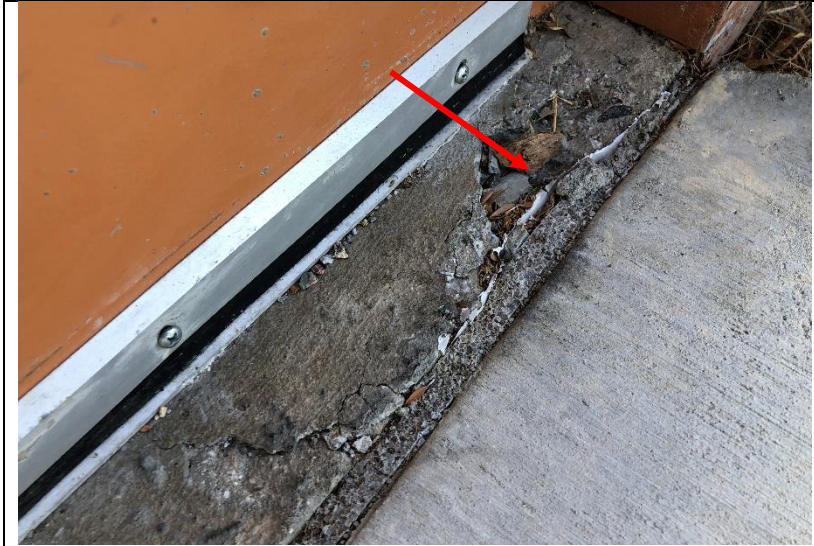
Photo 48:
Damage to the concrete surface at a door threshold.

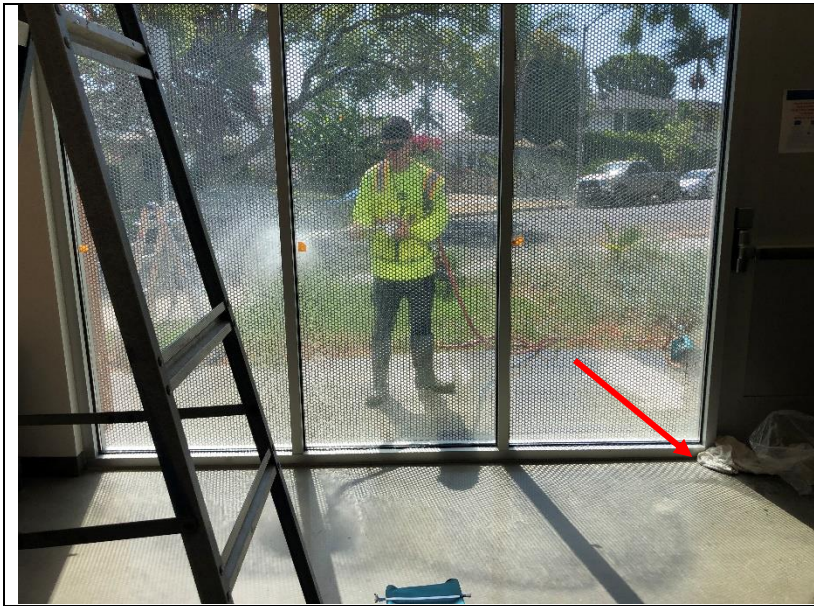
Photo 49:
During diagnostic testing on the east side of the building, the adjacent door leaked.

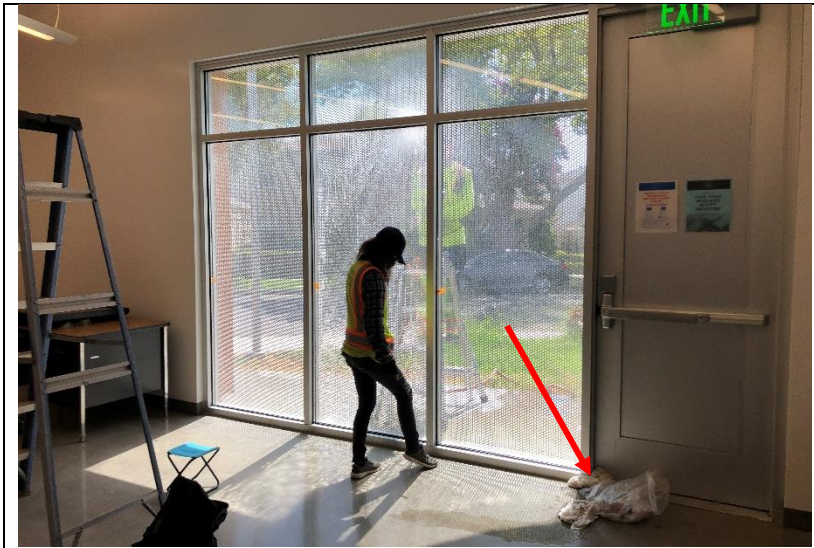
Photo 50:
Towels were used to clean up water that entered under the door during diagnostic testing.

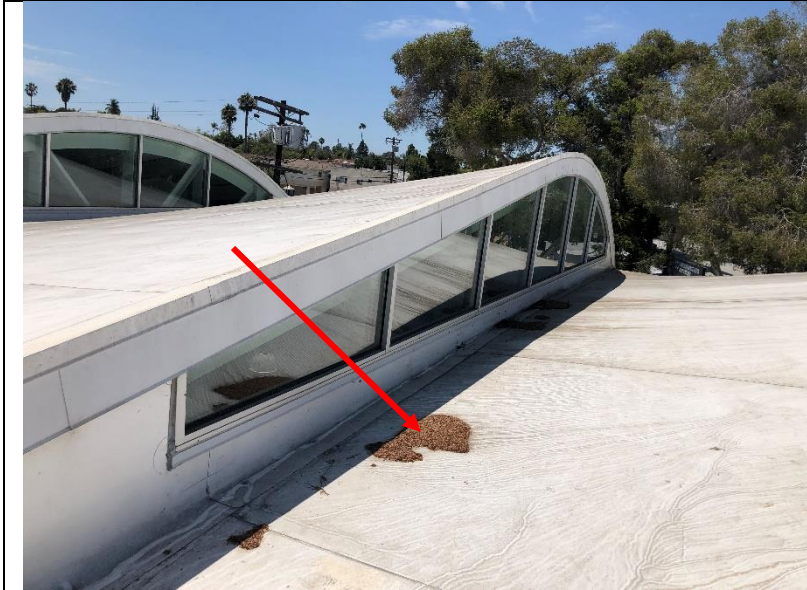
Photo 59:
Overview of the ribbon windows on the vaulted roof. Some debris was observed on the roof surface.

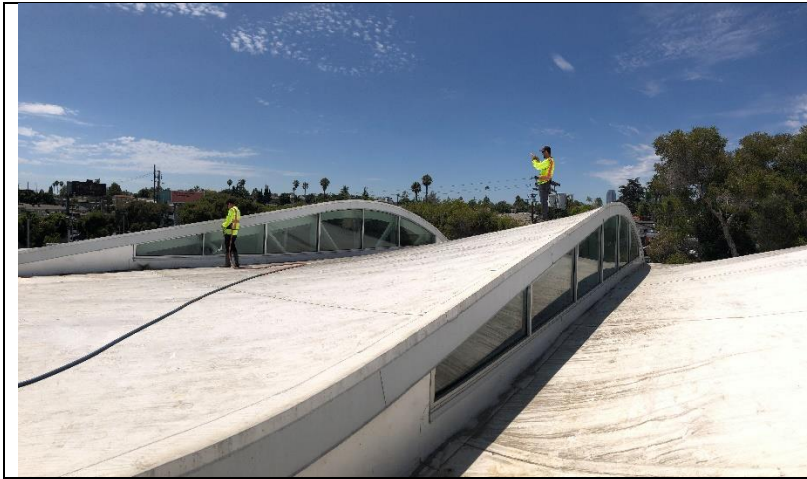
Photo 60:
Overview of the ribbon windows on the vaulted roof during diagnostic testing.

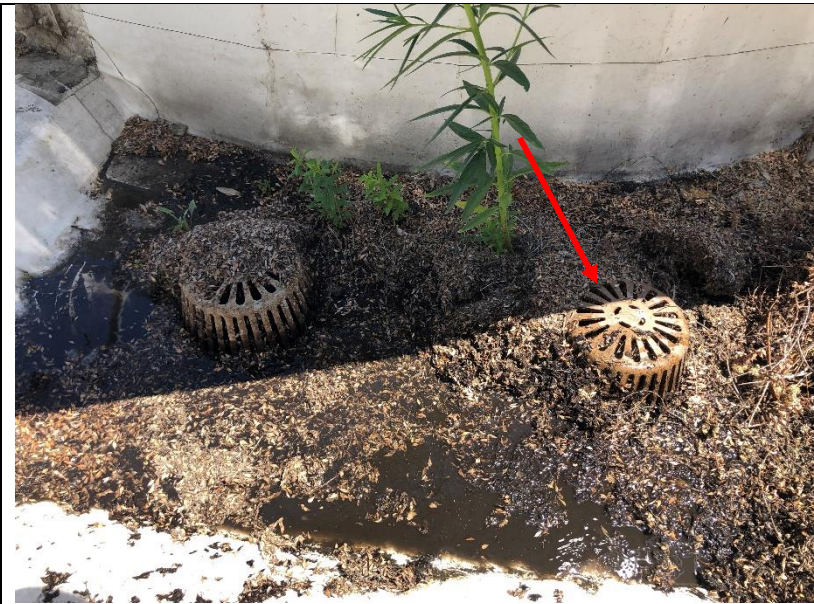
Photo 68:
The overflow drain* (red arrow) appears to be lower than the main roof drain.

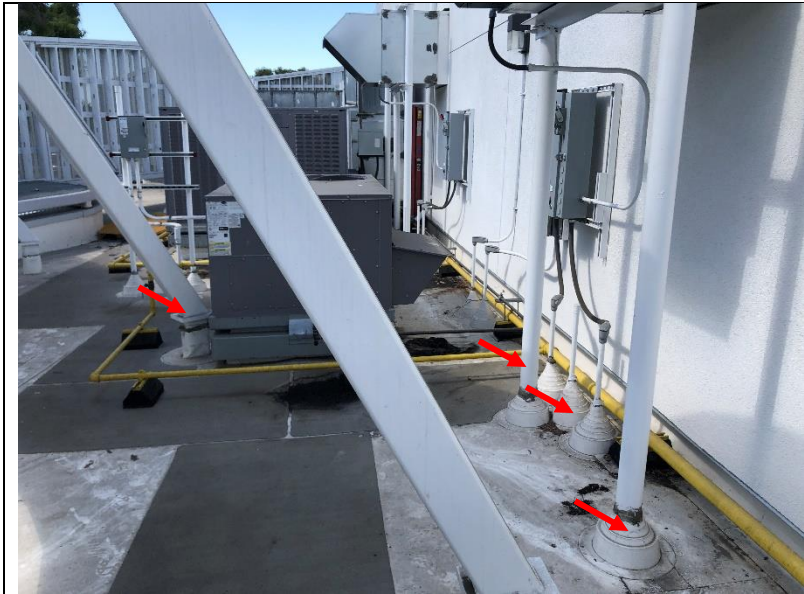
Photo 69:
Overview of penetrations on the lower mechanical roof.

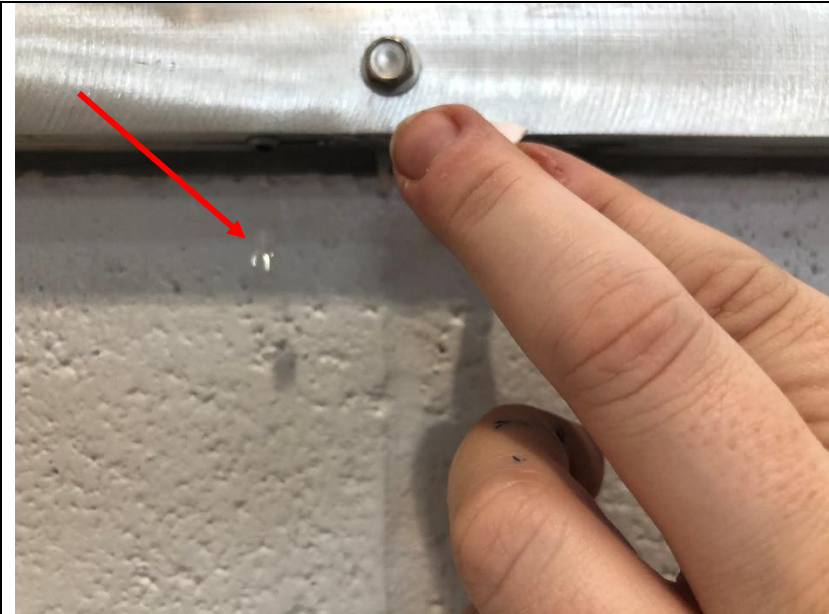
Photo 76:
A leak at the anchor fasteners at the perforated aluminum panels during diagnostic testing on the south side of the building.

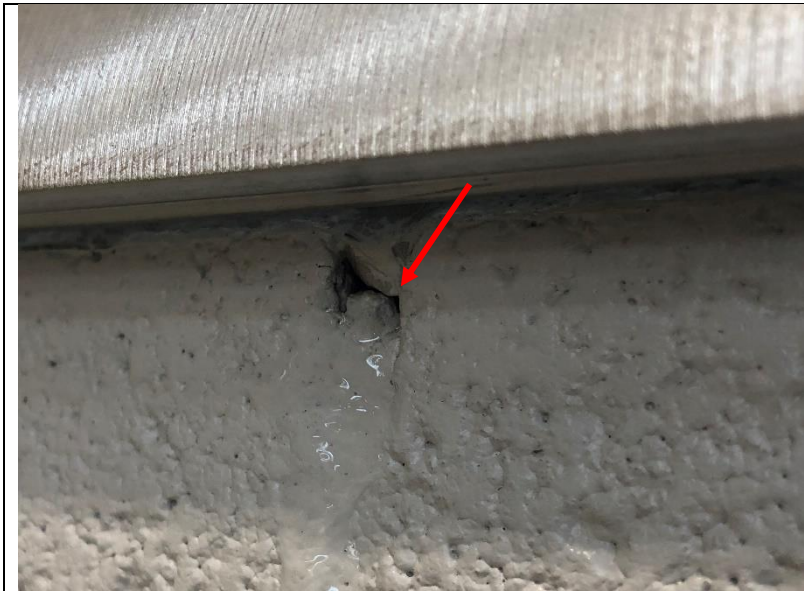
Photo 77:
A leak at a grout joint in the CMU wall below the perforated aluminum panels during diagnostic testing on the south side of the building.

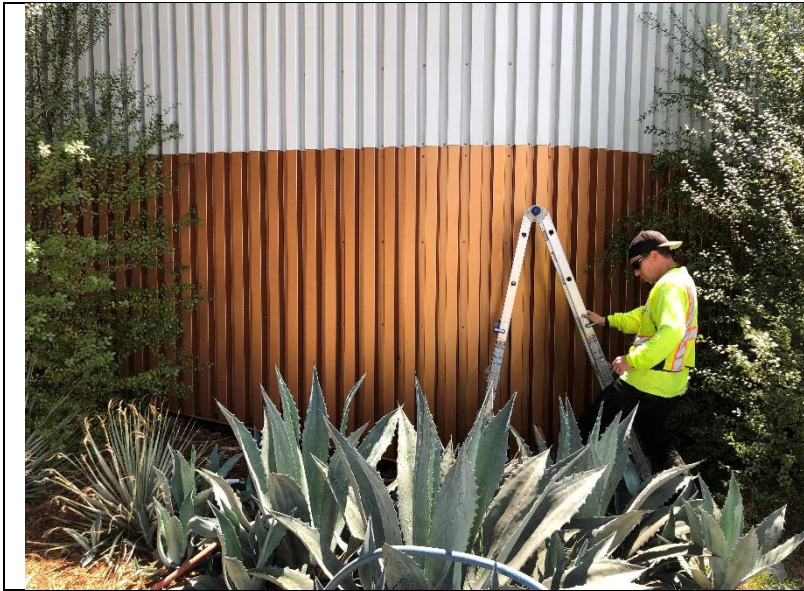
Photo 78:
Diagnostic testing preparation on the west side of the building.

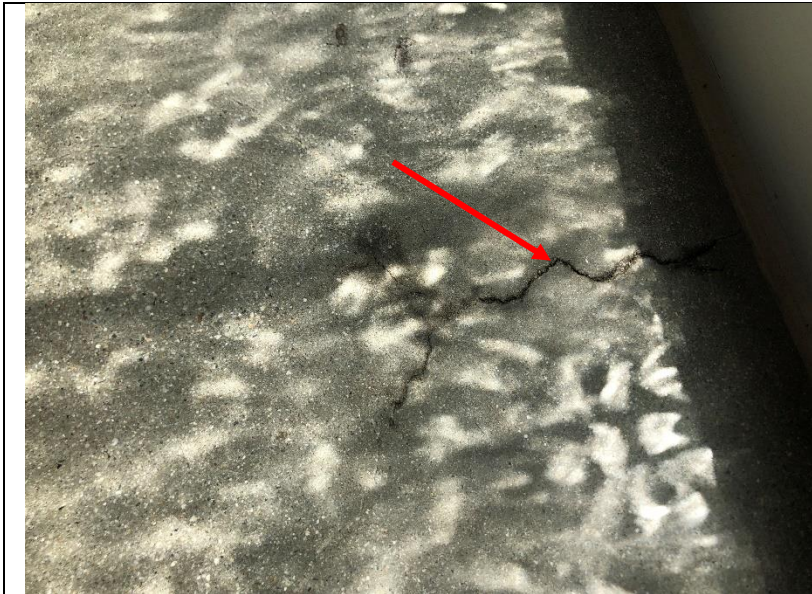
Photo 83:
Cracks on the interior slab became wet during testing at the storefront adjacent to the east entry.

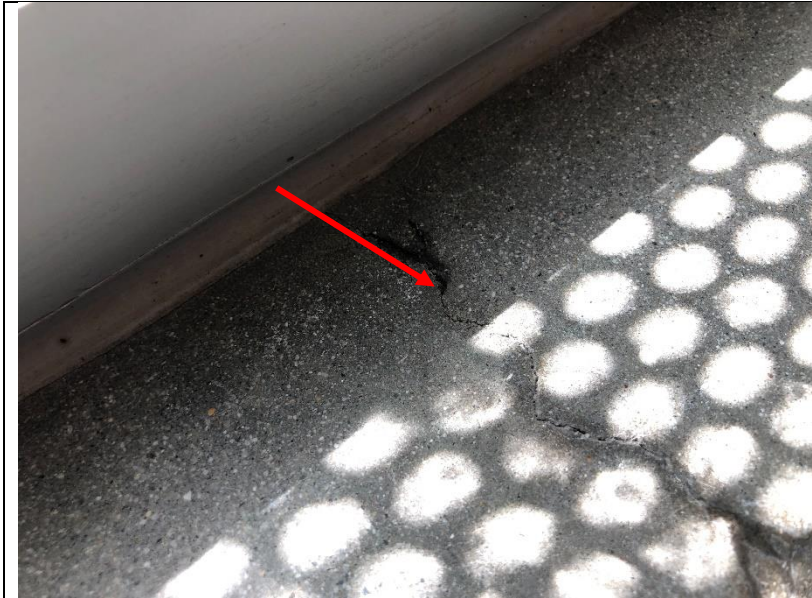
Photo 84:
Crack on the interior slab that became wet during testing at the storefront adjacent to the east entry.

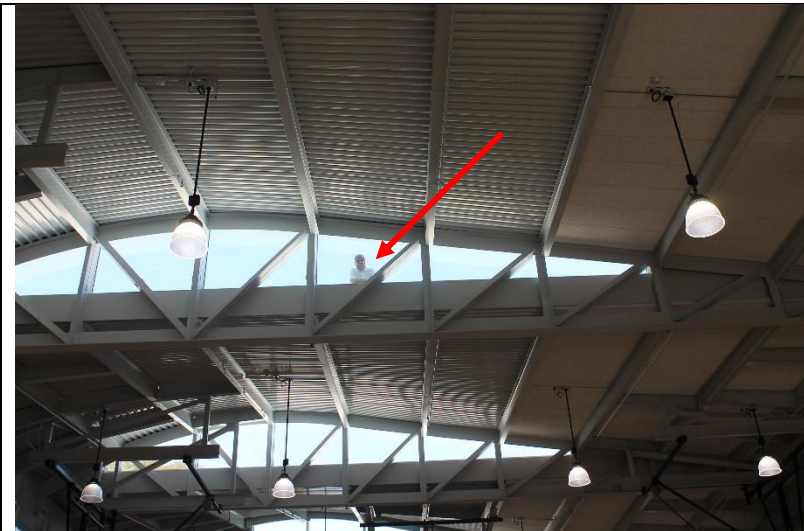
Photo 85:
DTR making observations of the ribbon windows.

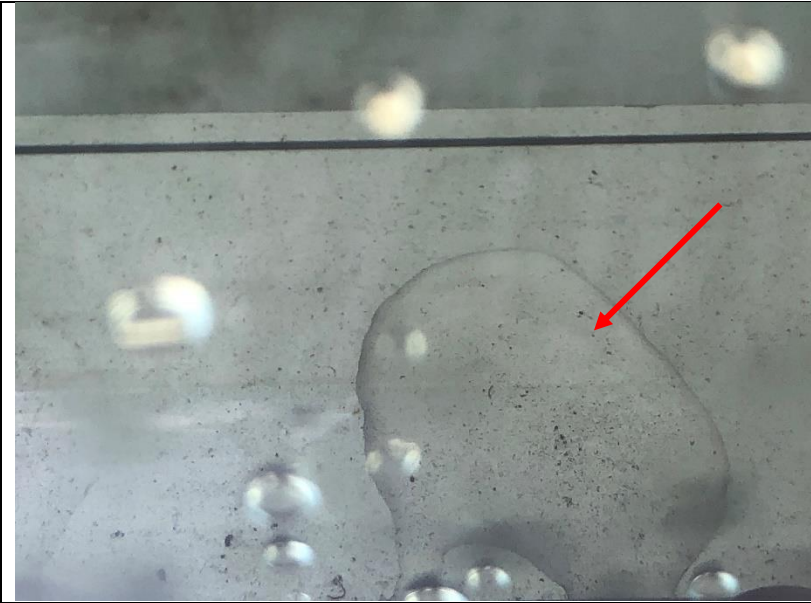
Photo 88:
Water was observed at the interior sill of the ribbon windows.

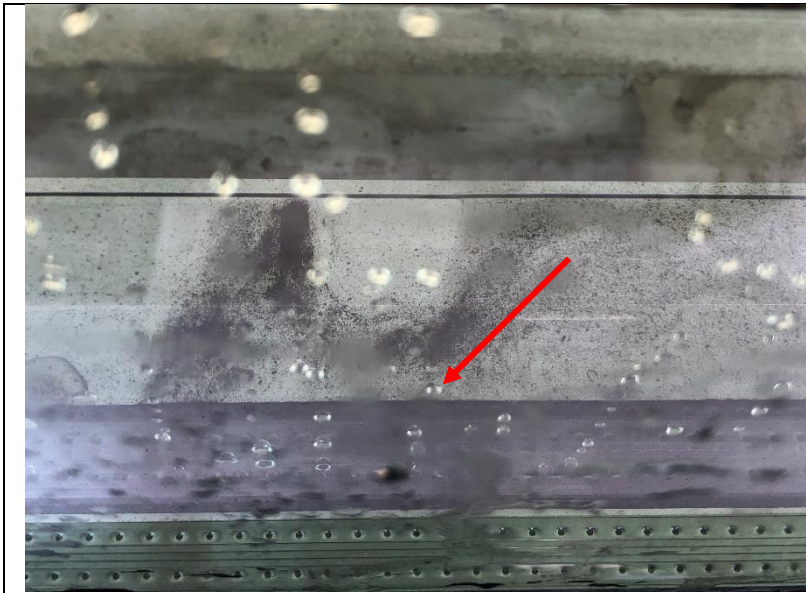
Photo 89:
Water was observed at the interior sill of the ribbon windows.

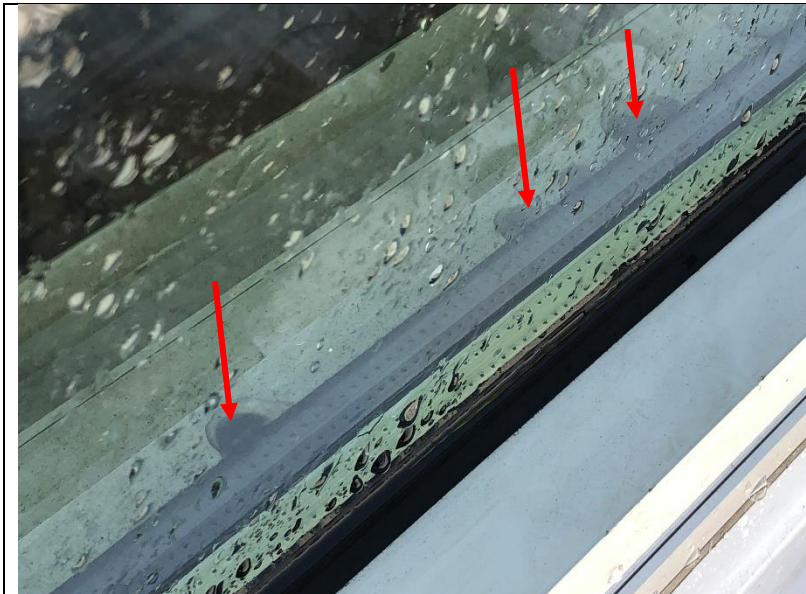
Photo 90:
Water was observed at the interior sill of the ribbon windows.

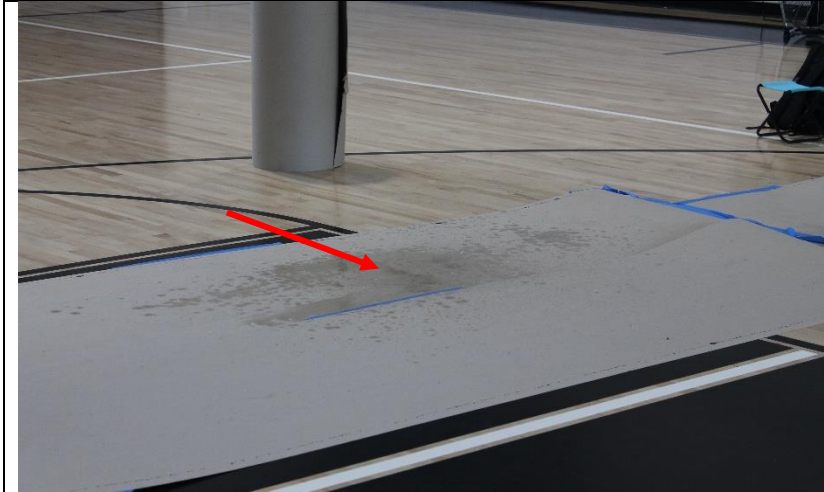
The water dripped onto the floor of the basketball court.

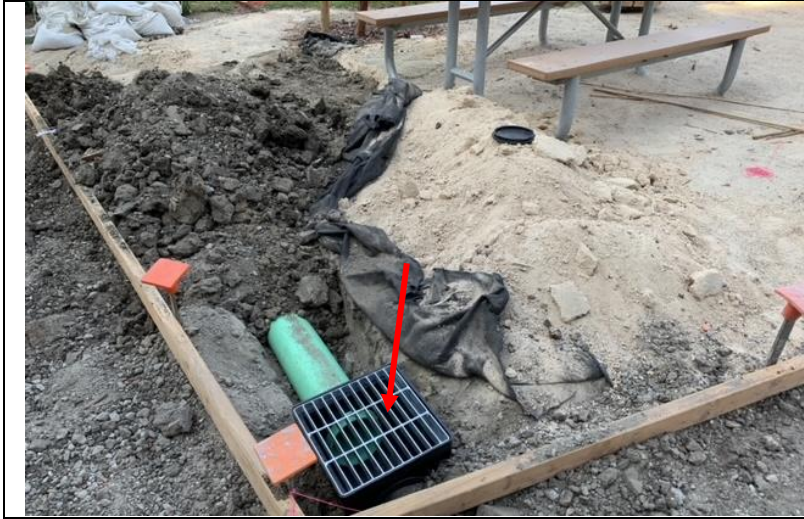
Photo 93:
A drain was installed on the south elevation when the sidewalk adjacent to the building was replaced.

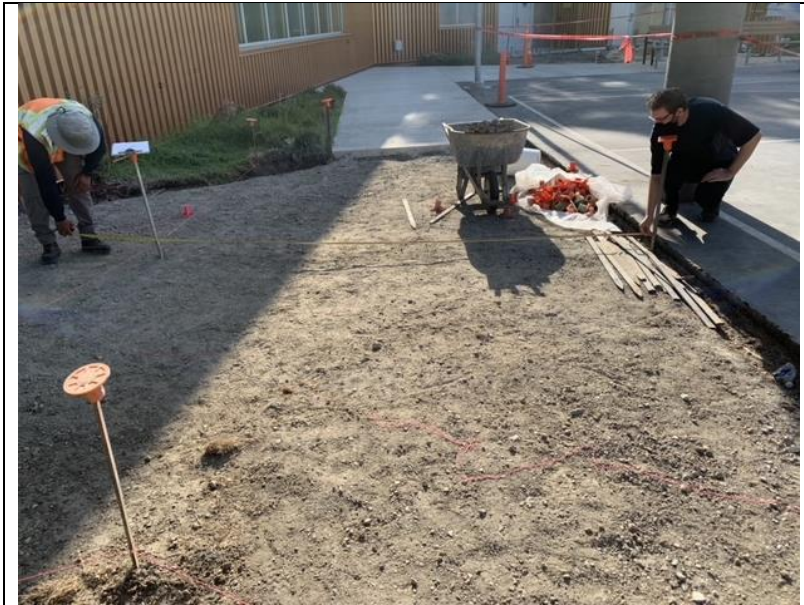
Photo 94:
Photo during the replacement of the sidewalk.

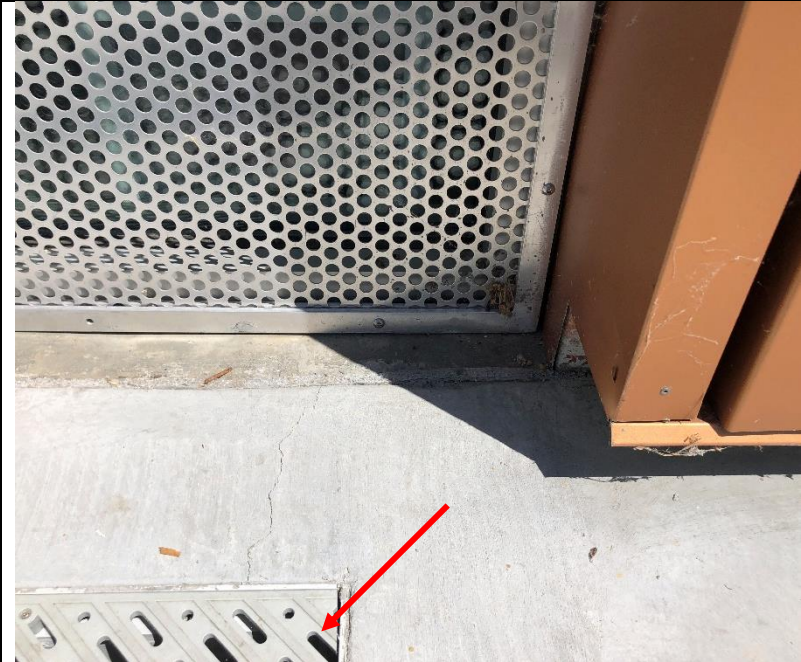
Photo 95:
Trench drains were installed near doors.

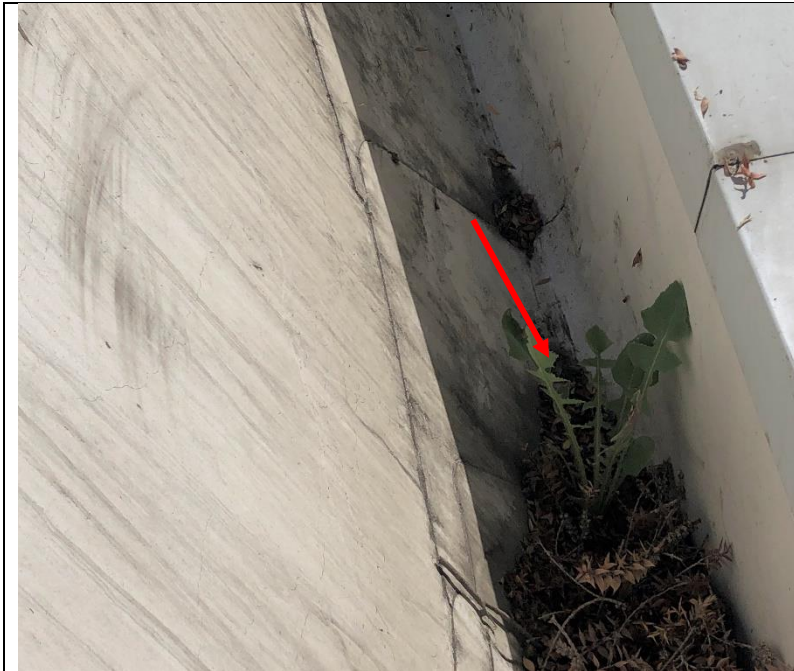
Photo 98:
Tree debris built up between the steep slope of the west roof and the low parapet.
Plants were observed growing in debris on the roof.

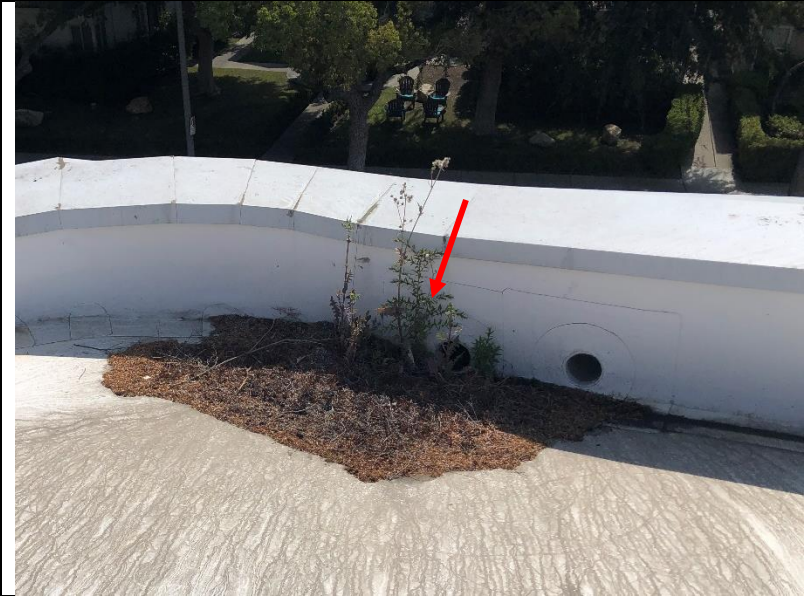
Photo 99:
Tree debris built up at scupper drains and along the low parapet.
Plants were observed growing in debris on the roof.

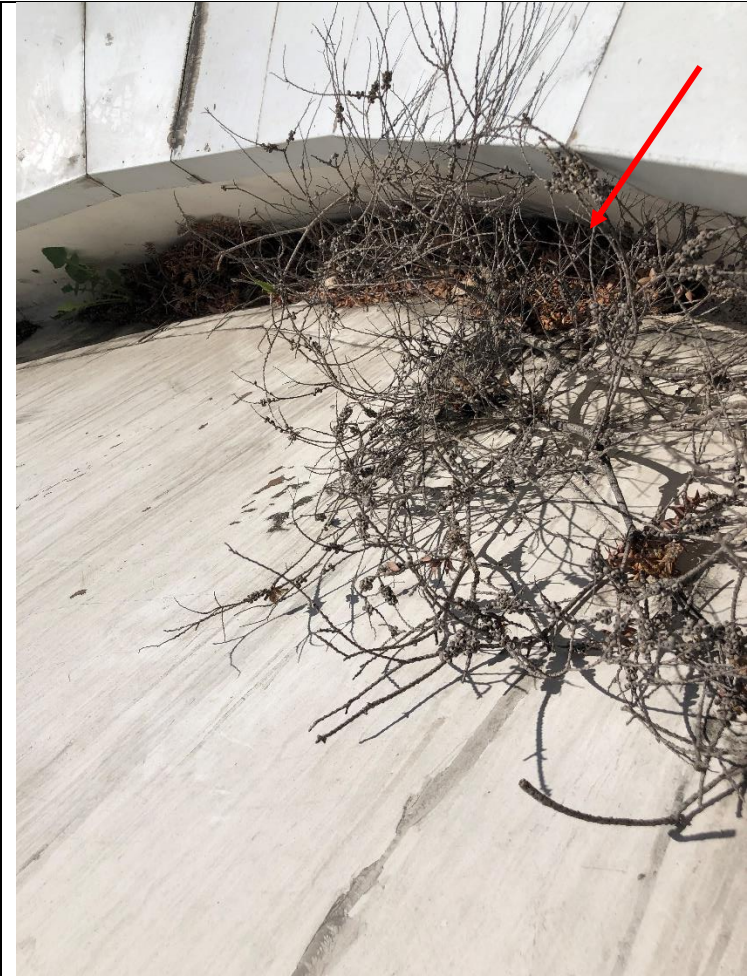
Photo 100:
A large amount of tree and leaf debris was observed on the roof. Tree debris built up between the steep slope of the west roof and the low parapet.

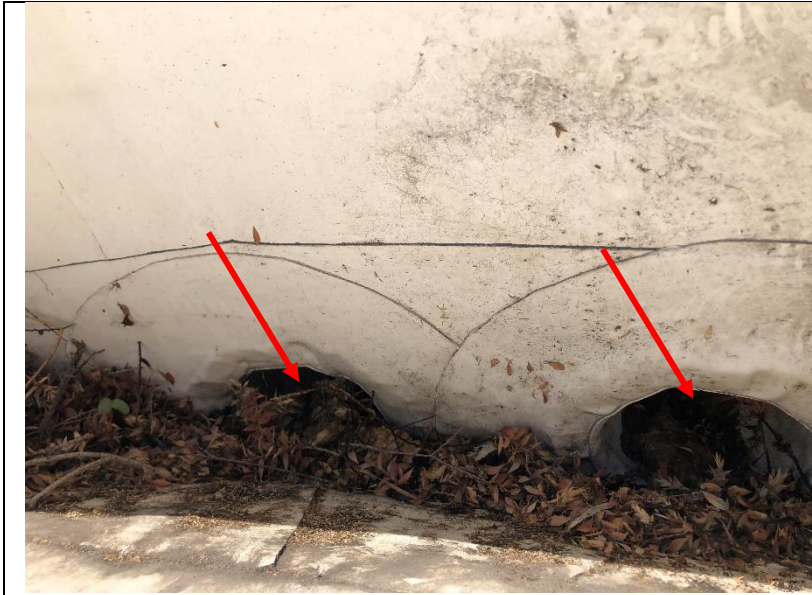
Photo 101:
A large amount of leaf and branch debris at drains on the roof.
