APR 21 2022

BOARD OF RECREATION
AND PARK COMMISSIONERS

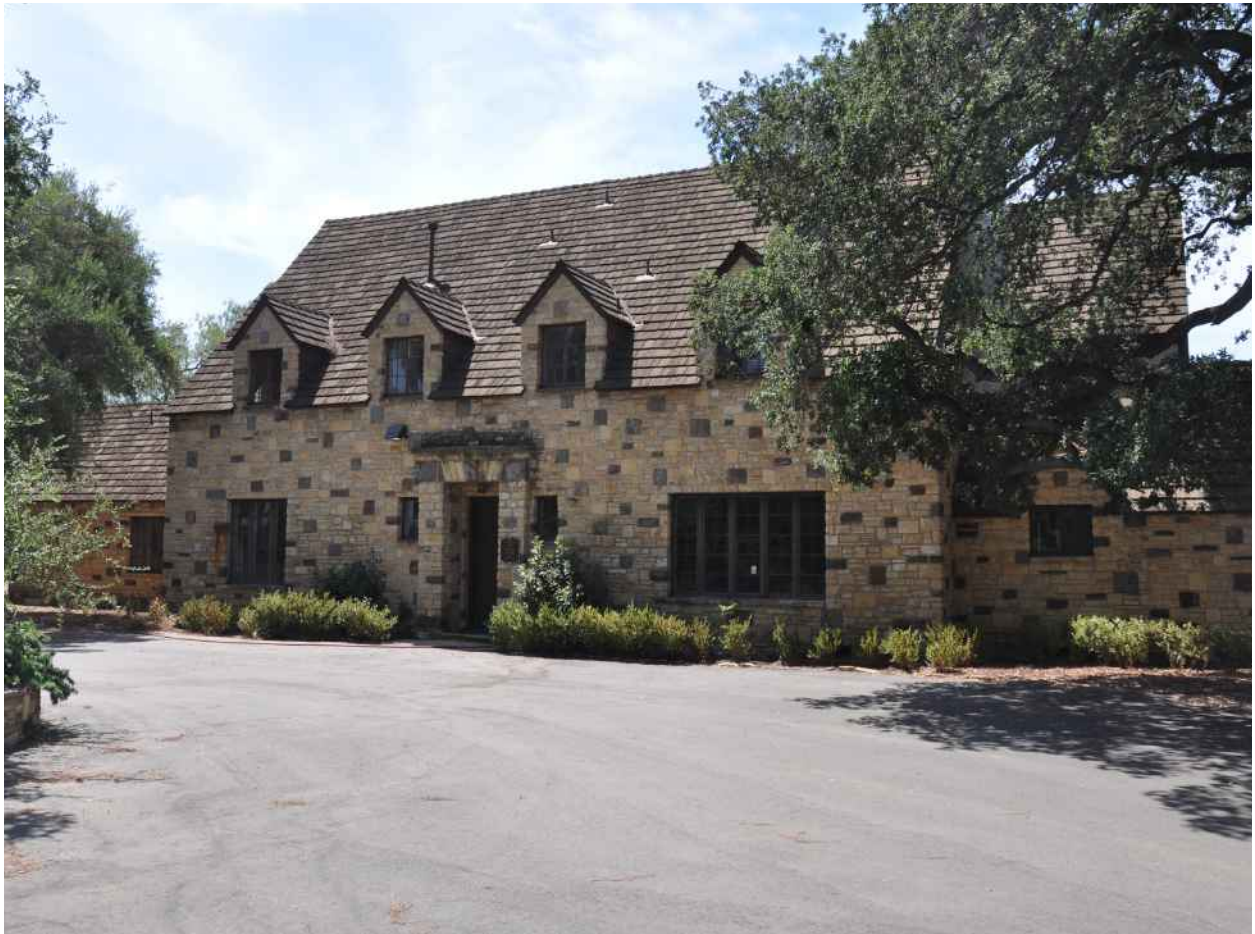
PREPARED FOR THE CITY OF LOS ANGELES
DEPARTMENT OF RECREATION AND PARKS

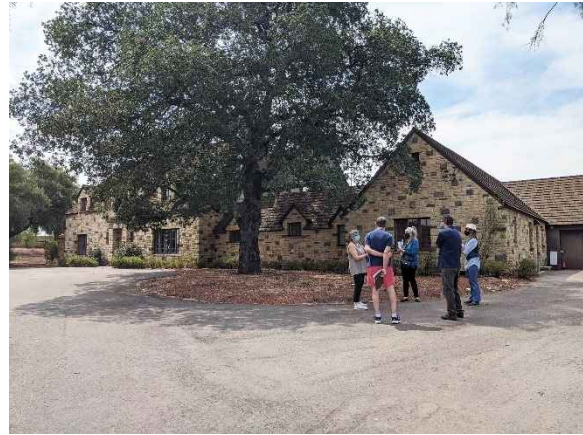
Figure 3: Site tour with Friends on June 29, 2021.

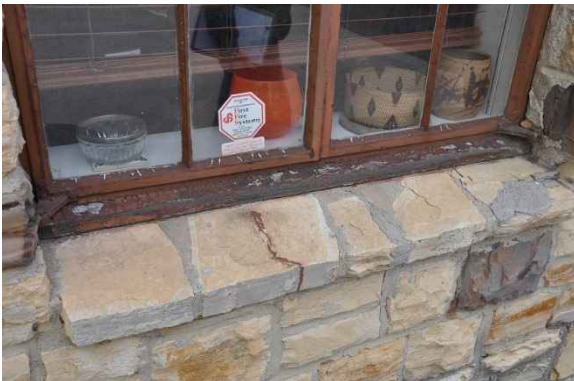
Figure 4: Wood sills typically require patching and paint.

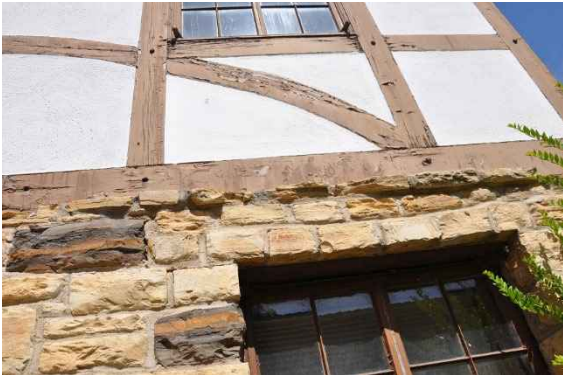
Figure 8: Flaking paint, wood deterioration and missing pegs at south second floor façade.

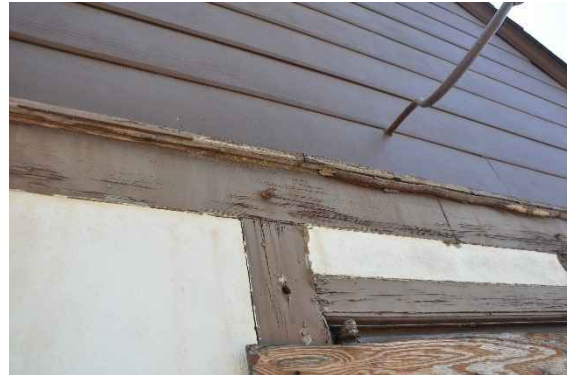
Figure 9: Flaking paint, wood deterioration and missing pegs at west garage facade.

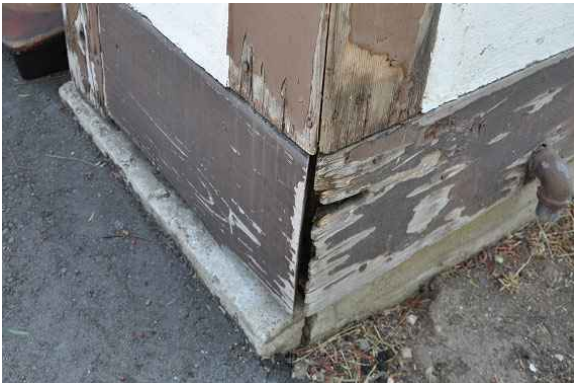
Figure 10: Deteriorated boards separating at northwest corner of garage.

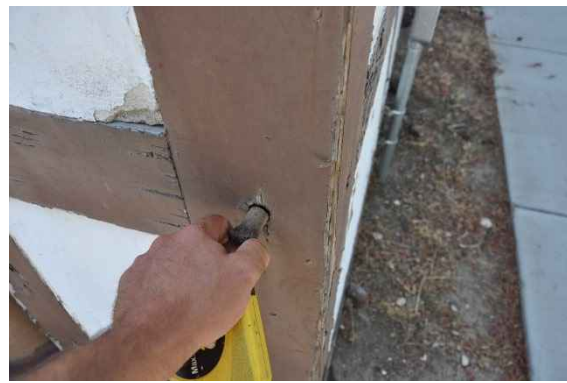
Figure 11: Loose peg at northwest corner of garage.

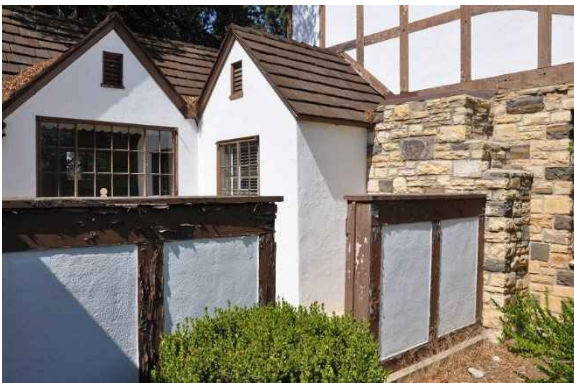
Figure 12: Wall at drying yard is not structurally sound and requires repairs using in-kind materials to match the existing wall.

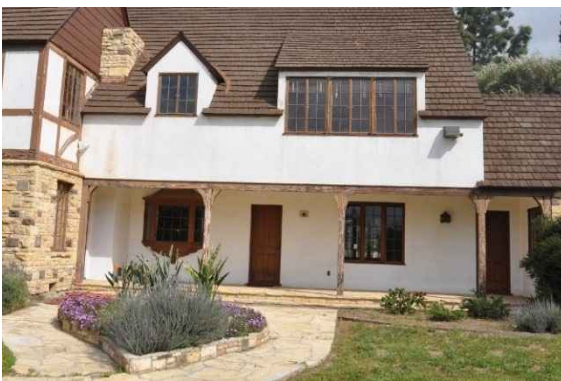
Figure 13: South facing porch looking north.

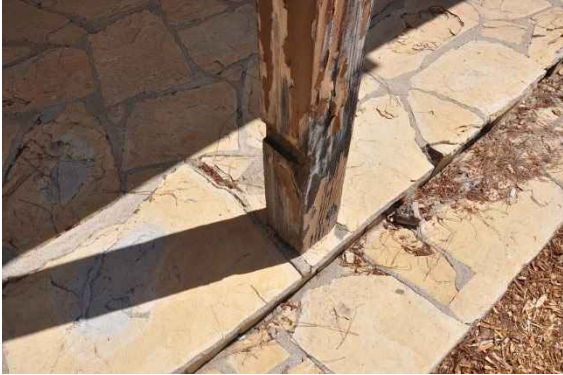
Figure 15: Damaged pier base with missing material.

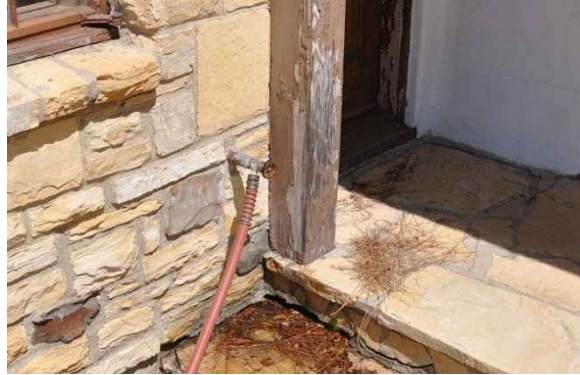
Figure 16: Pier base requiring paint repair.

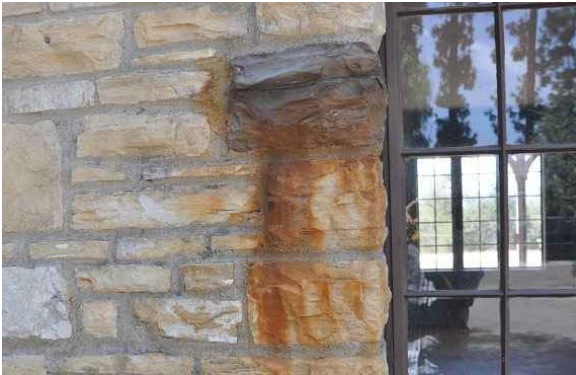
Figure 17: Dark sandstone is leaching iron onto surrounding limestone at north façade, creating dark orange streaks.

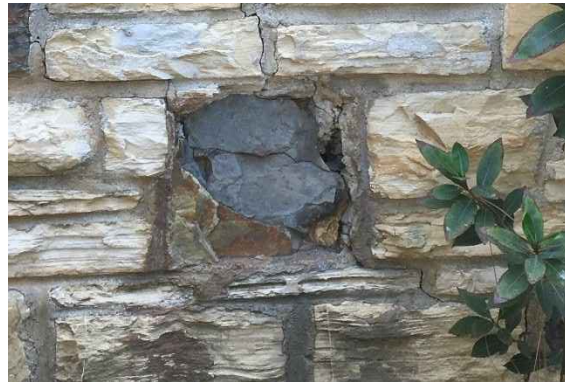
Figure 20: Dark sandstone has spalled and is missing pieces.

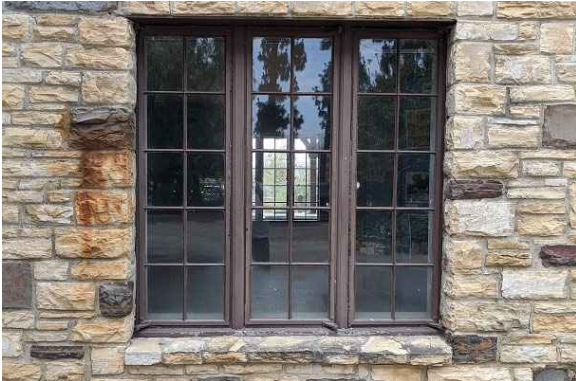
Figure 21: Typical steel window.

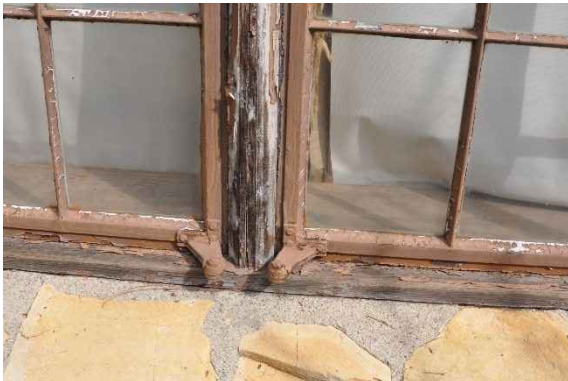
Figure 23: Window paint at exterior is generally deteriorated.

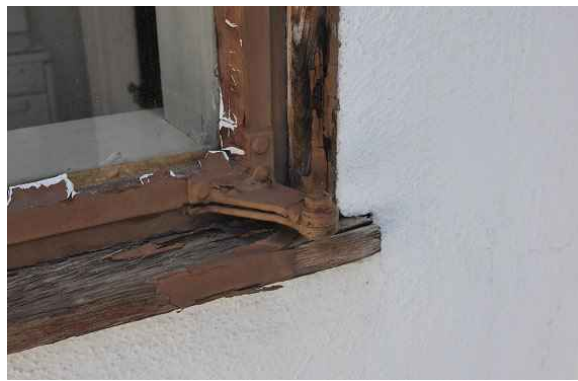
Figure 24: Glazing compound is typically cracked and wood sills require repair (see exterior wood section).

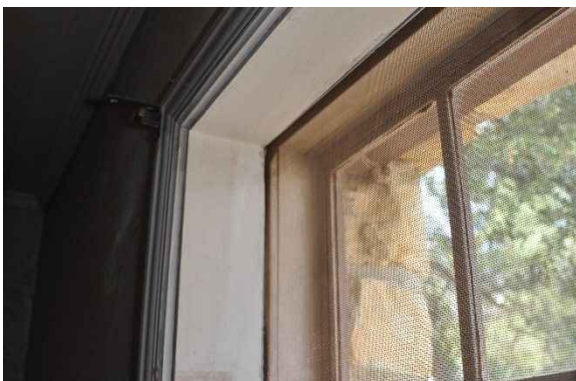
Figure 25: Most windows retain original retractable screens.

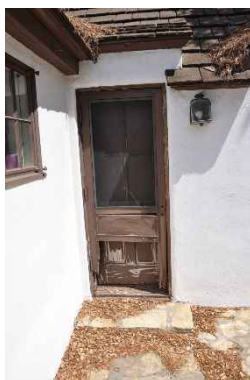
Figure 26: The screen door leading into the drying yard requires reconstruction.

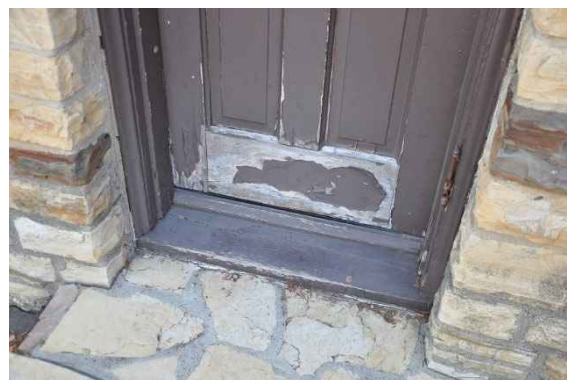
Figure 27: Lower portions of doors typically show more advanced deterioration.

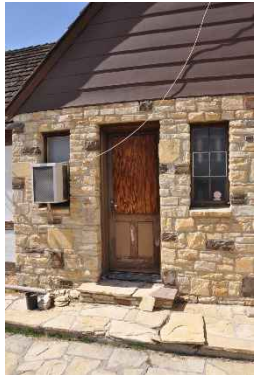
Figure 28: The door leading into one pool restroom is boarded where a large portion of panel was removed.

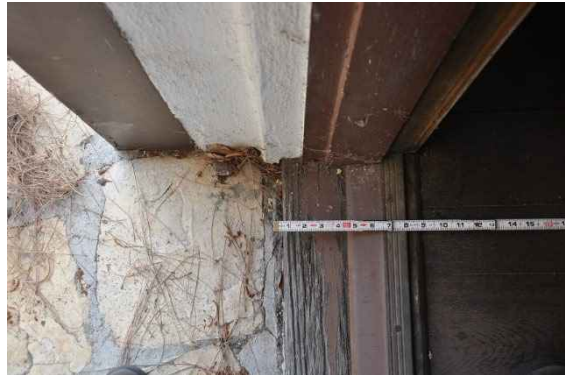
Figure 29: Exterior wood sills are typically deteriorated, and many require replacement.

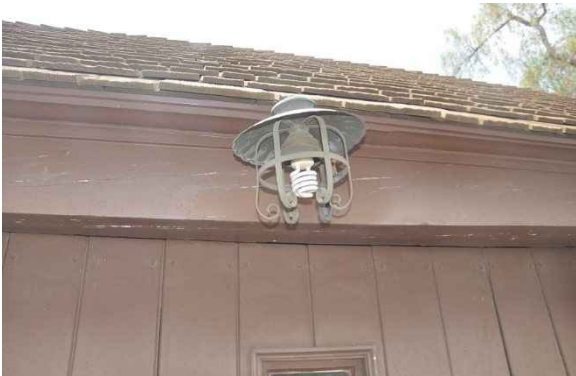
Figure 30: Original light fixture at the garage to be refurbished.

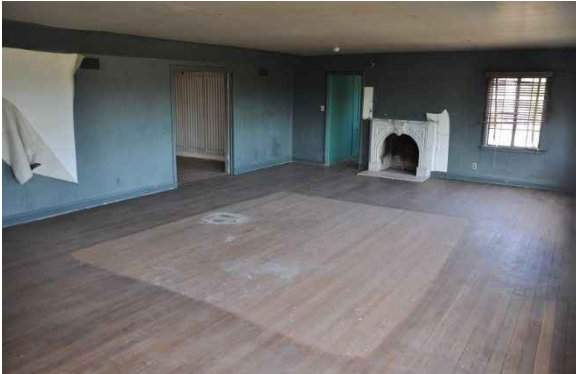
Figure 34: The master bedroom has original wood flooring with a significant difference in color at the center where a rug or carpet previously laid.

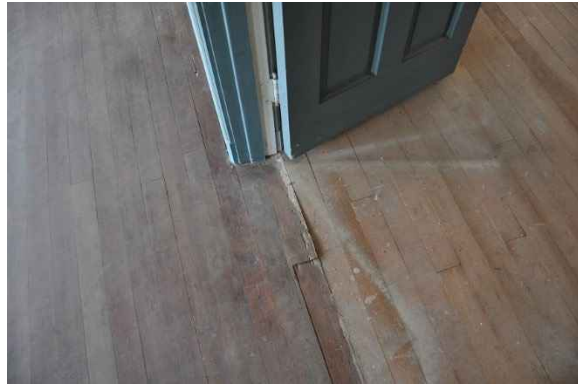
Figure 35: Loose boards at this room threshold should be reattached.

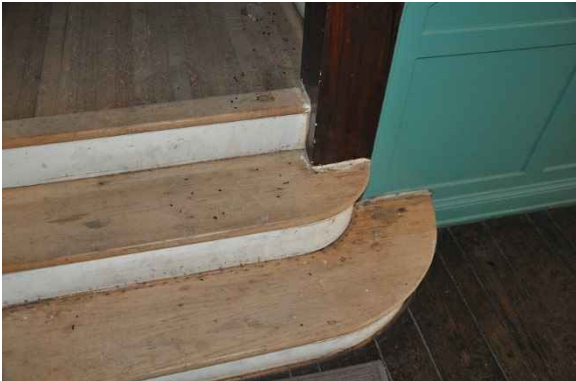
Figure 36: The first two stair treads at the entry hallway have exposed plywood subfloor with carpet tack holes and some discoloration.

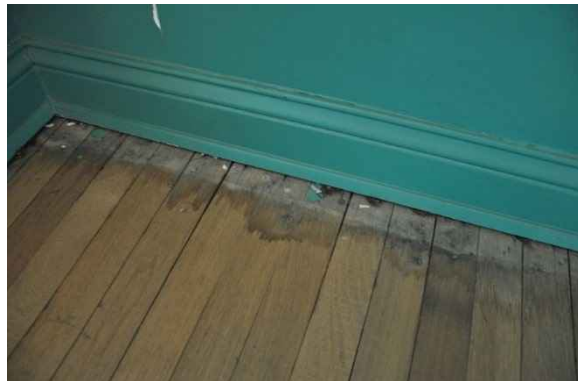
Figure 37: Water damage is present at floor boards in the second-floor corridor.

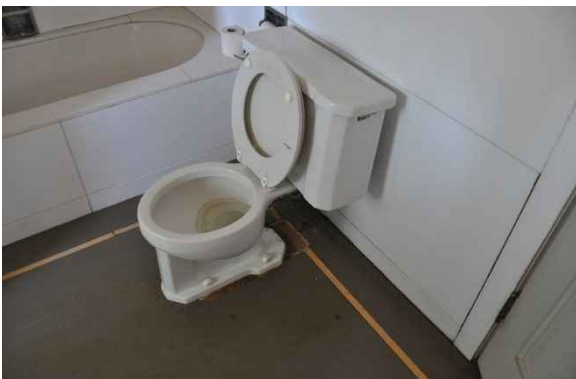
Figure 38: Original linoleum flooring remains in the guest wing bathroom.

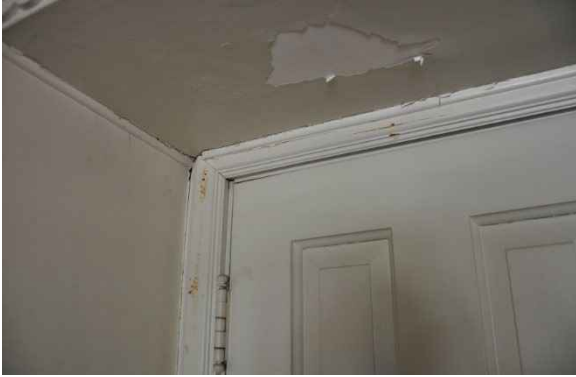
Figure 42: Thick layers of flaking paint have chipped and fallen away from plaster in some areas.

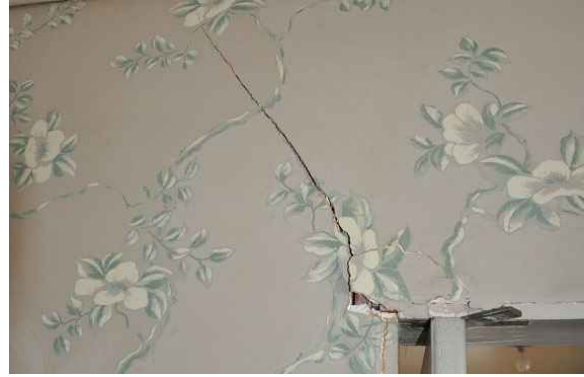
Figure 43: Wallpaper has ripped over cracking at plaster, often at corner joints.

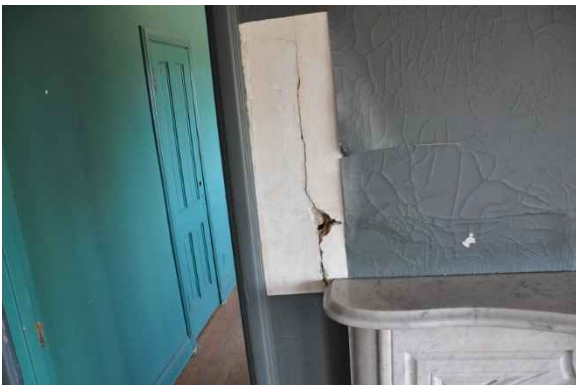
Figure 44: Typical plaster cracking condition.

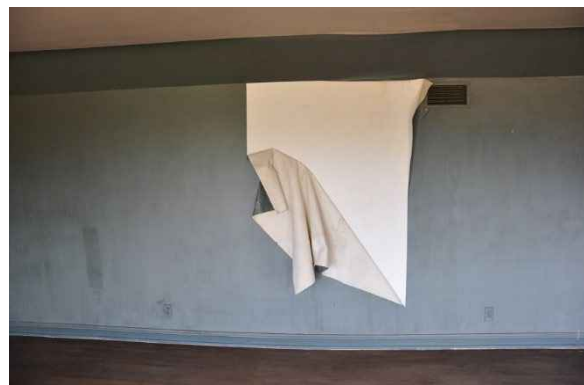
Figure 45: Large swaths of wallpaper have delaminated in some areas.

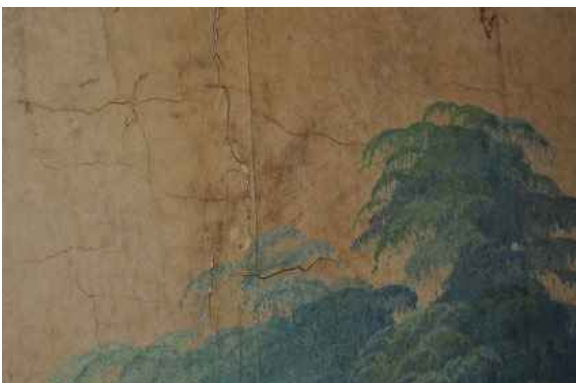
Figure 46: The Great Room wallpaper murals have cracked and discolored over time, likely due to heat and sun exposure.

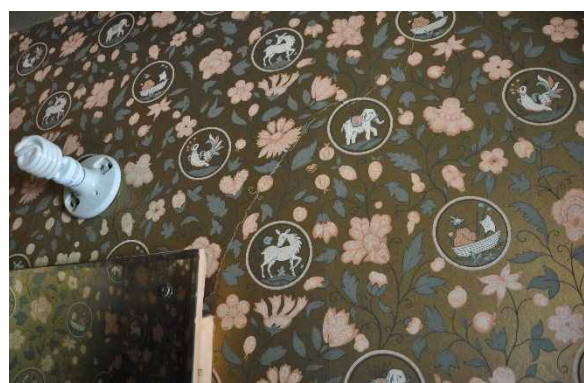
Figure 47: Ornate wallpaper remains in the Powder Room.

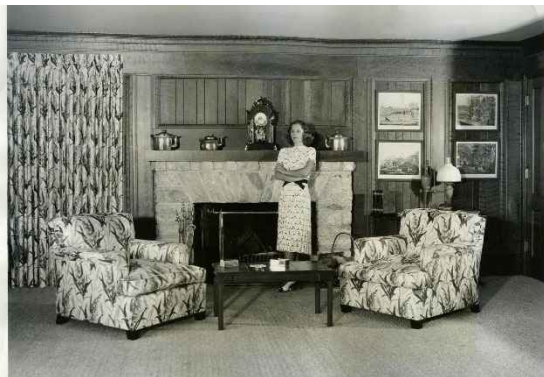
Figure 48: This photograph of Stanwyck in the Great Room shows the use of table lamps for mood lighting.

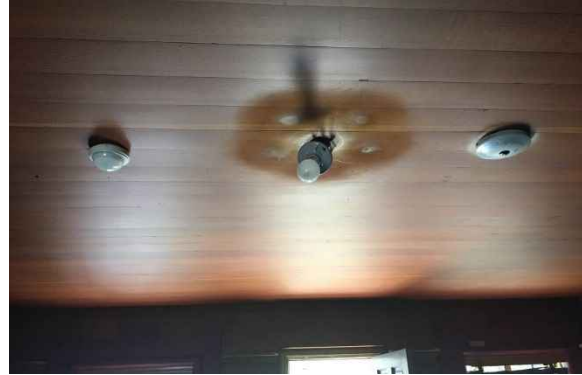
Figure 51: The Trophy Room ceiling bares evidence of a missing light fixture.

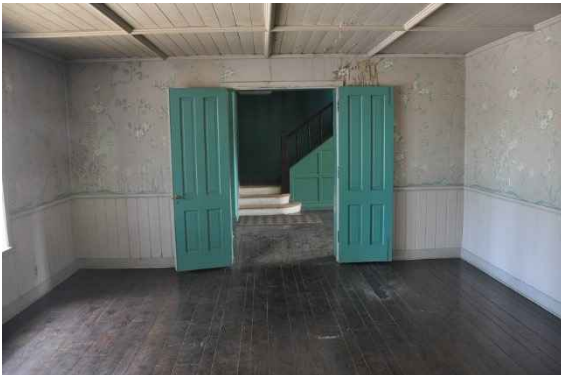
Figure 52: Original double wood panel doors leading into the dining room remain.

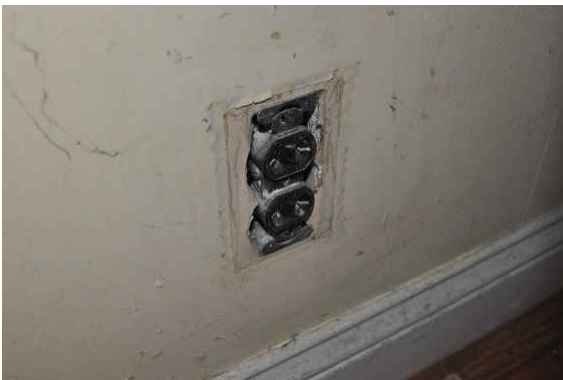
Figure 56: Many electrical outlets require repair.

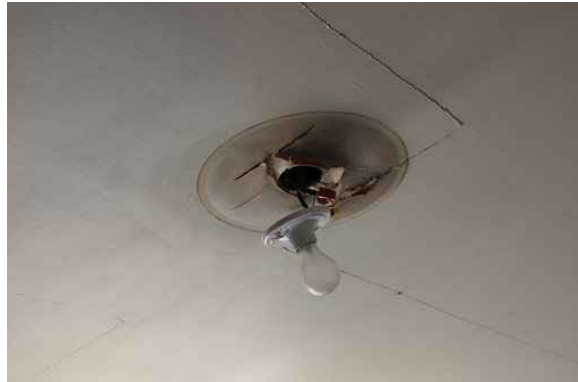
Figure 57: Light fixtures throughout the house have been damaged and likely require rewiring in order to restore operability.

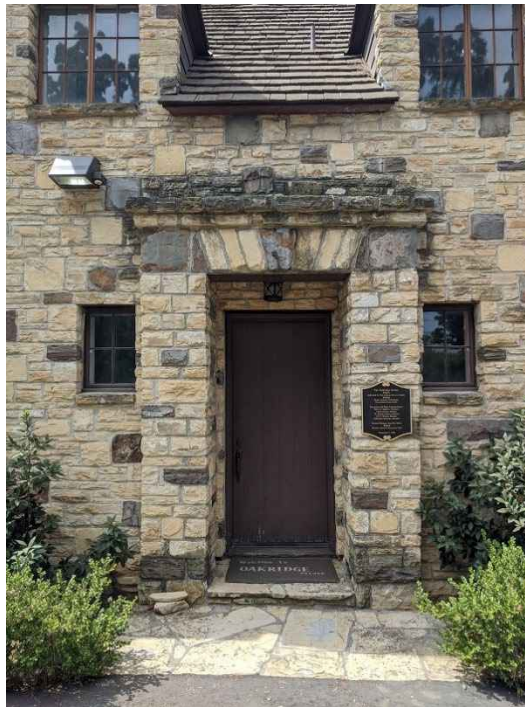
Figure 58: View of the front (north) entrance door, which does not have a level landing for accessible entry.

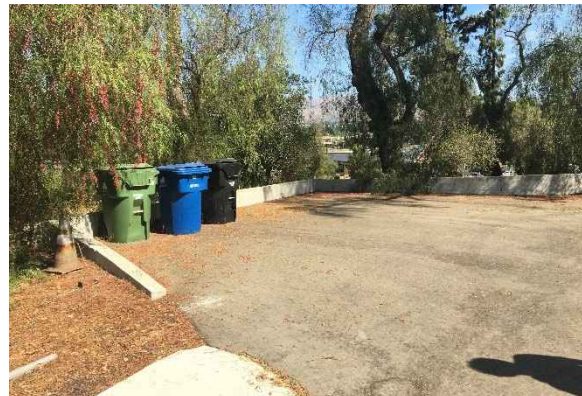
Figure 62: View of the recommended west accessible parking location with existing accessible path in foreground.

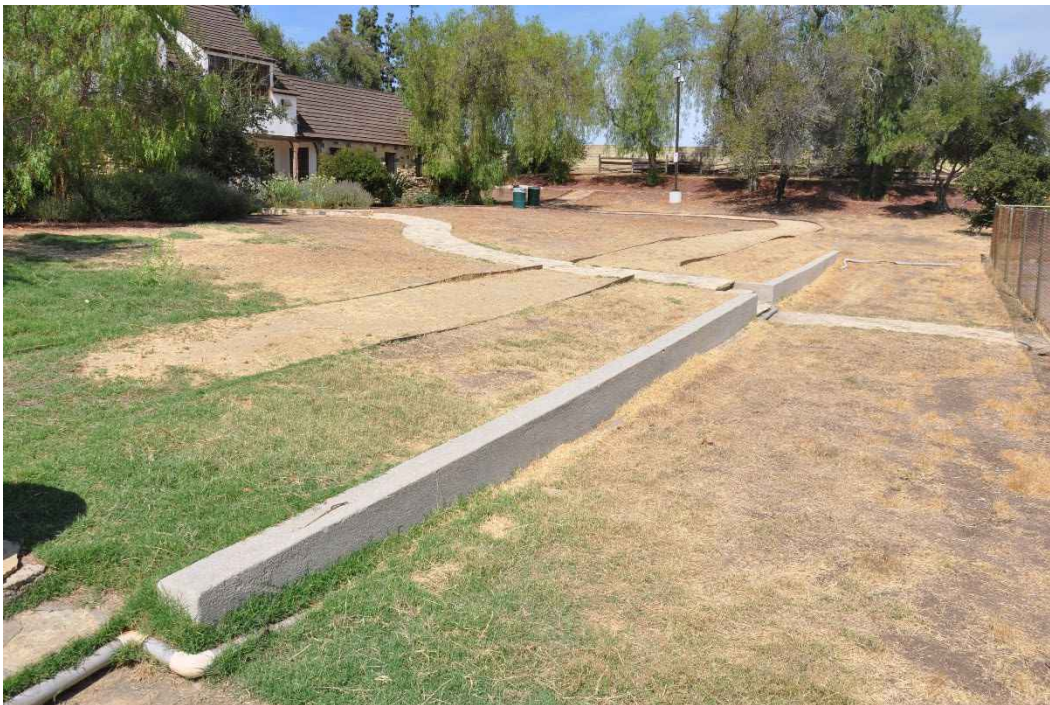
Figure 63: Rear yard zone looking northeast.

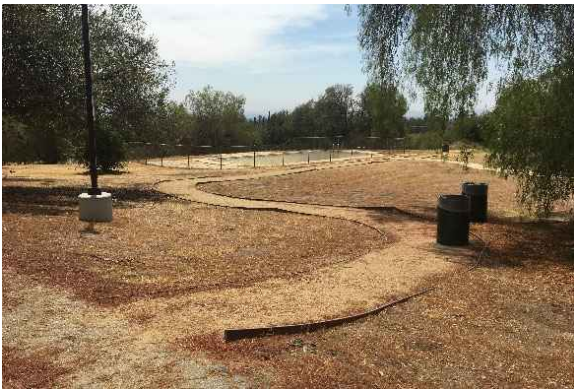
Figure 64: Existing decomposed granite paths and edging looking southwest.

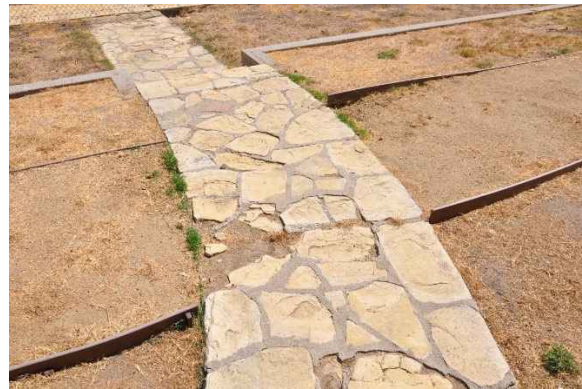
Figure 65: The flagstone paths throughout the yard zone require repair.

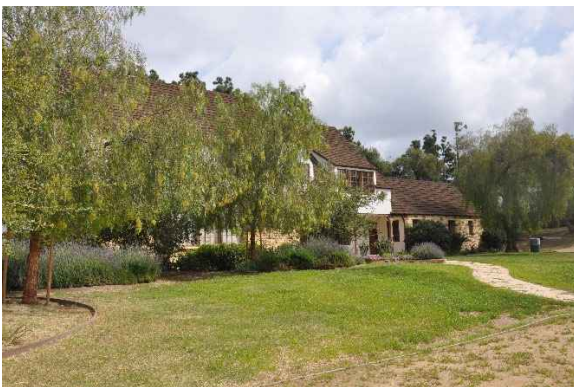
Figure 66: View of the lawn and trees looking northeast. Some trees directly adjacent to the house may require pruning or removal in order to promote the long-term health of other trees and preserve views of the house.

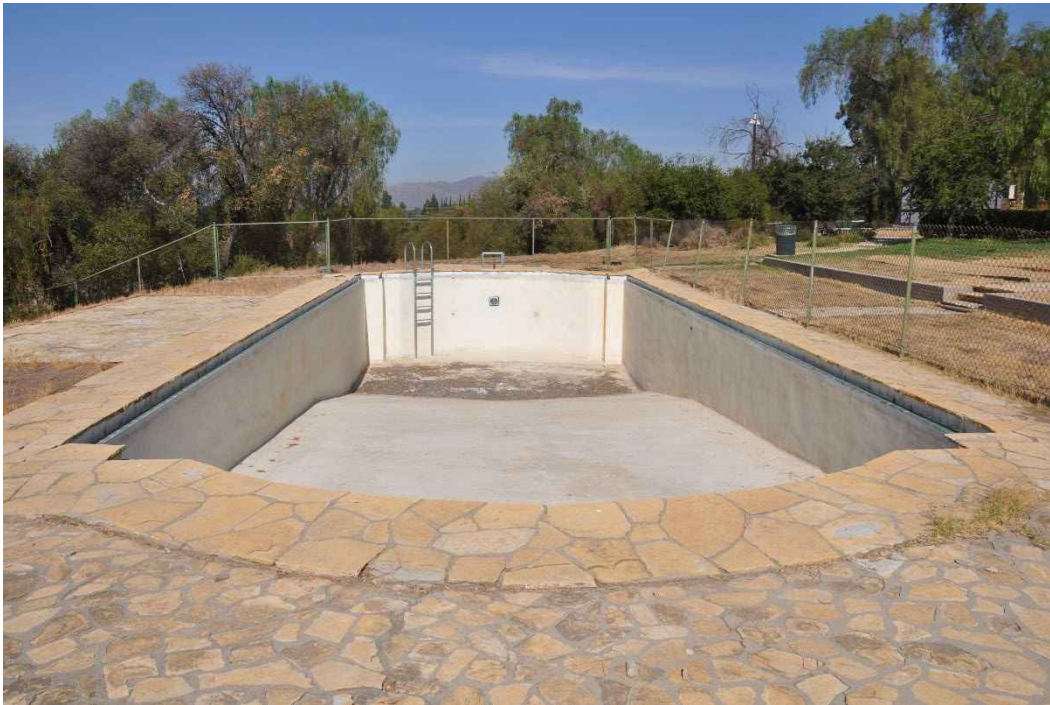
Figure 67: View of the pool looking west.

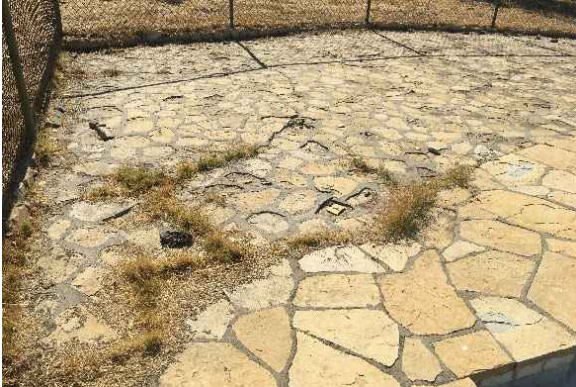
Figure 68: View of the flagstone pool surround showing deterioration and unwanted plant growth.

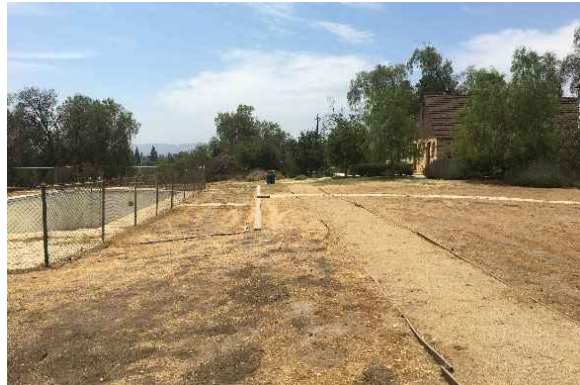
Figure 69: The landscape north of the pool would benefit from drought-tolerant plant species and waterwise irrigation strategies.

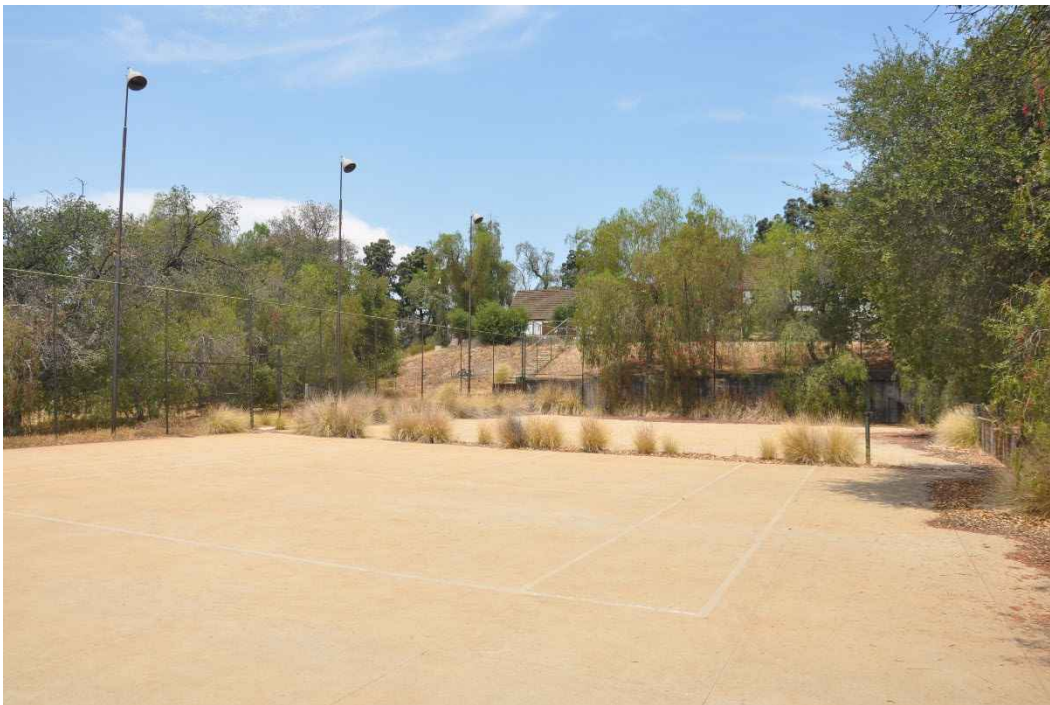
Figure 70: View of the tennis courts looking north towards the house.

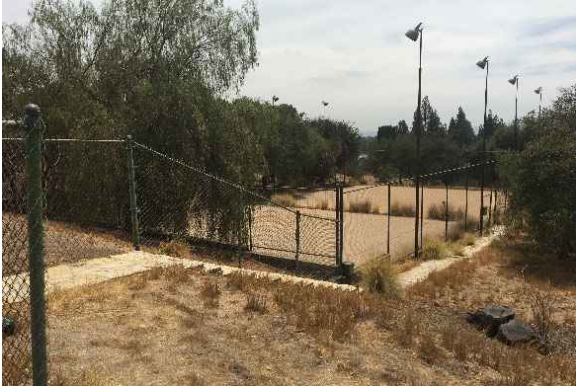
Figure 71: View of the stairs leading down to the tennis courts looking southeast.

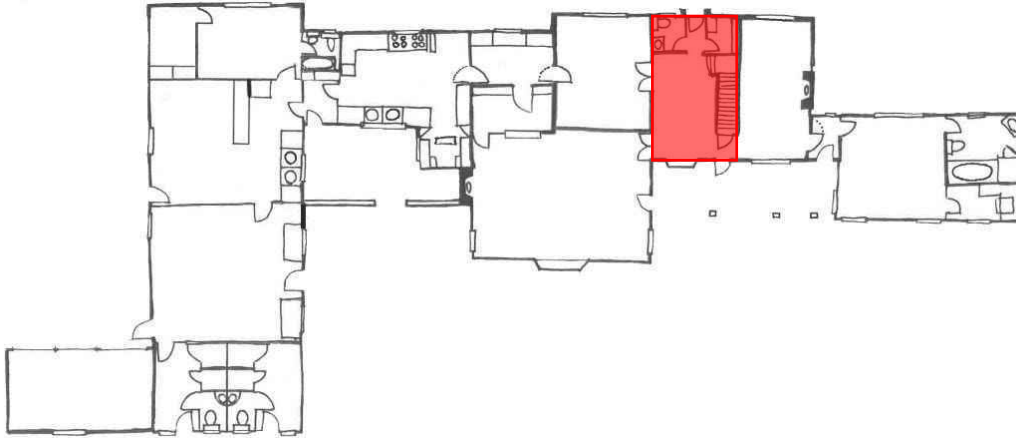
ENTRY HALLWAY, POWDER ROOM AND PHONE ROOM

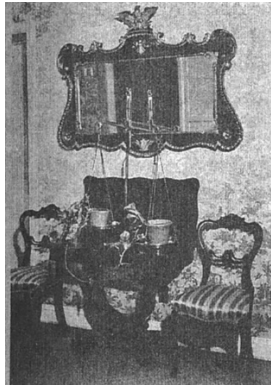
Figure 82: Historic photo showing the west wall of the entry hallway during the Stanwyck era.

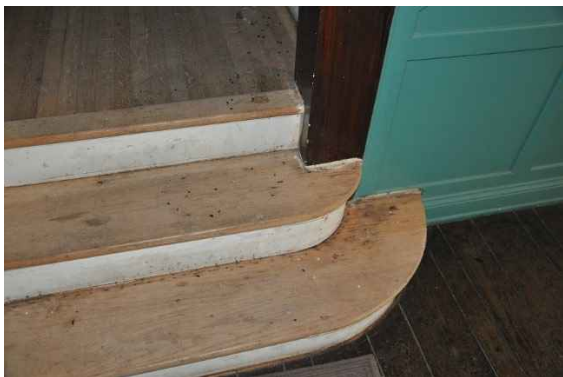
Figure 86: First two stair treads require repair.

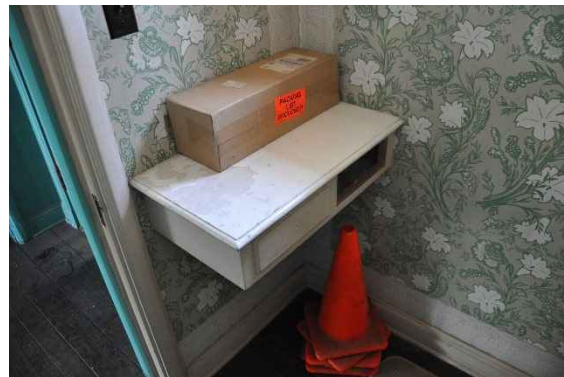
Figure 87: Phone room millwork requires repair.

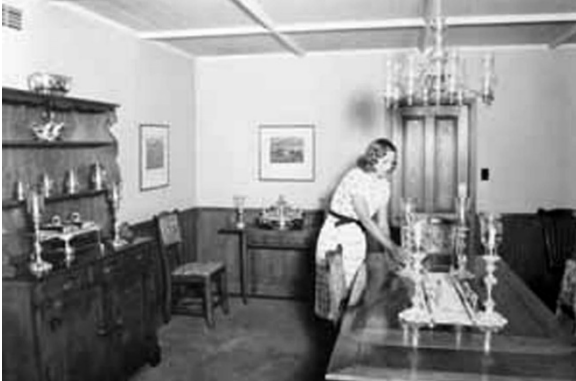
Figure 88: Historic photo showing Stanwyck arranging table settings in the dining room. Original finishes included painted plaster walls, natural wood wainscot and carpet.

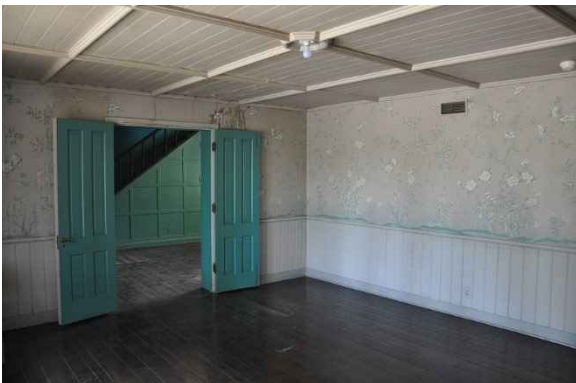
Figure 90: View looking east. Water damage is present at the east wall, floor and ceiling due to plumbing leak.

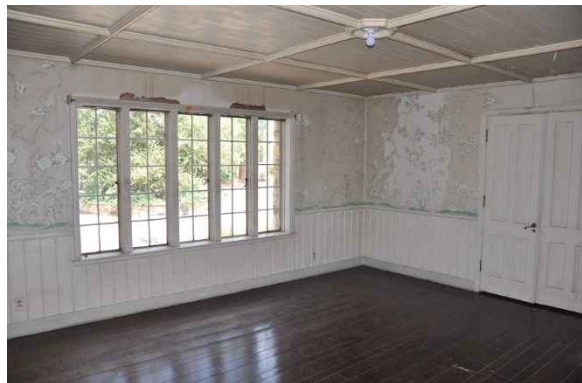
Figure 91: View looking north. Water damage is present above the windows.

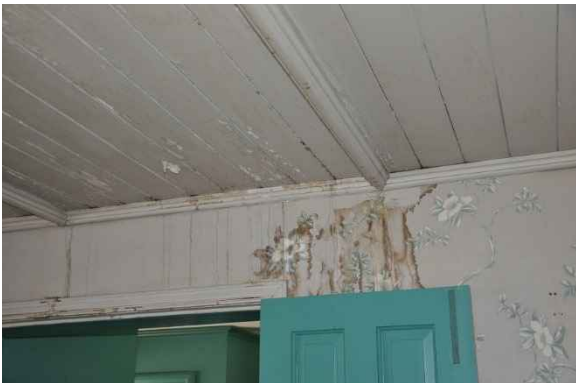
Figure 92: Detail of water damage at the east door.

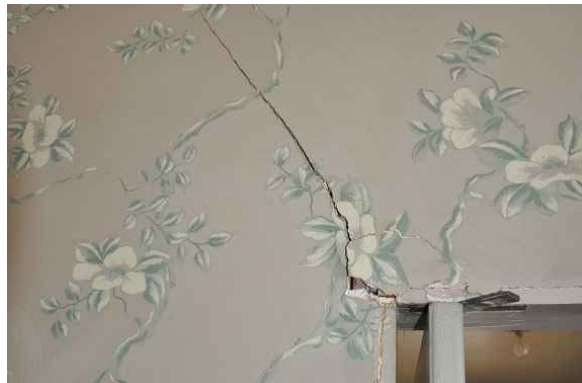
Figure 93: Detail of plaster crack at the west door.

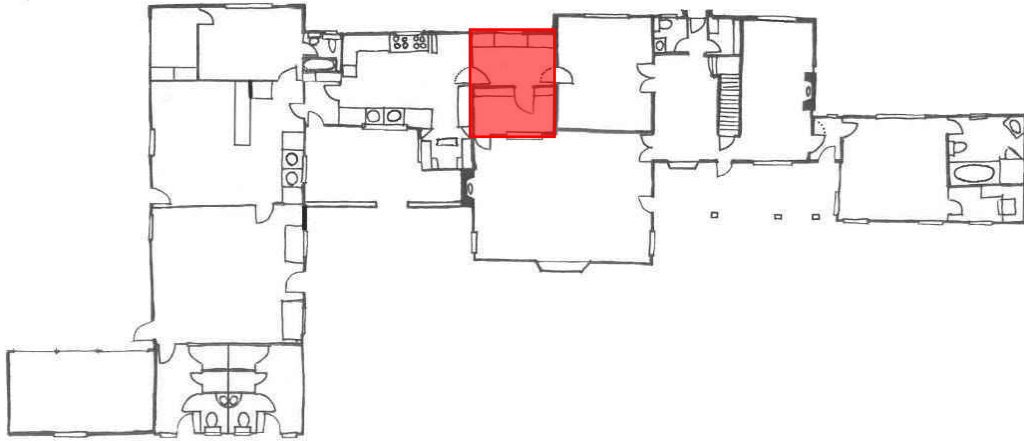
BUTLER'S PANTRY AND BAR

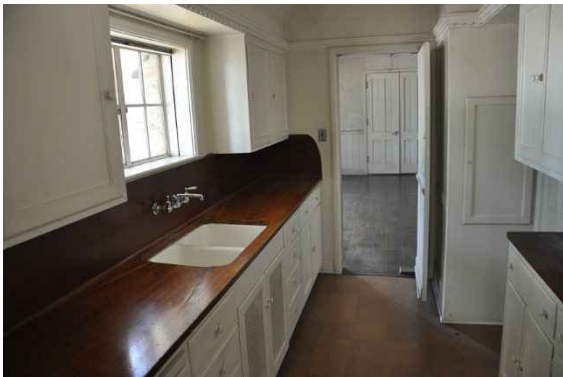
Figure 94: Butler's pantry looking west.

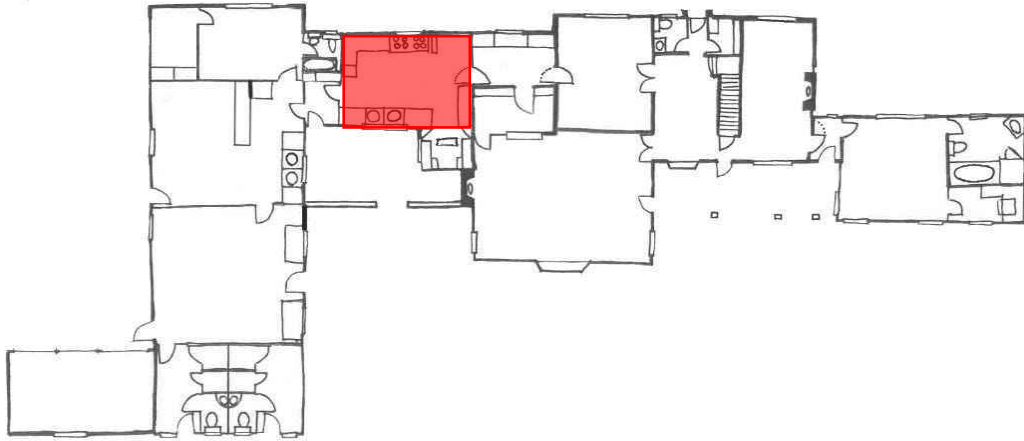
KITCHEN AND DINING NOOK

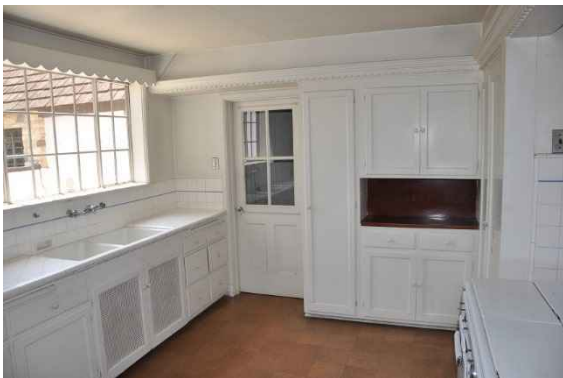
Figure 96: Kitchen looking west.

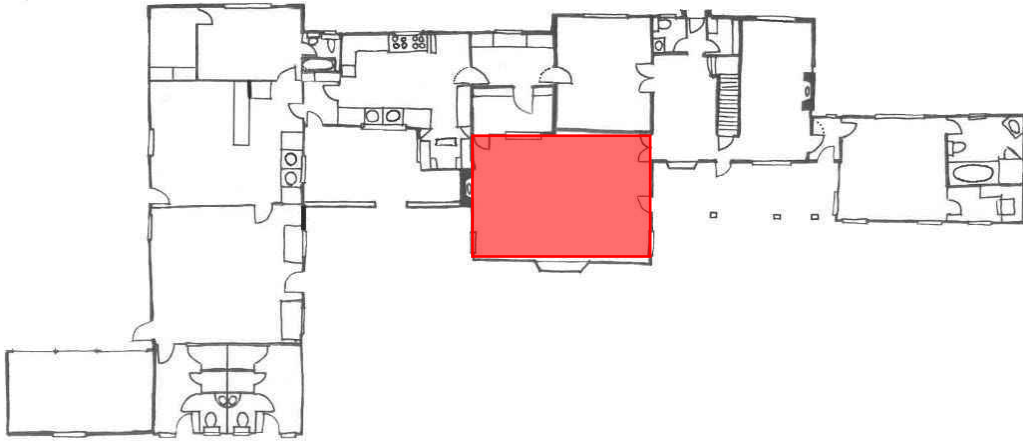
GREAT ROOM (MURAL ROOM)

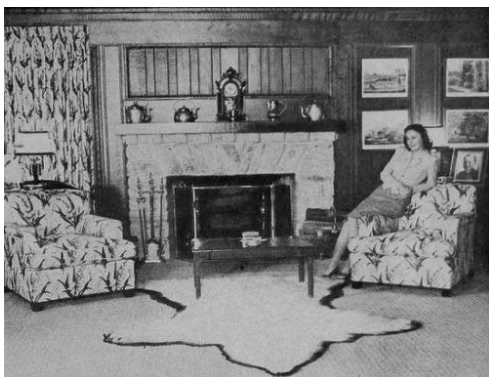
Figure 100: Stanwyck posing in the Great Room during her tenure at the house.

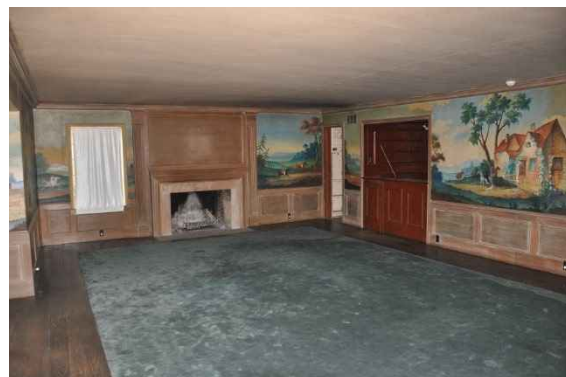
Figure 101: Current condition of the Great Room from a similar angle.

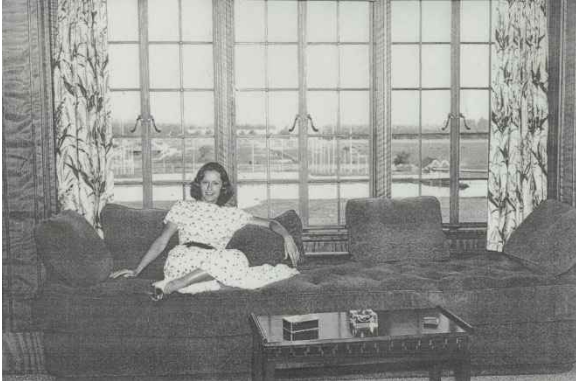
Figure 102: Stanwyck at the south bay window.

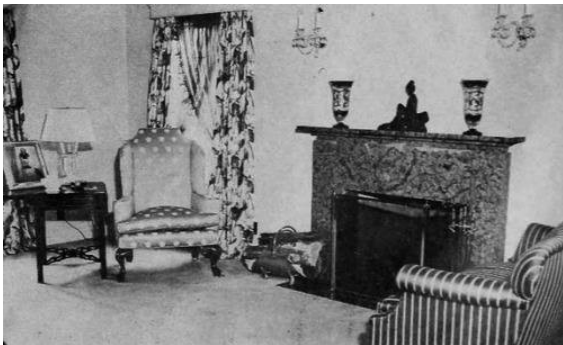
Figure 106: Stanwyck era photo showing original decorative sconces on the east wall.

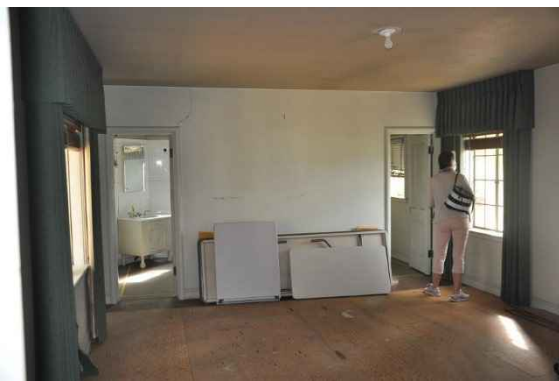
Figure 109: View looking east.

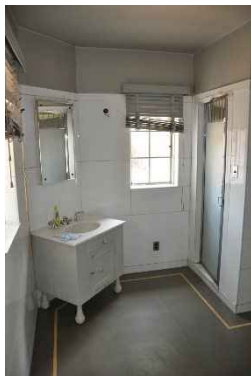
Figure 113: View looking east showing vanity wall sconces removed.

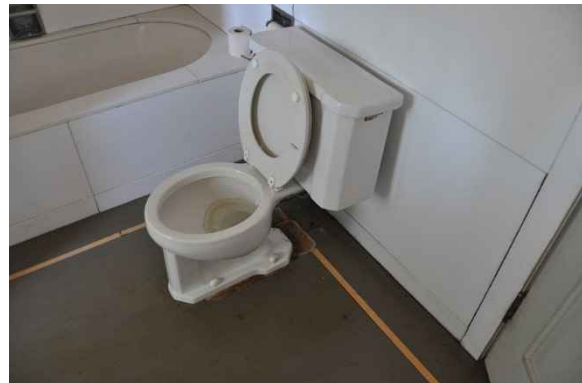
Figure 114: Original linoleum floors remain, and some repair is required.

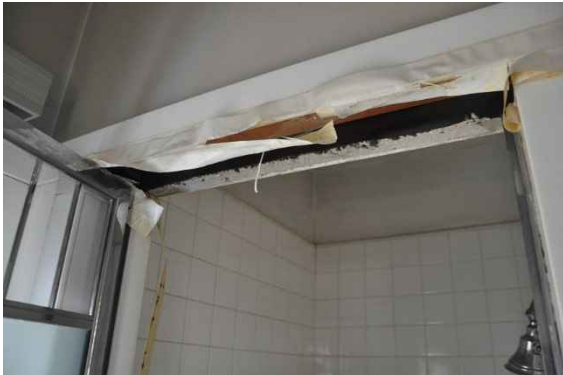
Figure 115: The shower door header requires repair.

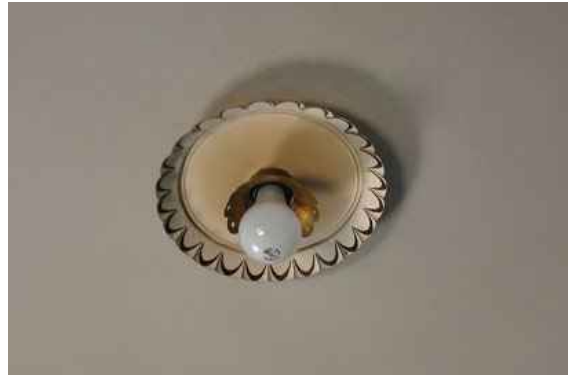
Figure 116: The original ceiling light fixture canopy remains but it may be missing its shade.

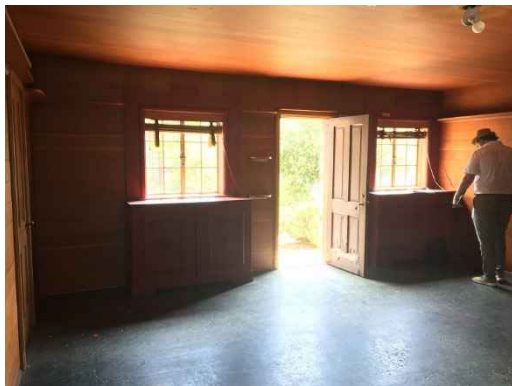
Figure 117: View looking east.

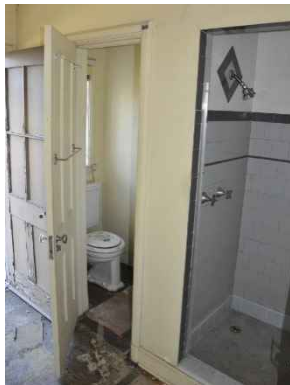
Figure 123: View of “pointers” bath looking south.

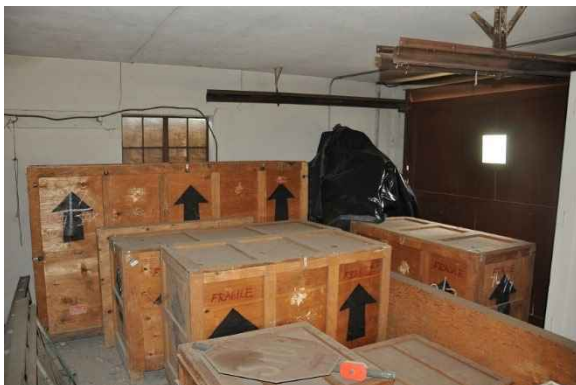
Figure 127: View looking west.

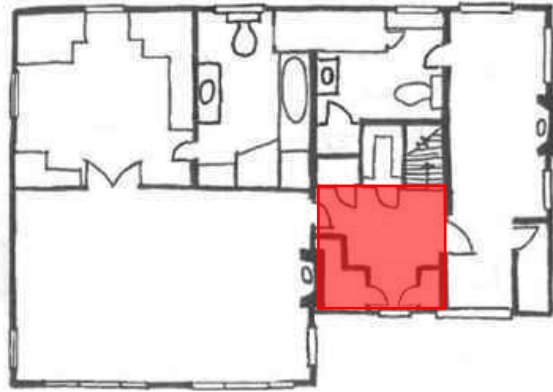
Second Floor CORRIDOR

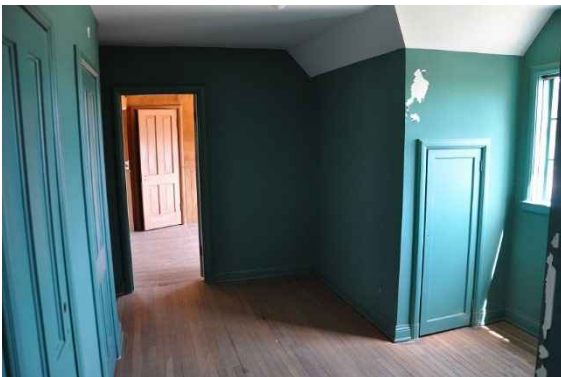
Figure 129: View looking east.

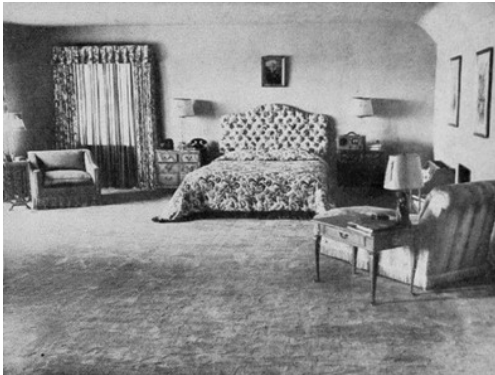
Figure 131: Historic image during the Stanwyck era looking west.

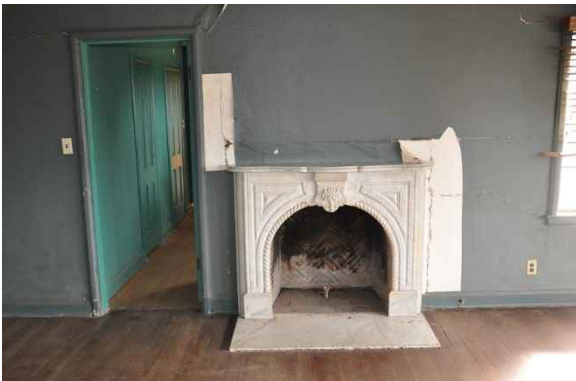
Figure 135: Original marble fireplace surround and adjacent cracked plaster wall with delaminating wallpaper.

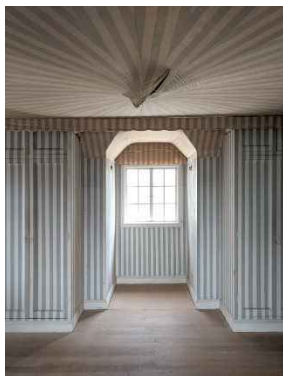
Figure 136: View looking north.

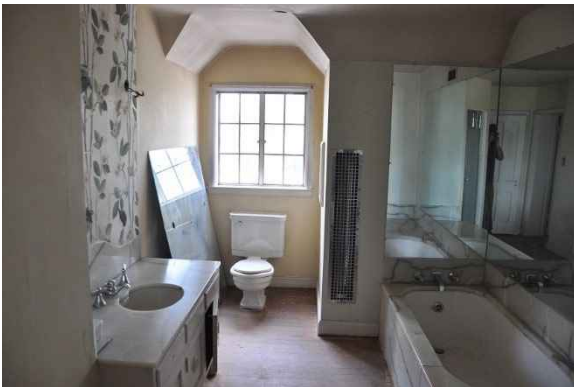
Figure 142: View looking north.

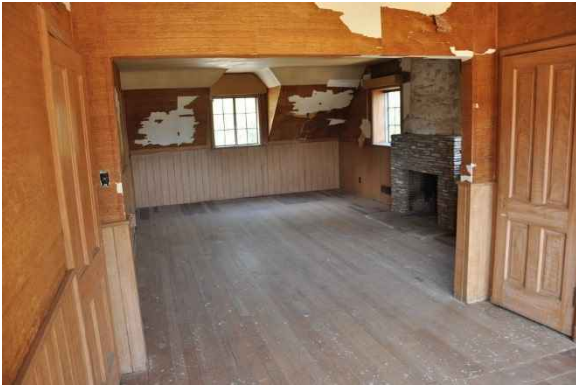
Figure 144: View looking north.

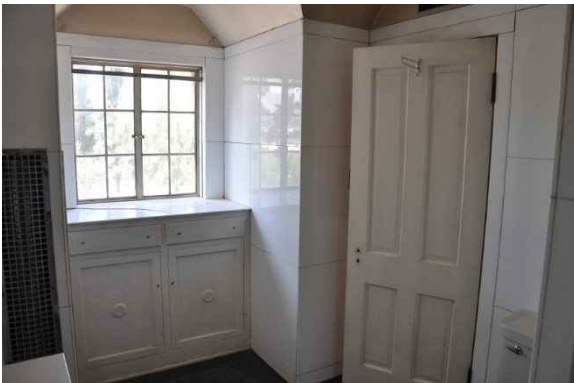
Figure 148: View looking north.

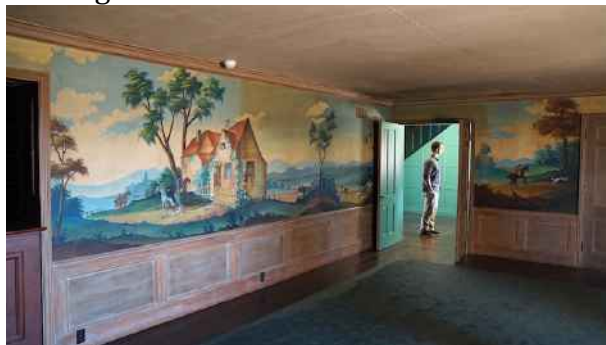
Title: Old European countryside scenes
