APR 21 2022

BOARD OF RECREATION
AND PARK COMMISSIONERS

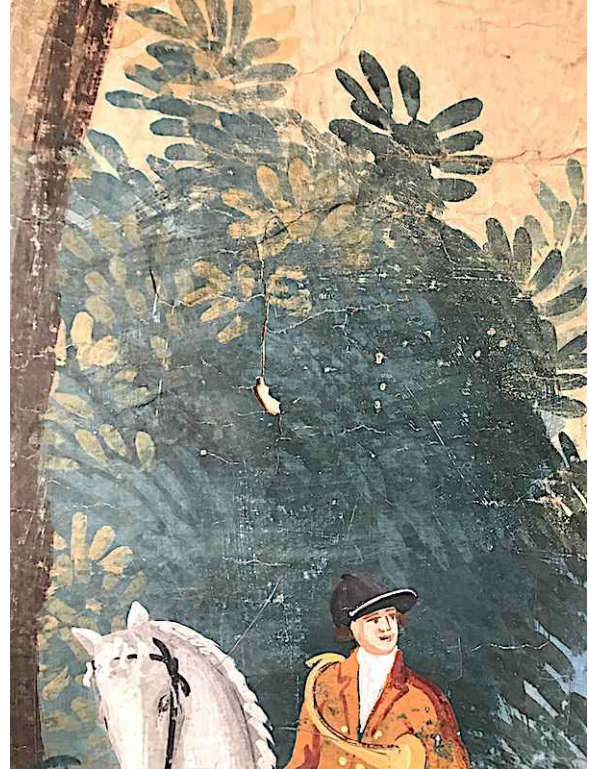
Conditions due to previous restorations:

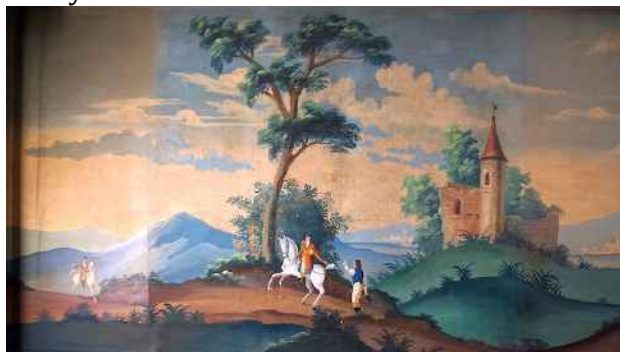
The blue colors in the center section are original.
The yellowish/brownish right and left sides are discolored due to previous poor quality retouching/restoration

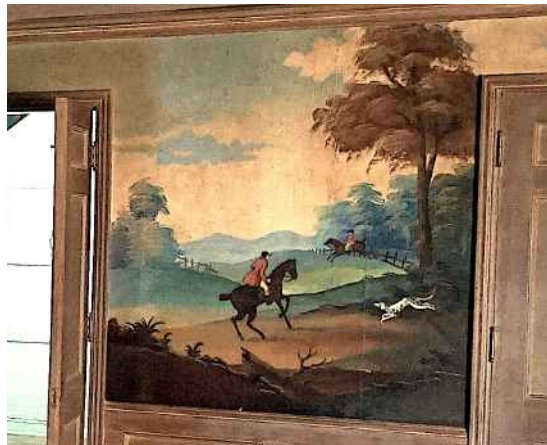
Wall with the most unstable paper adhesion (area of past water leakage?)

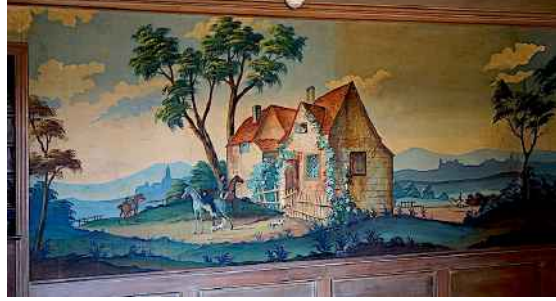
Right side (yellowed) is due to previous retouchings discolored.
House etc also damaged (abraded) in a previous cleaning.

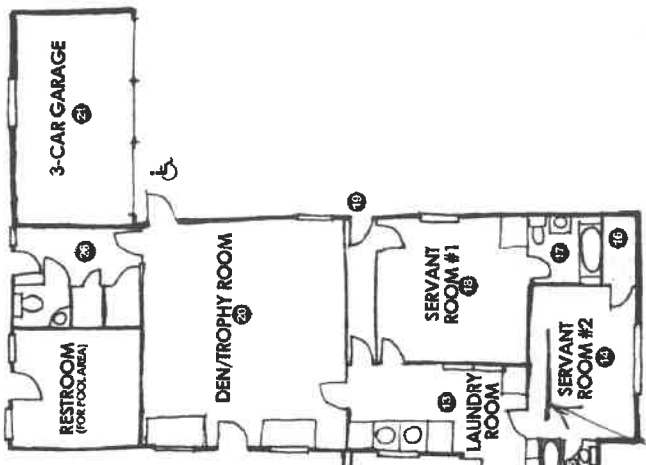
FIRST FLOOR PLAN SKETCH (N.T.S.)

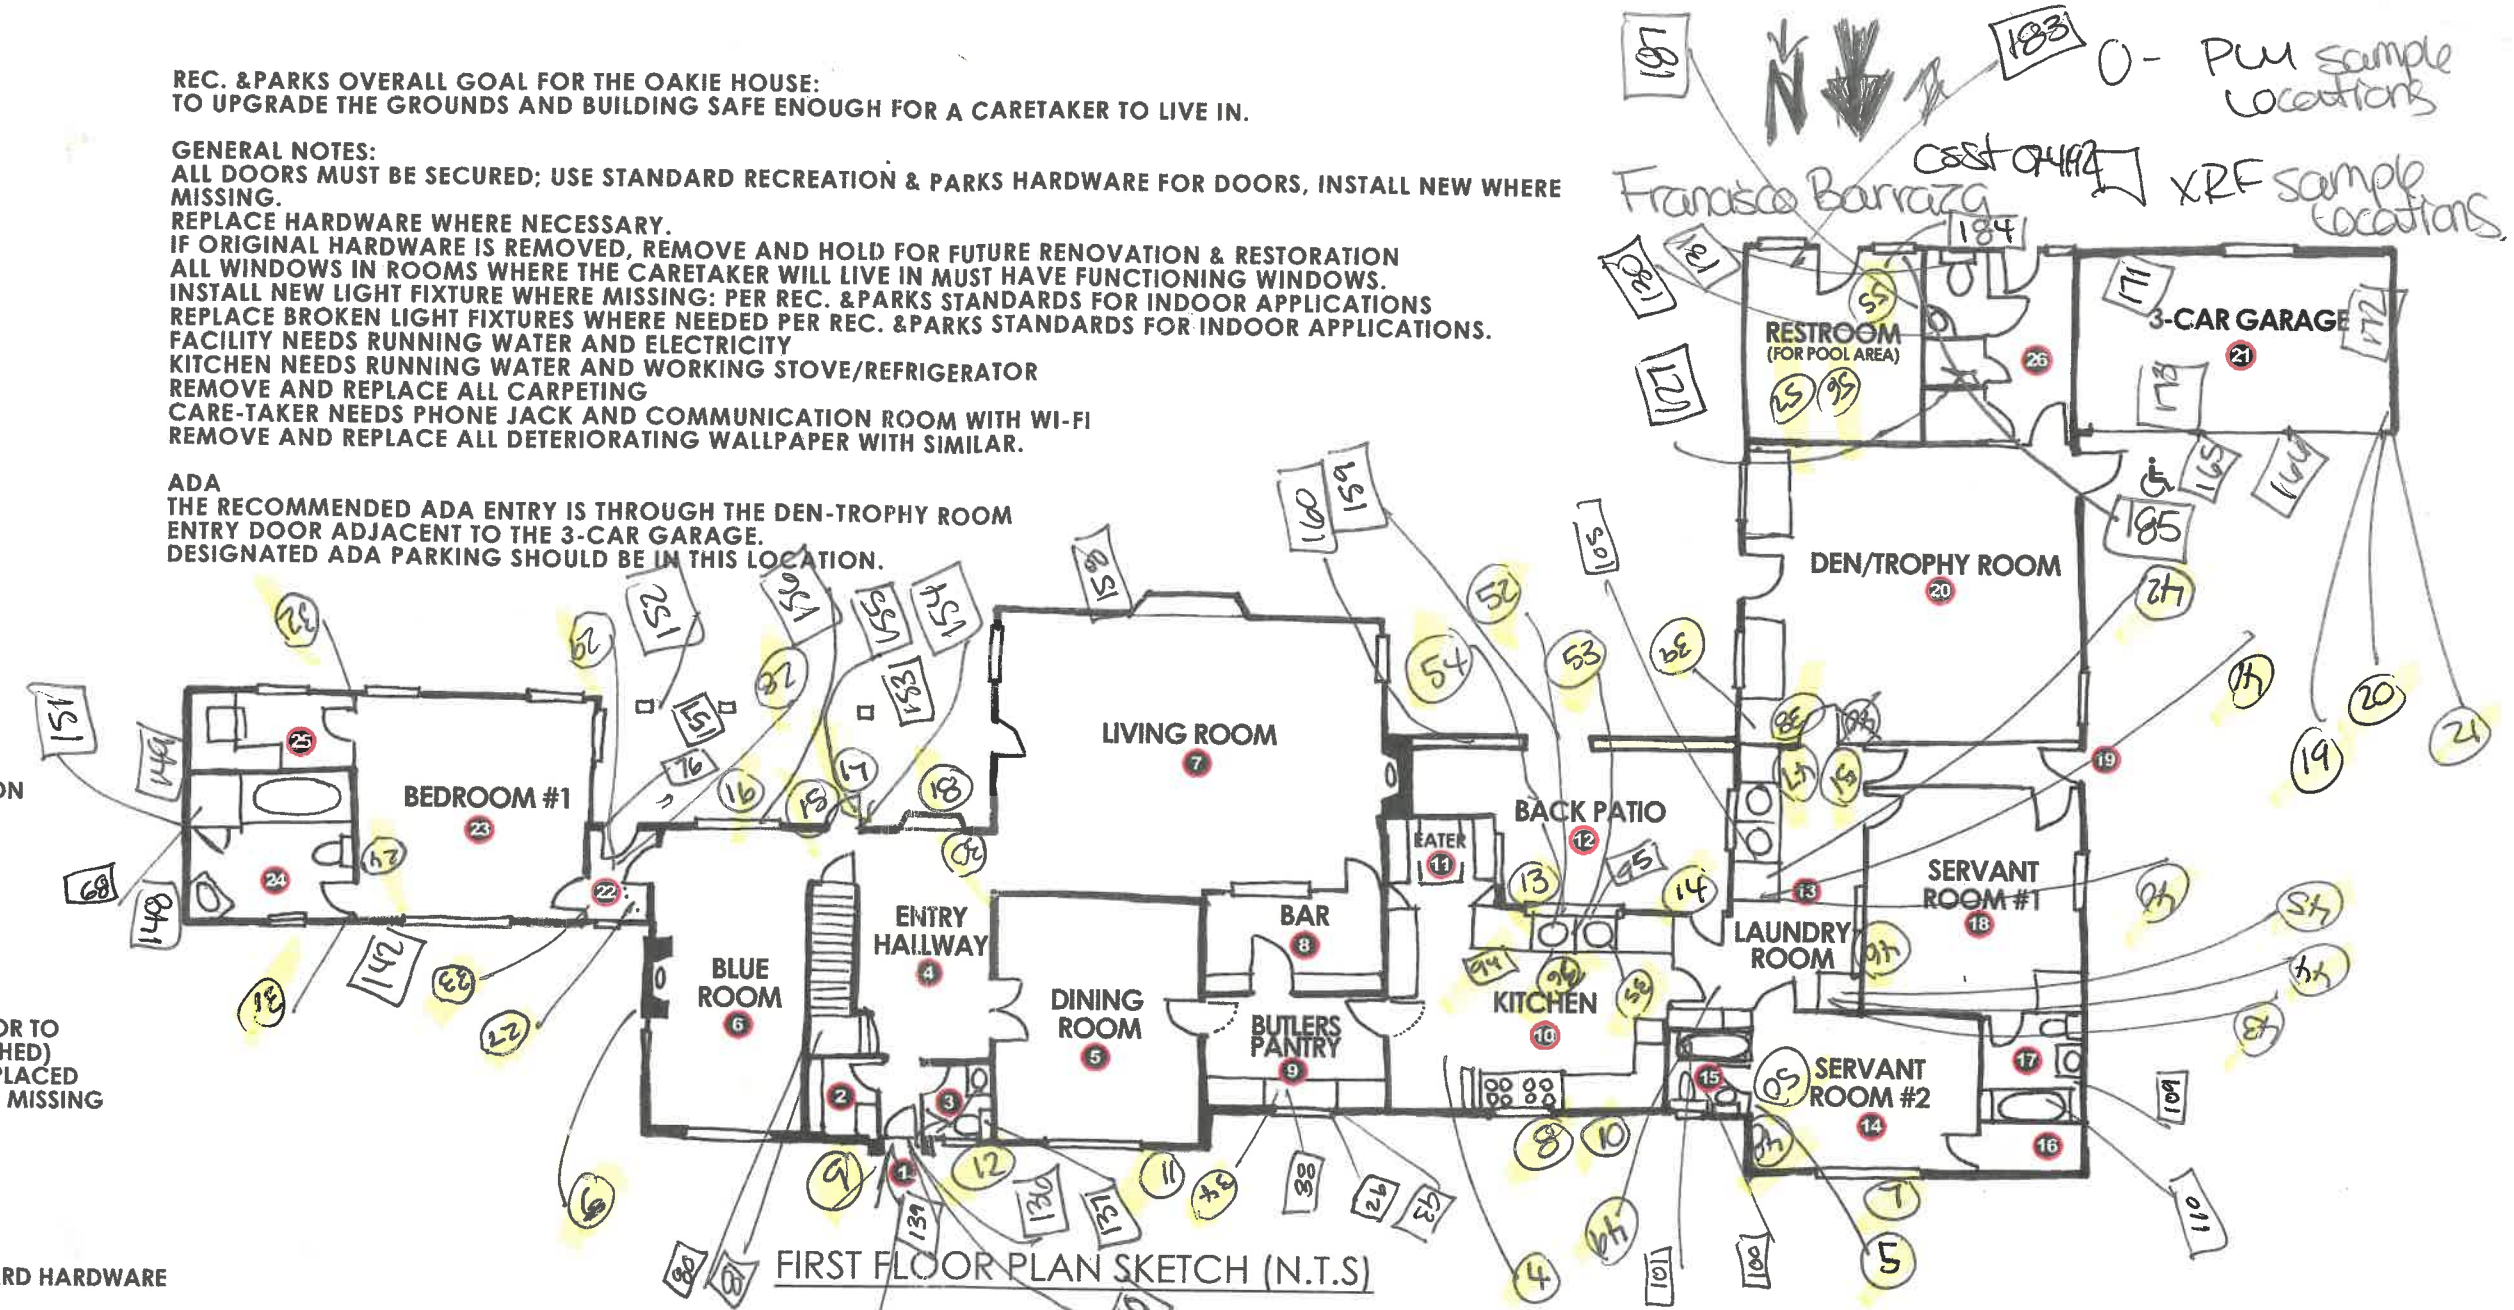
Oakie House 18650 Devonshire Street
A 2 STORY, 6500 SQ.FT. ENGLISH MANOR STYLE HOUSE DESIGNED BY ARCHITECT PAUL WILILAMS IN 1937

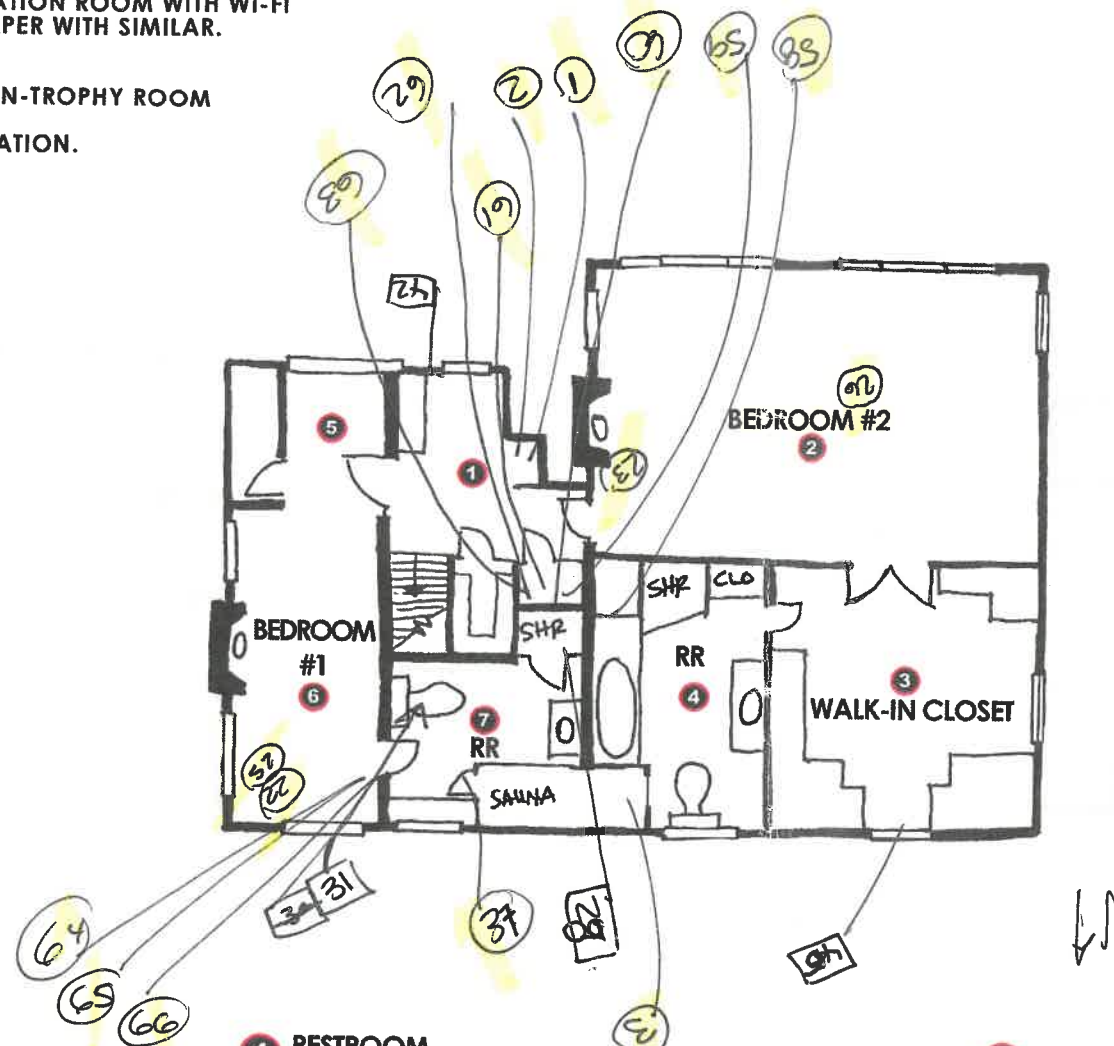
- 1 HALLWAY SPACE**
 -MISSING DOOR HANDLES FOR CLOSEST - INSTALL NEW
 -REMOVE/REPLACE CARPETING
- 2 BEDROOM #2**
 -FIREPLACE HAS MINOR CRACKS
 -REMOVE AND REPLACE DETERIORATING WALLPAPER
 -REMOVE AND REPLACE CARPETING
- 3 WALK-IN CLOSET**
 -REMOVE AND REPLACE CARPETING WITH SIMILAR
 -INSTALL ALL CLOSET DOOR HANDLES
 -TWO DOUBLE DOORS BROKEN, NEED TO BE REPAIRED

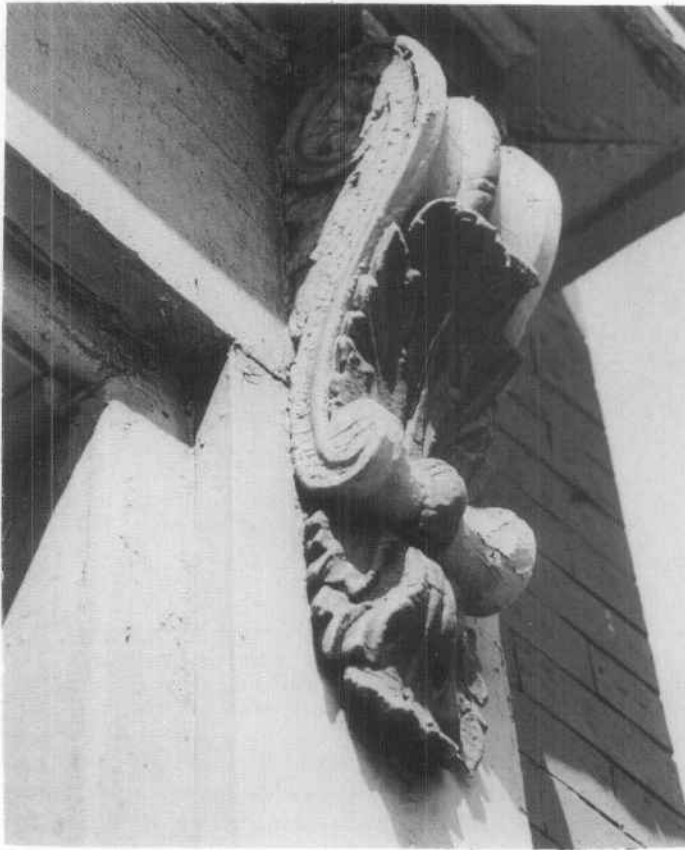
Fig. 1 Excessive paint build-up on architectural details such as this ornamental bracket does not in itself justify total paint removal. If paint is cracked and peeling down to bare wood, however, it should be removed using the gentlest means possible. Photo: David W. Look, AIA.

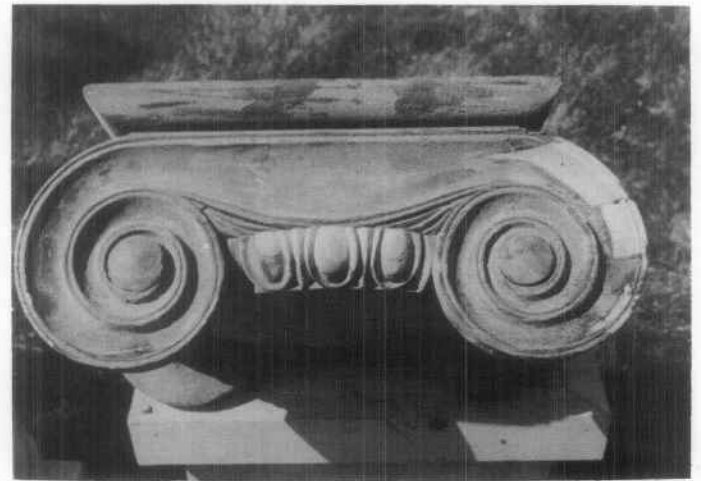
Fig. 3 If damage to parts of a wooden element is severe, new sections of wood will need to be pieced-in. When such piecing is required, paint on the adjacent woodwork should be removed so that the old and new woods will make a smooth profile when joined. After repainting, the repair should be virtually impossible to detect. Photo: Morgan W. Phillips.

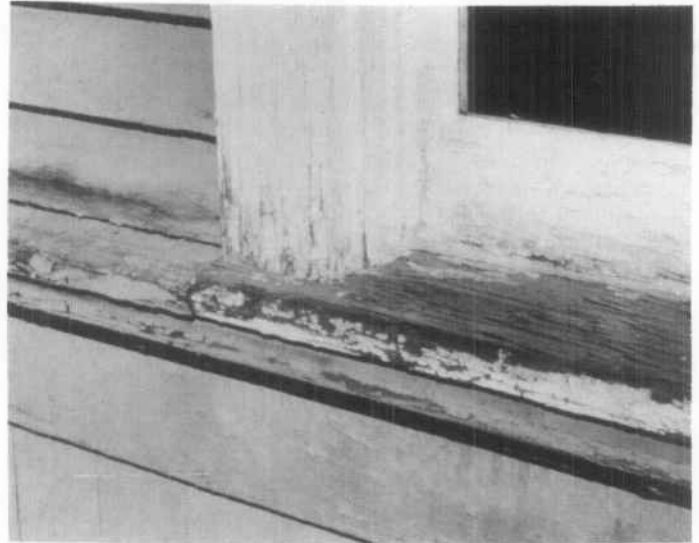
Staining of paint coatings usually results from excess

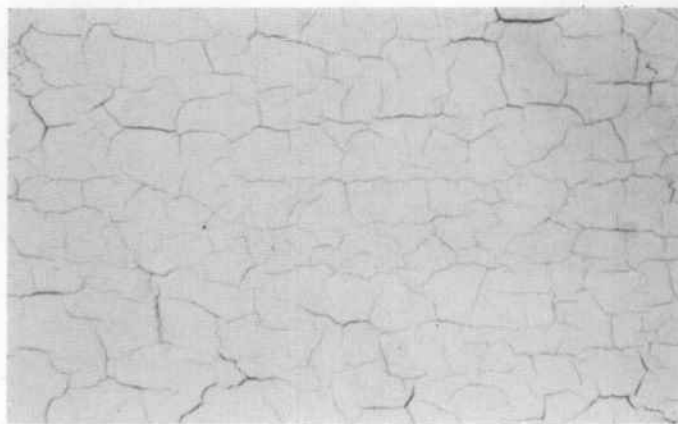
Fig. 5 Crazing—or surface cracking—is an exterior surface condition which can be successfully treated by sanding and painting. Photo: Courtesy, National Decorating Products Association.

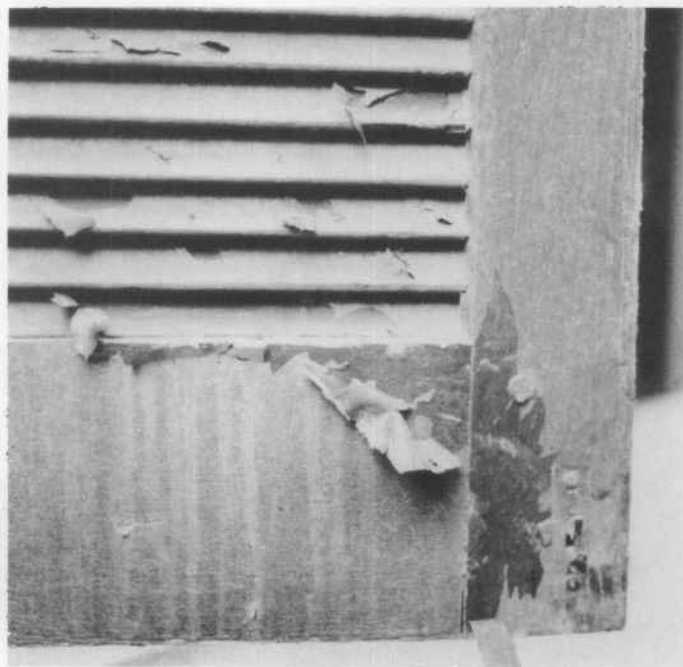
Fig. 6 This is an example of intercoat peeling. A latex top coat was applied directly over old oil paint and, as a result, the latex paint was unable to adhere. If latex is being used over oil, an oil-base primer should be applied first. Although much of the peeling latex paint can be scraped off, in this case, the best solution may be to chemically dip strip the entire shutter to remove all of the paint down to bare wood, rinse thoroughly, then repaint. Photo: Mary L. Oehrlein, AIA.

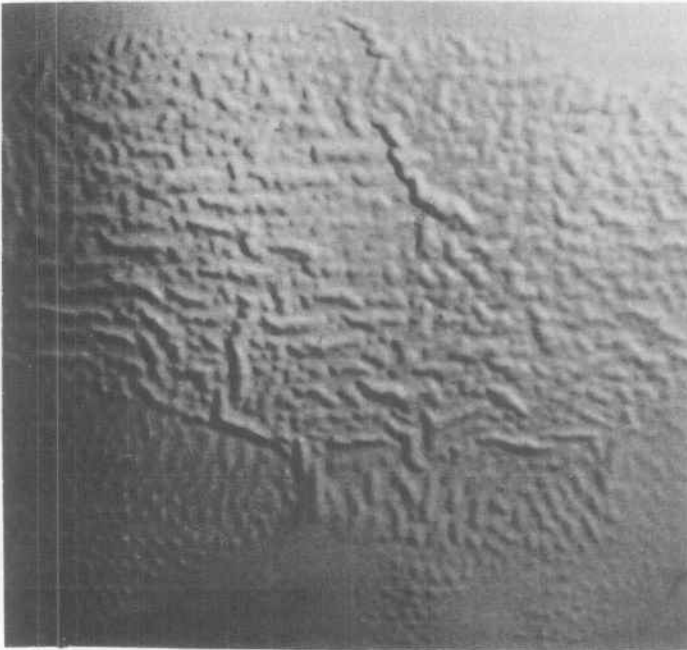
Fig. 7 Wrinkled layers can generally be removed by scraping and sanding as opposed to total paint removal. Following manufacturers' application instructions is the best way to avoid this surface condition. Photo: Courtesy, National Decorating Products Association.

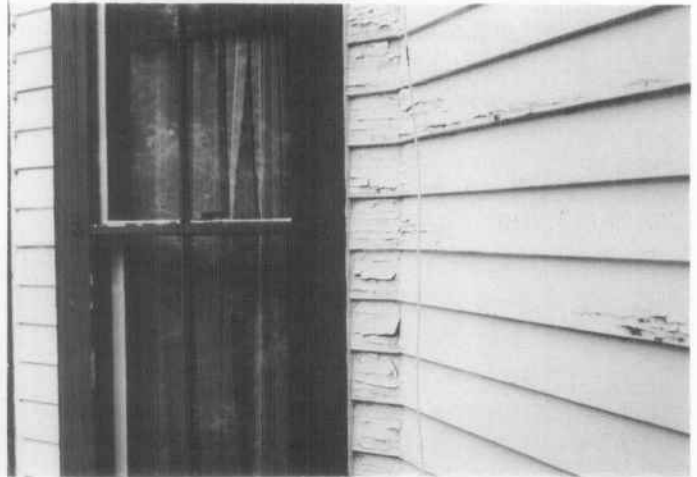
Fig. 8 Peeling to bare wood—one of the most common types of paint failure—is usually caused by an interior or exterior moisture problem. Photo: Anne E. Grimmer.

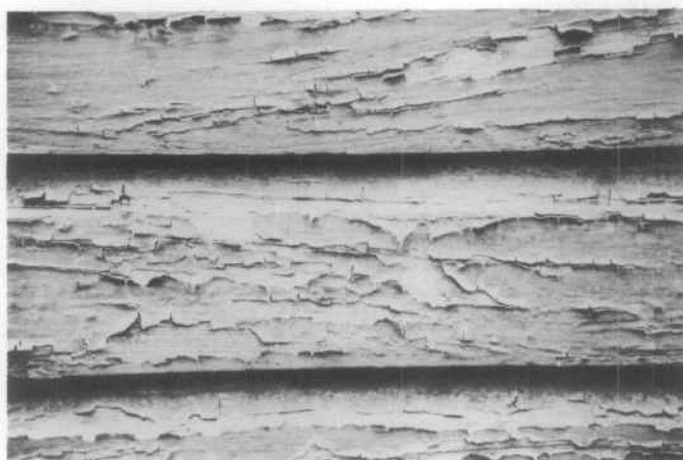
Fig. 9 Cracking, alligatoring, and flaking are evidence of long-term neglect of painted surfaces. The remaining paint on the clapboard shown here can be removed with an electric heat plate and wide-bladed scraper. In addition, unsound wood should be replaced and moisture problems corrected before primer and top coats of paint are applied. Photo: David W. Look, AIA.

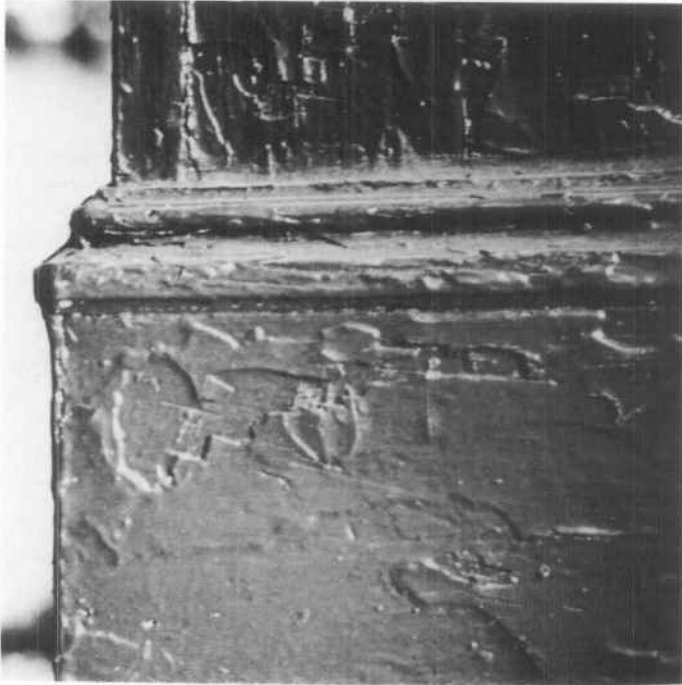
Fig. 10 An excellent example of inadequate scraping before re-painting, the problems here are far more than cosmetic. This improperly prepared surface will permit moisture to get behind the paint film which, in turn, will result in chipping and peeling. Photo: Baird M. Smith, AIA.

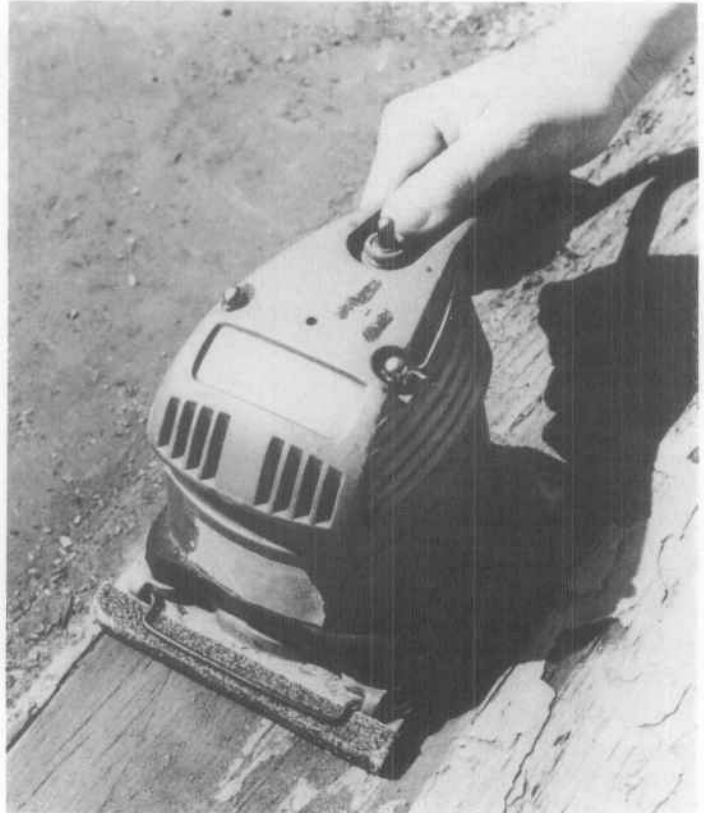
Fig. 11 The orbital sander can be used for limited paint removal, i.e., for smoothing flat surfaces after the majority of deteriorated paint has already been scraped off. Photo: Charles E. Fisher, III.

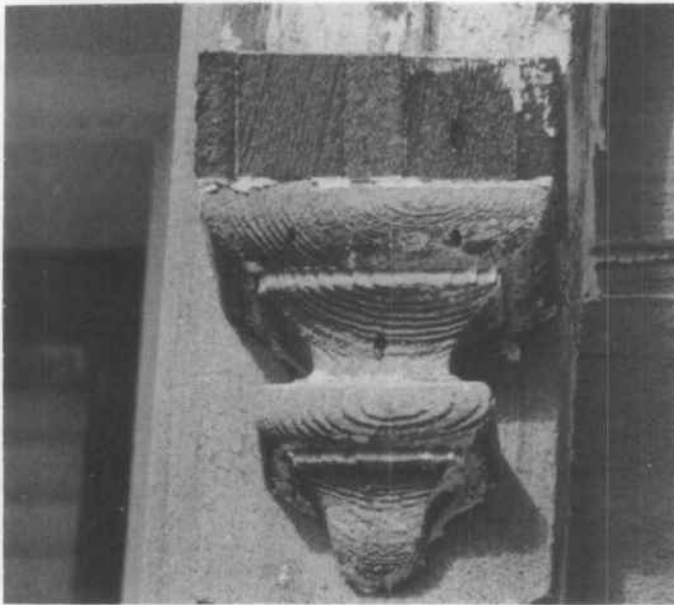
Fig. 12 Sandblasting has permanently damaged this ornamental bracket. Even paint will not be able to hide the deep erosion of the wood. Photo: David W. Look, AIA.

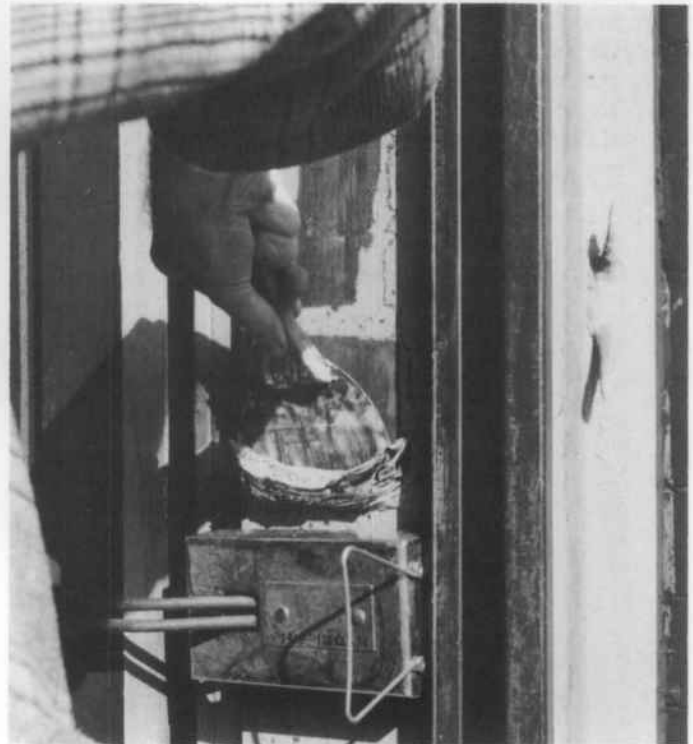
Fig. 13 The electric heat plate (with paint scraper) is particularly useful for removing paint down to bare wood on flat surfaces such as doors, window frames, and siding. After scraping, some light sanding will probably be necessary to smooth the surface prior to application of primer and top coats. Photo: David W. Look, AIA.

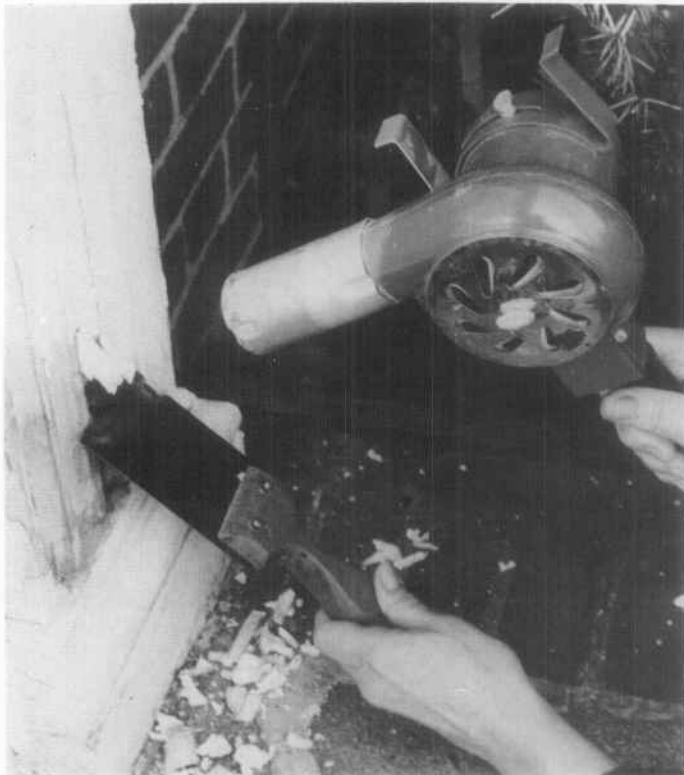
Fig. 14 The nozzle on the electric heat gun permits hot air to be aimed into cavities on solid decorative elements such as this applied column. After the paint has been sufficiently softened, it can be removed with a profiled scraper. Photo: Charles E. Fisher, III.

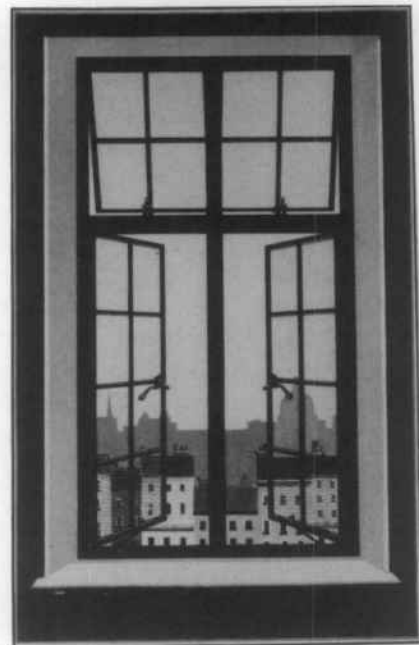
The Secretary of the Interior's "Standards for Rehabilitation" require that where historic windows are individually significant features, or where they contribute to the character of significant facades, their distinguishing visual qualities must not be destroyed. Further, the rehabilitation guidelines recommend against changing the historic appearance of windows through the use of inappropriate designs, materials, finishes, or colors which radically change the sash, depth of reveal, and muntin configuration; the reflectivity and color of the glazing; or the appearance of the frame.

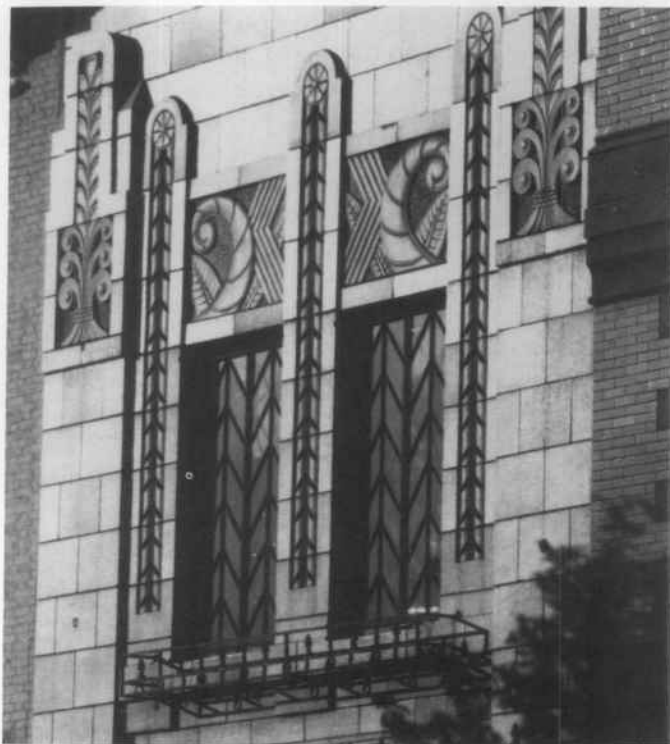
Fig. 1 Often highly distinctive in design and craftsmanship, rolled steel windows play an important role in defining the architectural character of many later nineteenth and early twentieth century buildings. Art Deco, Art Moderne, the International Style, and Post World War II Modernism depended on the slim profiles and streamlined appearance of metal windows for much of their impact. Photo: William G. Johnson.

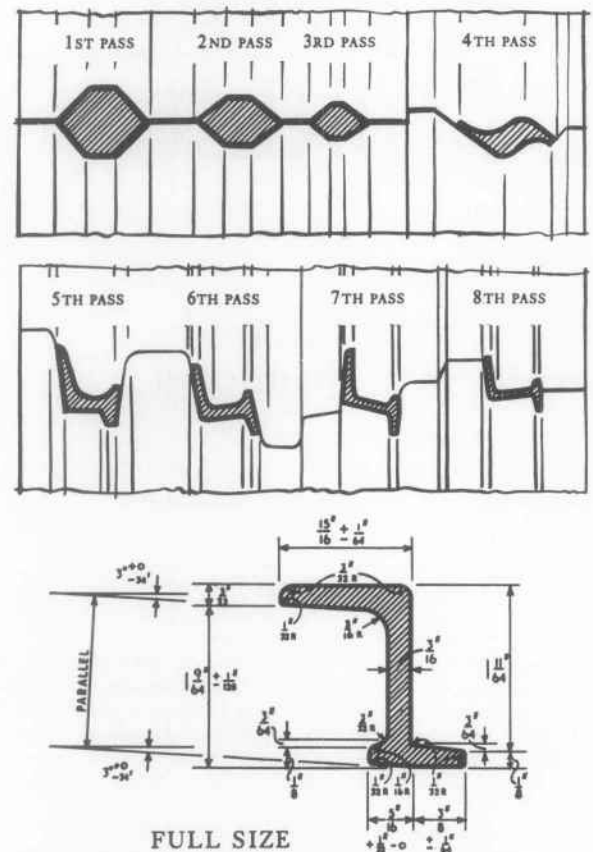
Fig. 2. The process of rolling a steel bar into an angled section is illustrated above. The shape and size of the rolled section will vary slightly depending on the overall strength needed for the window opening and the location of the section in the assembly: subframe, frame, or sash. The 1/8" thickness of the metal section is generally standard. Drawing: *A Metal Window Dictionary*. Used with permission.

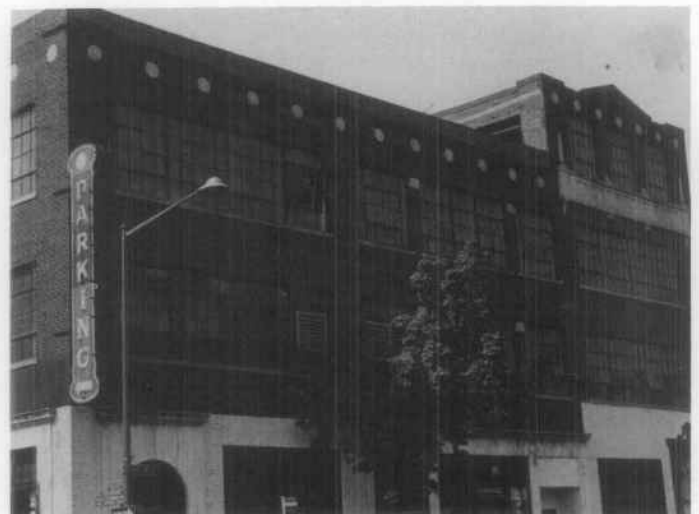
Fig. 5 Windows often provide a strong visual element to relatively simple or unadorned industrial or commercial buildings. This design element should be taken into consideration when evaluating the significance of the windows. Photo: Michael Auer.

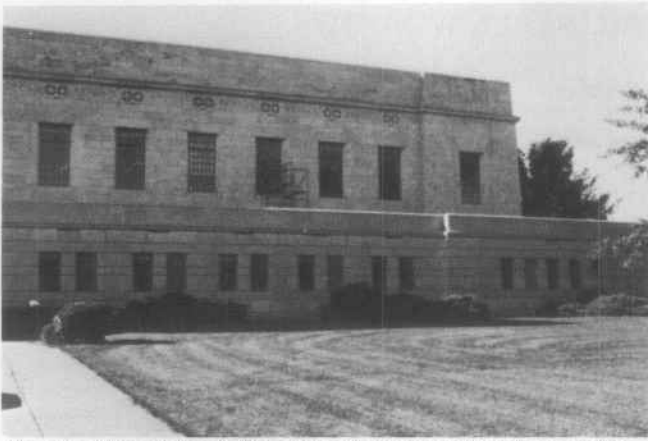
Fig. 6 a. View of the flanking wing of the State Capitol where the rolled steel casement windows are being removed for repair.

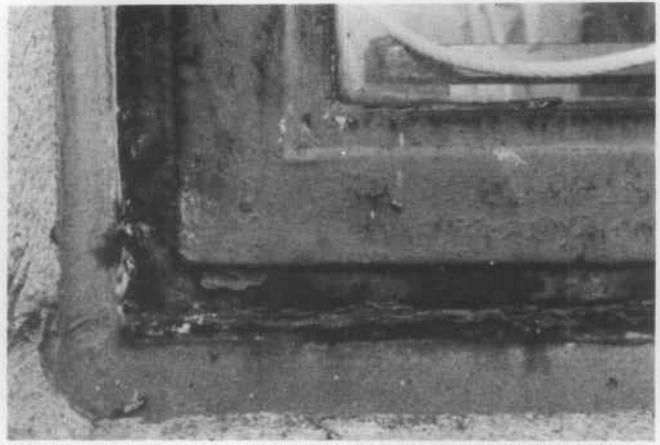
Fig. 6 b. View from the exterior showing the deteriorated condition of the lower corner of a window prior to repair. While the sash was in relatively good condition, the frame behind was rusted to the point of inhibiting operation.

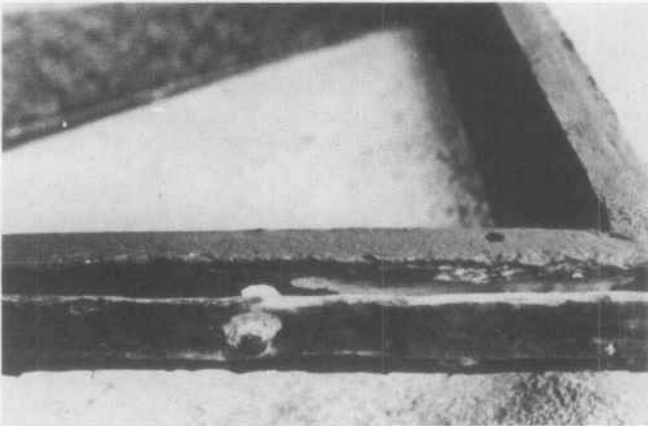
Fig. 6 c. View of the rusted frame which was unscrewed from the subframe and removed from the window opening and taken to a workshop for sandblasting. In some cases, severely deteriorated sections of the frame were replaced with new sections of milled bar steel.

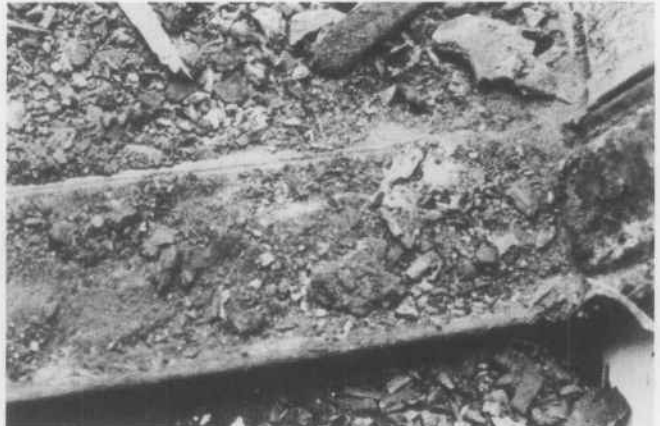
Fig. 6 d. View looking down towards the sill. The subframes appeared very rusted, but were in good condition once debris was vacuumed and surface rust was removed, in place, with chemical compounds. Where necessary, epoxy and steel filler was used to patch depressions in order to make the subframe serviceable again.

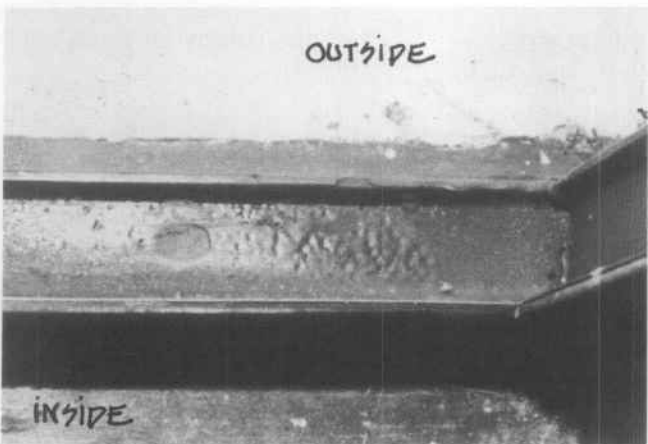
Fig. 6 e. View looking down towards the sill. The cleaned frame was reset in the window opening. The frame was screwed to the refurbished subframe at the jamb and the head only. The screw holes at the sill, which had been the cause of much of the earlier rusting, were infilled. Vinyl weatherstripping was added to the frame.

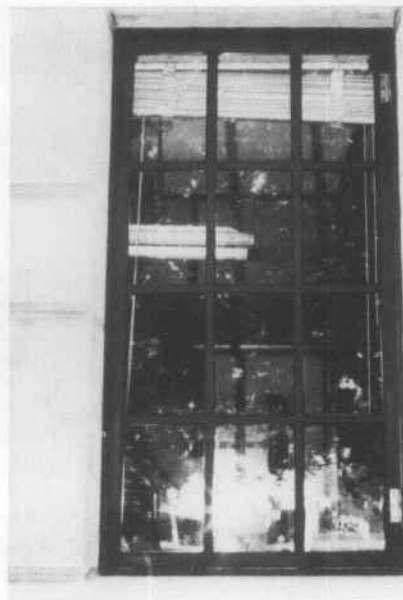
Fig. 6 f. View from the outside of the completely refurbished window. In addition to the steel repair and the installation of vinyl weatherstripping, the exterior was caulked with polyurethane and the single glass was replaced with individual lights of thermal glass. The repaired and upgraded windows have comparable energy efficiency ratings to new replacement units while retaining the historic steel sash, frames and subframes.

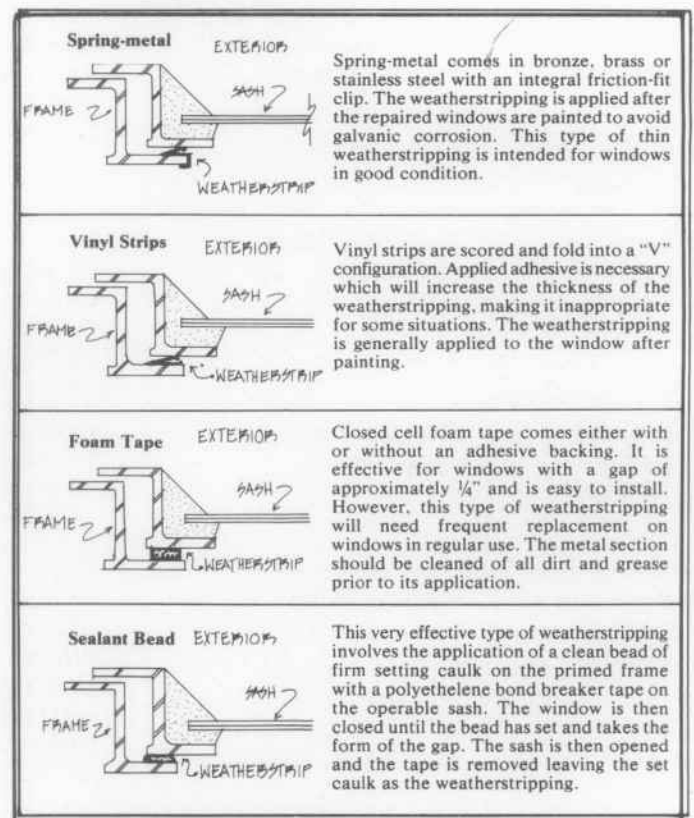
Fig. 8 APPROPRIATE TYPES OF WEATHERSTRIPPING FOR METAL WINDOWS. Weatherstripping is an important part of upgrading the thermal efficiency of historic steel windows. The chart above shows the jamb section of the window with the weatherstripping in place. Drawings: Sharon C. Park, AIA.

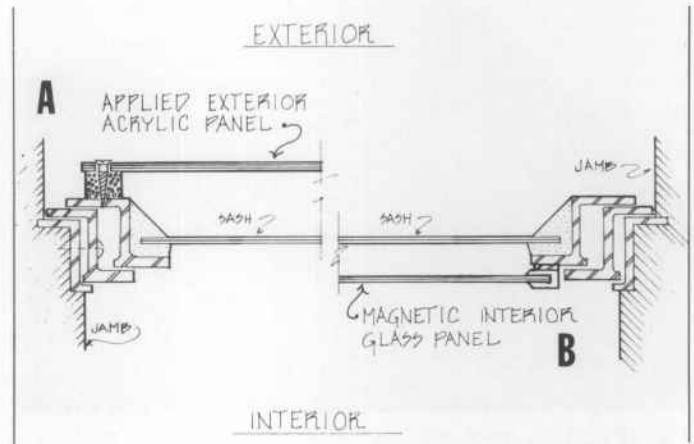
Fig. 9 Two examples of adding a second layer of glazing in order to improve the thermal performance of historic steel windows. Scheme A (showing jamb detail) is of a 1/4" acrylic panel with a closed cell foam gasket attached with self-tapping stainless steel screws directly to the exterior of the outwardly opening sash. Scheme B (showing jamb detail) is of a glass panel in a magnetized frame affixed directly to the interior of the historic steel sash. The choice of using glass or acrylic mounted on the inside or outside will depend on the ability of the window to tolerate additional weight, the location and size of the window, the cost, and the long-term maintenance outlook. Drawing: Sharon C. Park, AIA.

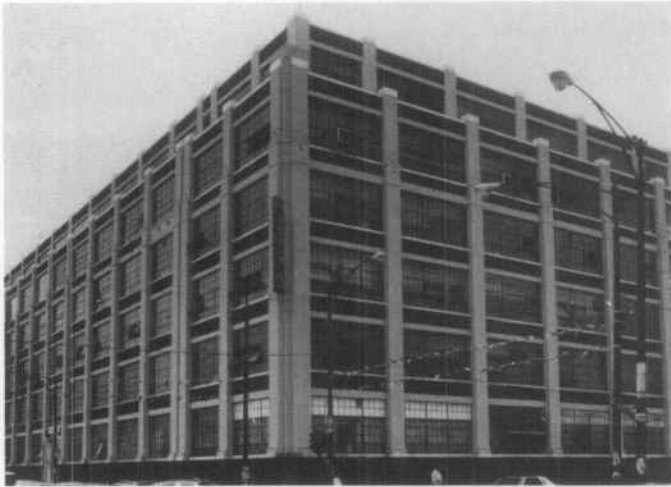
Fig. 10 a. A six-story concrete manufacturing building prior to the replacement of the steel pivot windows. Photo: Charles Parrott.

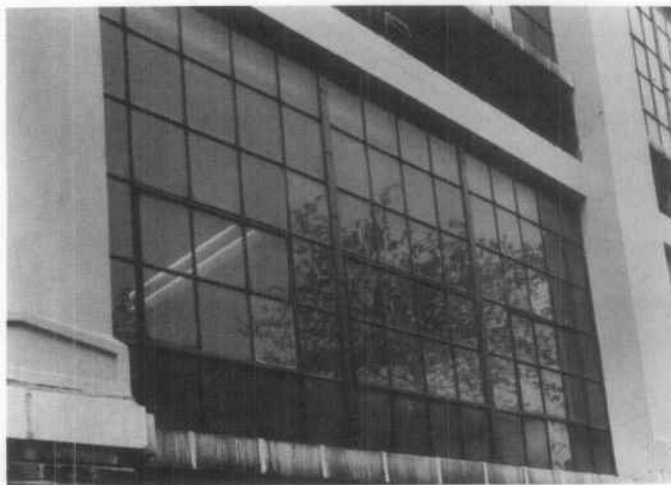
Fig. 10 b. Close-up view of the new replacement steel windows which matched the multi-lighted originals exactly. Photo: Charles Parrott.

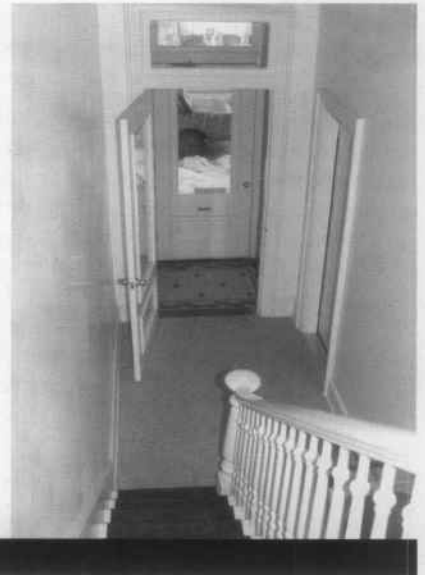
Lead-based paint, a toxic material, was widely used in North America on both the exteriors and interiors of buildings until well into the second half of the twentieth century. If a "historic" place is broadly defined in terms of time as having attained an age of fifty years, this means that almost every historic house contains some lead-based paint. In its deteriorated form, it produces paint chips and lead-laden dust particles that are a known health hazard to both children and adults. Children are particularly at risk when they ingest lead paint dust through direct hand-to-mouth contact and from toys or pacifiers. They are also at risk when they chew lead-painted surfaces in accessible locations. In addition to its presence in houses, leaded paint

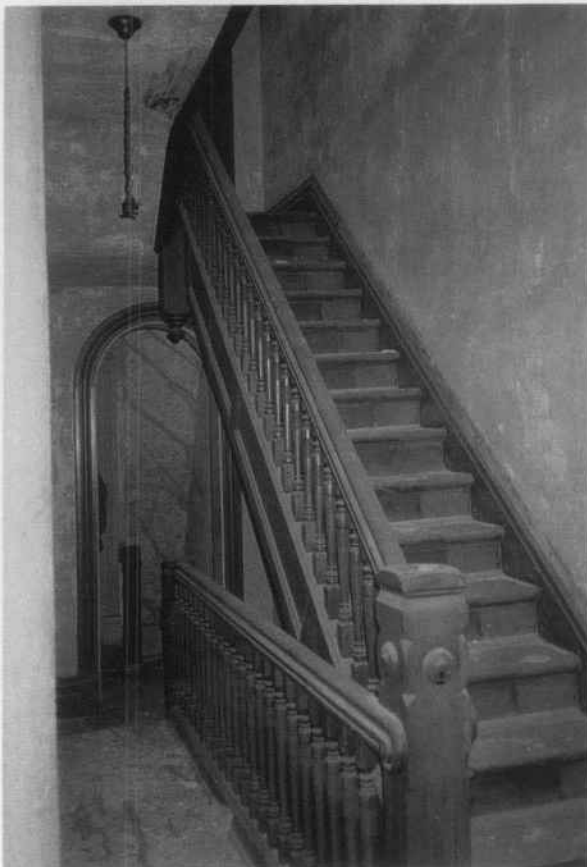
The premise of this Preservation Brief is that historic housing can be made lead-safe for children without removing significant decorative features and finishes, or architectural trimwork that may contribute to the building's historic character (see fig. 1). *Historic housing*—encompassing private dwellings and all types of rental units—is necessarily the focus of this Brief because federal and state laws primarily address the hazards of lead and

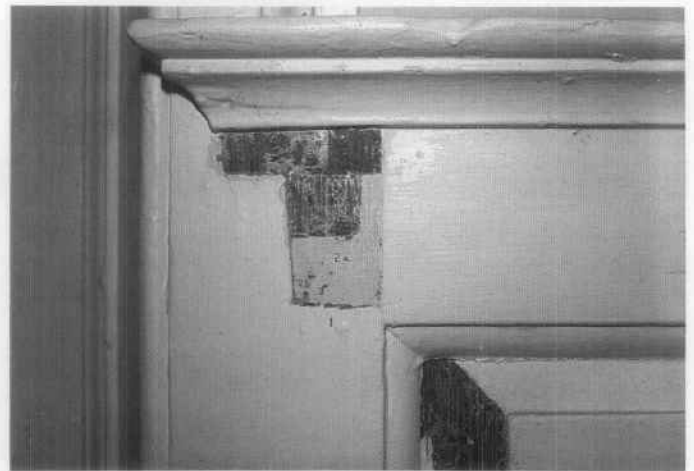
Figure 2. The paint chronology of this mantel, seen in the exposed paint layers in the left corner, proved it had been relocated from another room of the house. To remove a significant feature's paint history and the evidence of its original sequence of color by stripping off all the paint is inappropriate — and unnecessary — as part of a lead hazard reduction project. Careful surface preparation and repainting with lead-free top coats is recommended. Photo: NPS Files.

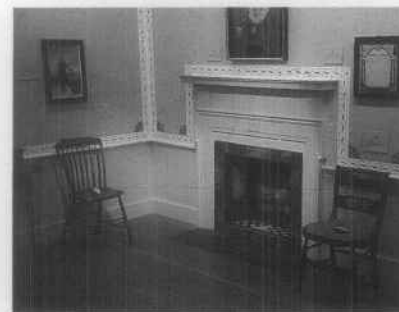
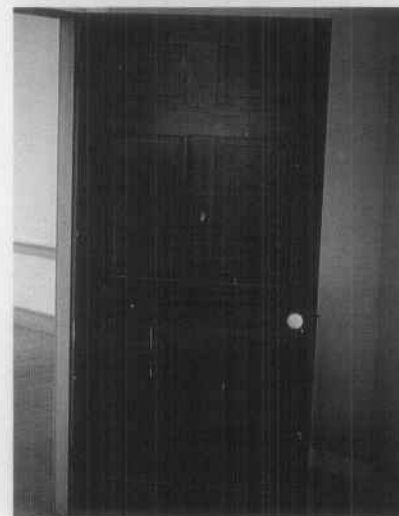
Figure 3. Significant architectural features and their finishes should not be removed during a project incorporating lead hazard controls. If the decorative stenciling above, or hand grained doors below, or painted murals need repair, then a paint conservator should be consulted. Once loose paint is consolidated or otherwise stabilized, a clear finish or other reversible clear protective surface or coating can be added to areas subject to impact or abrasion. Photos: NPS Files.

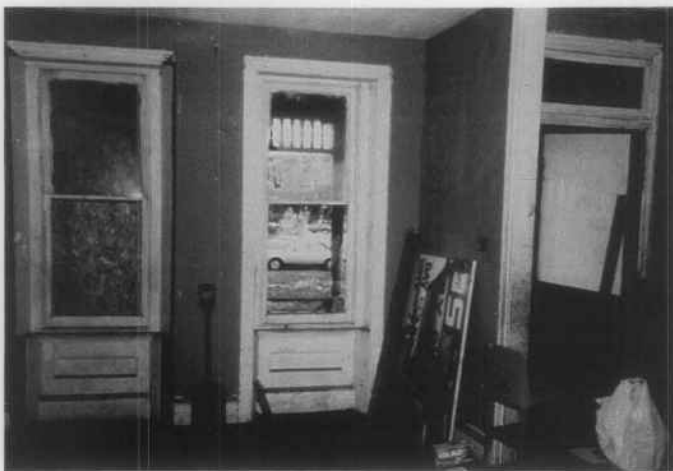
The historical significance, integrity, and architectural character of the building always need to be assessed before work is undertaken that might adversely affect them. An owner may need to enlist the help of a preservation architect, building conservator or historian. The State Historic Preservation Office (SHPO) may be able to provide a list of knowledgeable preservation professionals who could assist with this evaluation.

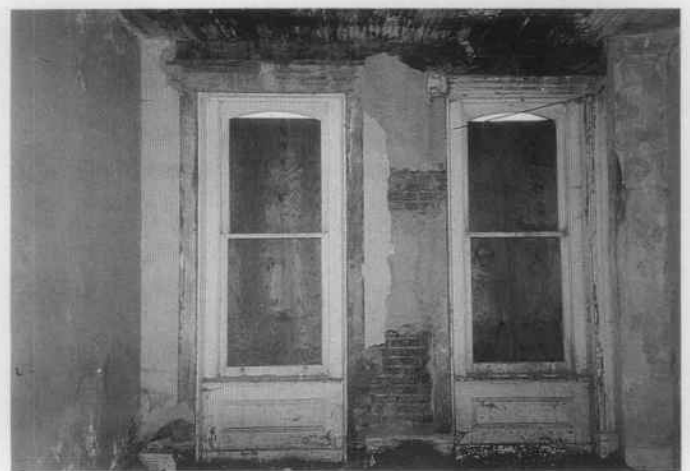
Figure 4. The typical method for abating lead-based paint through substrate removal is not consistent with the Standards for Rehabilitation. In this project, all the historic trim, base panels, and the transom were removed. While the unit is lead-safe, its character has been severely altered. Figure 5 shows a similar, but successful, balance of historic preservation and lead hazard control work. Photo: NPS Files.

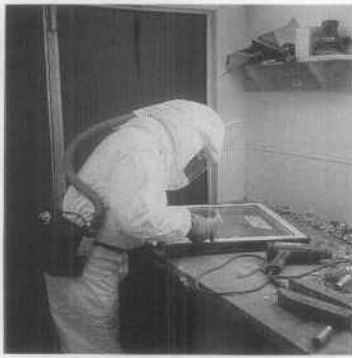
Low-level heat guns can be used to remove lead-based paint from significant historic windows and trimwork, but a worker exposed to lead dust over an extended period of time must be protected from the hazards created during the process of paint removal. Photo: Williamsport Preservation Training Center.

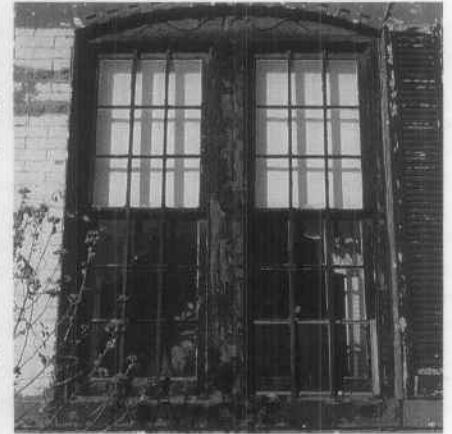
Figure 7. Chalking exterior paint can cause dangerous lead levels in soil around a house. Lead levels are usually highest in the one foot wide area adjacent to the building foundation. In these cases, the existing soil should be replaced with new soil or sod. This is particularly important if children and small pets play in contaminated areas, then inadvertently track the dirt inside.

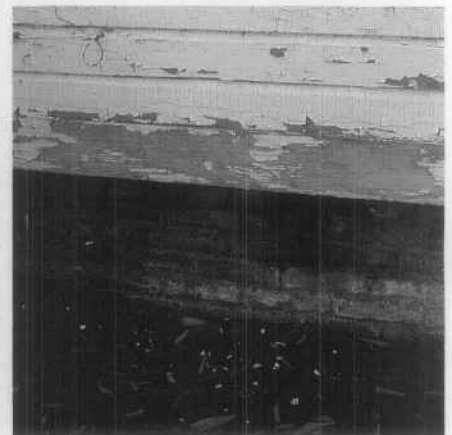
Finally, features and finishes that characterize simple, vernacular buildings should be retained and preserved; in the process of removing hazards, there are usually reasonable options for their protection. Wholesale removal of historic trim, and other seemingly less important historic material, undermines a building's overall character and integrity and, thus, is never recommended.

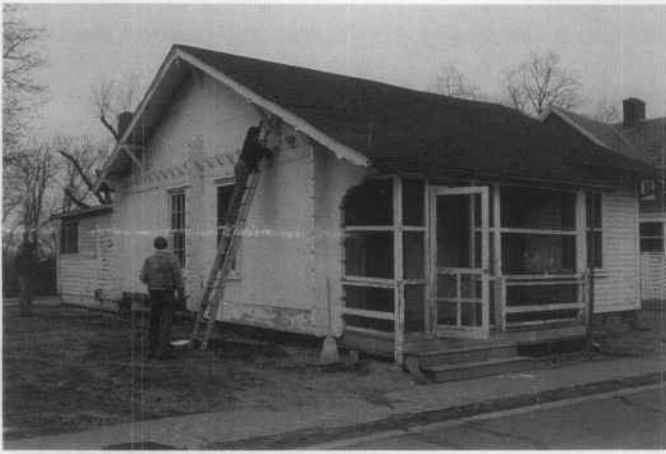
This hierarchy gives an owner a working guide for making decisions about appropriate methods of removing lead paint.
