APR 21 2022

BOARD OF RECREATION
AND PARK COMMISSIONERS

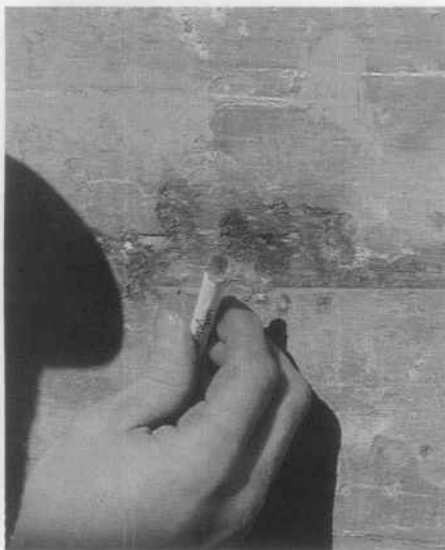
- the paint's location
- the paint's condition
- lead content of paint and soil
- the type of surface (friction; accessible to children for chewing; impact)
- how much lead dust is actively present
- how the family uses and cares for the house
- the age of the occupants who might come into contact with lead paint.

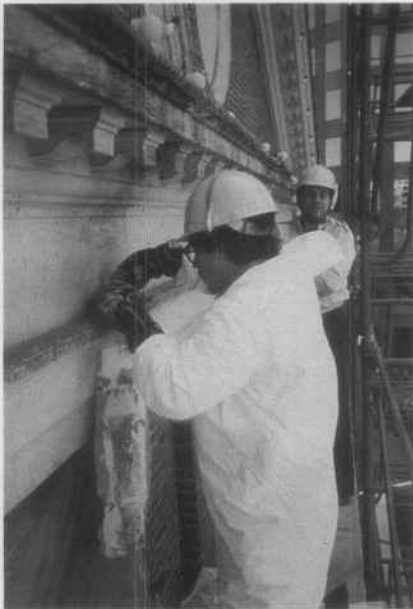
Figure 10. The choice of paint removal method will trigger various environmental controls and worker protection. The chemical poultice-type paint remover uses a paper backing that keeps the lead waste contained for proper disposal. The worker is adequately protected by a suit and gloves; for this work a respirator was not required. Local laws required containment and neutralization of any after-wash water run off. Photo: NPS Files.

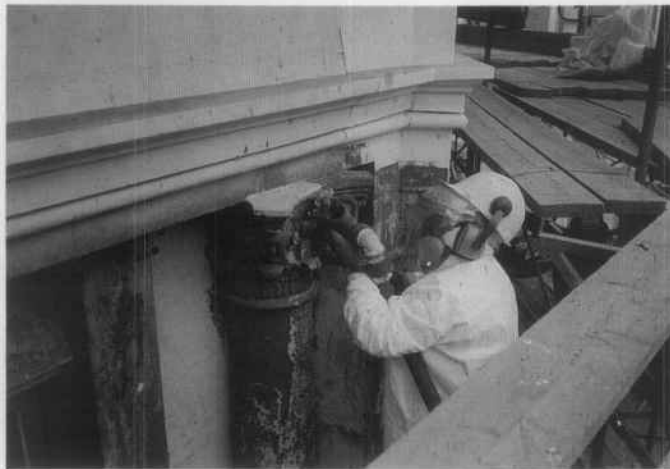
Figure 11. New methods are being developed or adapted to safely remove lead-based paint from various substrates. On this cast iron building undergoing rehabilitation for apartment units, multiple layers of lead-based paint were removed with pneumatic needle guns with vacuum attachments. Paint chips and waste containing lead-based paint were placed in 55 gallon drums for transport to a special waste site, and the workers were fully protected. The cleaned metal was primed and repainted. Photo: Building Conservation Associates, Inc.

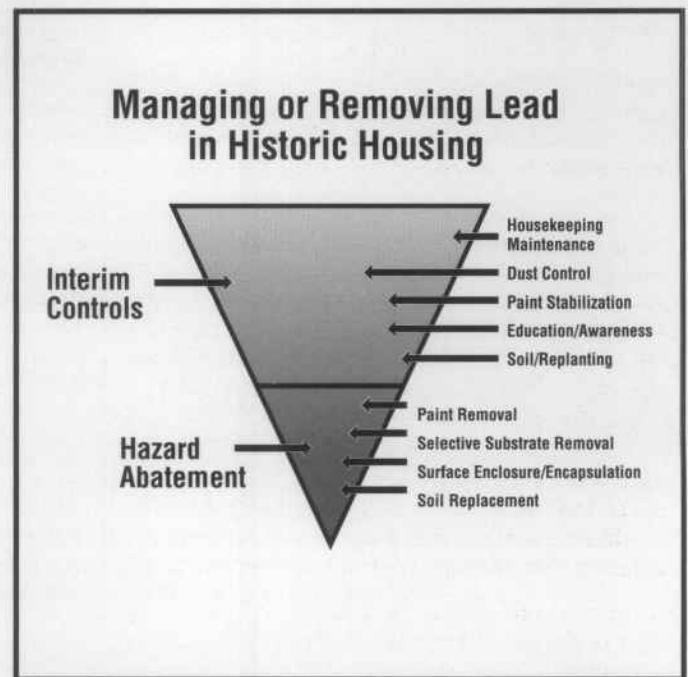
Figure 12. An inverted triangle makes the point that most of the nation's housing can be made lead-safe using interim control methods, such as dust control, paint stabilization, and good housekeeping. Shaded from light to dark, the lighter interim controls will generally not harm the historic materials. The darker, more aggressive controls, can be implemented with rehabilitation projects where paint removal, selective replacement of deteriorated elements, and encapsulation or enclosure are incorporated into other work.

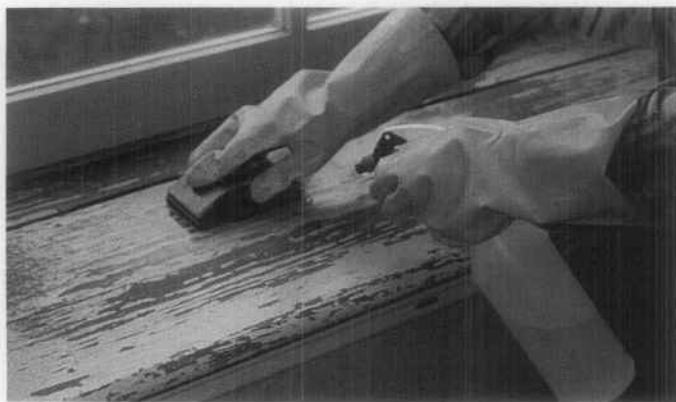
Figure 15. Wet sanding of interior surfaces will keep dust levels down, reduce the need for workers' protection, and provide a sound surface for repainting. Priming and repainting with oil/alkyd, latex or latex acrylic should be undertaken according to manufacturers' instructions.

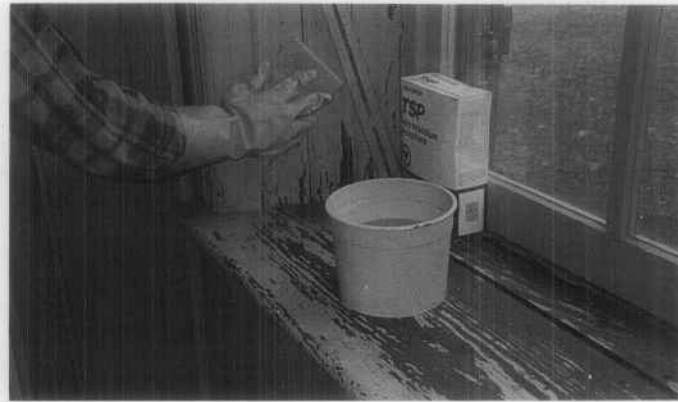
Figure 16. Washing windows and cleaning debris from window wells on a periodic basis can substantially reduce lead dust. Using water and tri-sodium phosphate (TSP or equivalent) will remove loose paint, and, after rinsing, the surface can be repainted with latex, oil/alkyd, or latex acrylic paints.

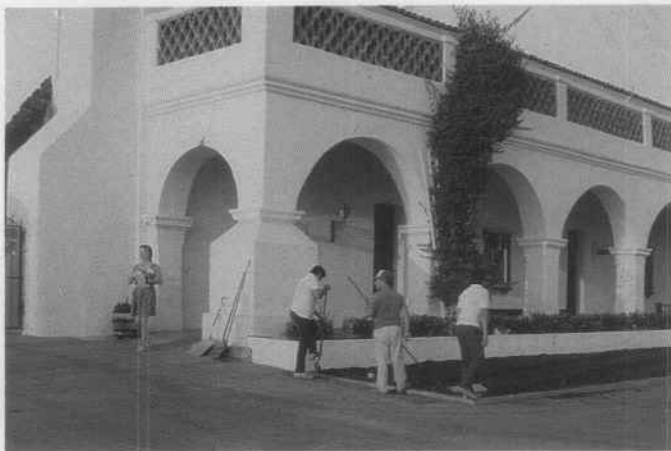
Figure 17. When historic sites are found to contain high levels of lead in bare soil — particularly around foundations — it is important to reduce the hazard without destroying significant landscapes. In many cases, contaminated soil can be removed from the foundation area and appropriate plantings or ground covers replanted in new soil. Photo: Charles A. Birnbaum, ASLA.

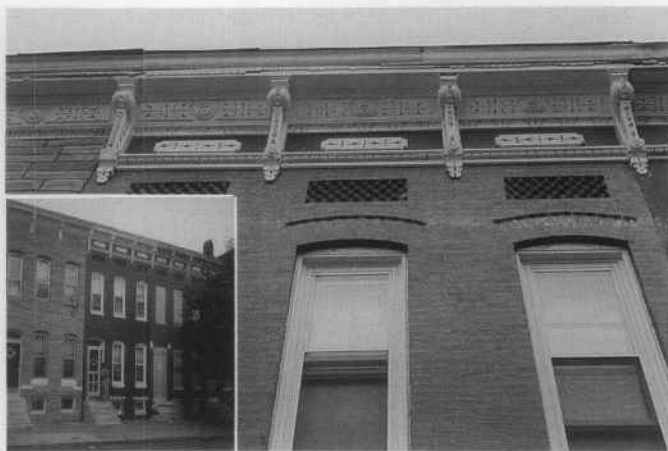
Figure 18. As part of an urban housing grant program, the exterior of this row house was successfully made lead-safe and met the Secretary of the Interior's Standards for Rehabilitation. The exterior was washed, then repainted with exterior grade alkyd paint. The decorative roof brackets and cornice were repainted; not removed or covered as is often recommended in typical abatement guidelines. The previously altered, deteriorated window sashes were replaced with new sash and jamb liners set within the historic frames. Photos: Deborah Birch.

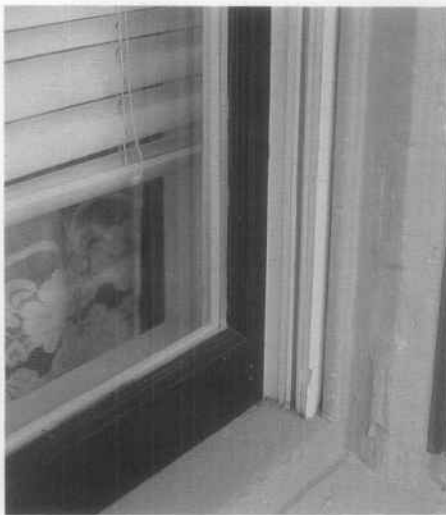
Figure 20. Operable windows have friction surfaces between the sash and the frames, which can be a source of fine lead dust. In this case, the deteriorated sash was replaced, but the historic frame remains in place, successfully isolated from the sash with a simple vinyl jamb liner that is part of the new sash operation.

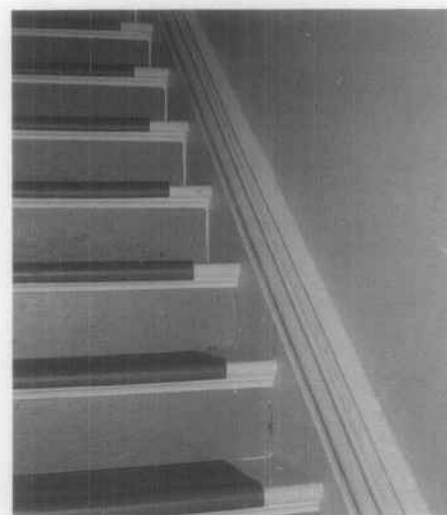
Figure 21. Painted stairs and floors can cause a problem because lead dust settles between the wooden boards. In this case, the steps were sanded, repainted, and covered with rubber stair treads. The floors could not be effectively cleaned and sealed so they were isolated with a new subflooring, and a washable tile finish installed.

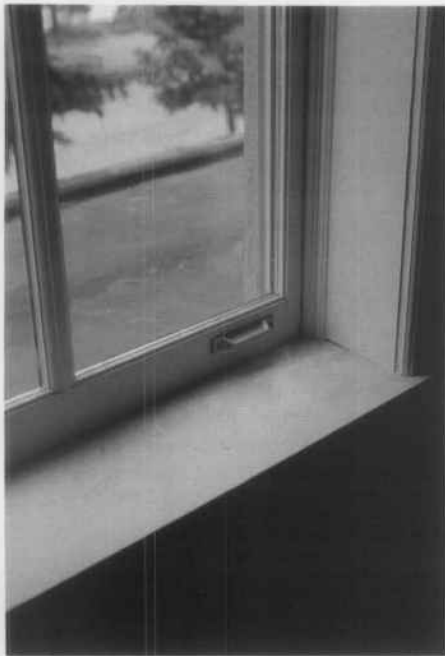
Figure 22. Research has shown that some small children will chew on projecting window sills while teething. As part of a lead hazard control project, the edge of the sill can be stripped to bare wood or an encapsulating paint applied. In this case, a new window sill was installed as part of a window upgrade that retained the historic trim and frame.

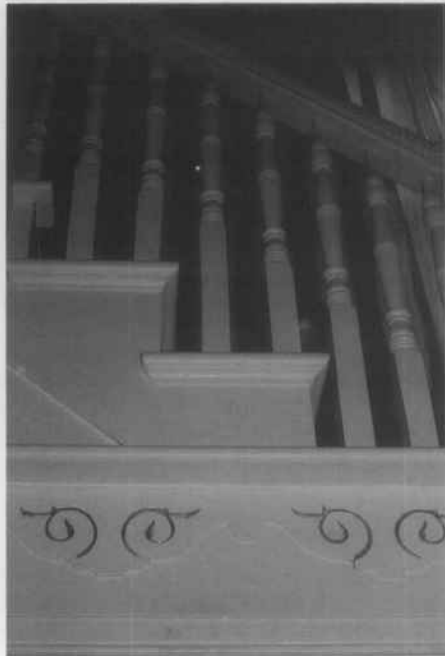
Impact Surfaces. Painted surfaces near doorways and along corridors tend to become chipped and scraped simply because of their location. This is particularly true of baseboards, which were designed to protect wall surfaces, and also for doorjamb. Owners should avoid hitting painted impact surfaces with vacuums, brooms, baby carriages, or wheeled toys. Adding new shoe moldings can give greater protection to some baseboards. In most cases, stabilizing loose paint and repainting with a high quality interior paint will provide a durable surface. Clear panels or shields can be installed at narrow doorways, if abrasion continues, or these areas can be stripped of paint and repainted. Features in poor condition may need to be replaced with new, matching materials (see fig. 24).

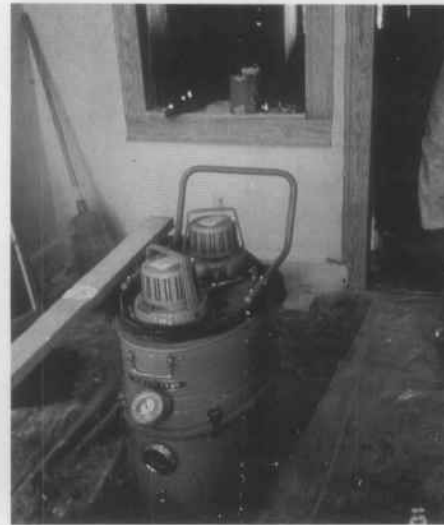
Figure 24. Historic baseboards are often bumped by brooms and vacuum cleaners, causing lead-based paint chips to fall on the floor. Shoe moldings can be added or replaced to increase protection to the baseboard itself. In this case, because the condition of the interior warranted substantial repair, simple historic board trim was replaced with new matching trim. Note the HEPA filter vacuum in the foreground. Photo: NPS file.

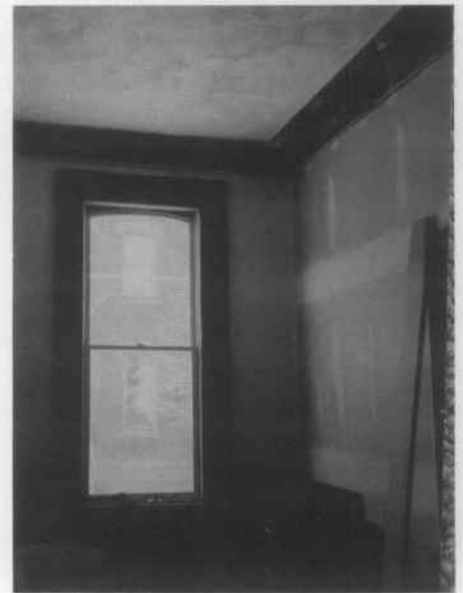
If a new drywall surface needs to be applied, care should be taken that the historic relationship of wall to trim is not lost. Also, if there are significant features, such as crown moldings or ceiling medallions, they should always be retained and repaired (see fig. 26).

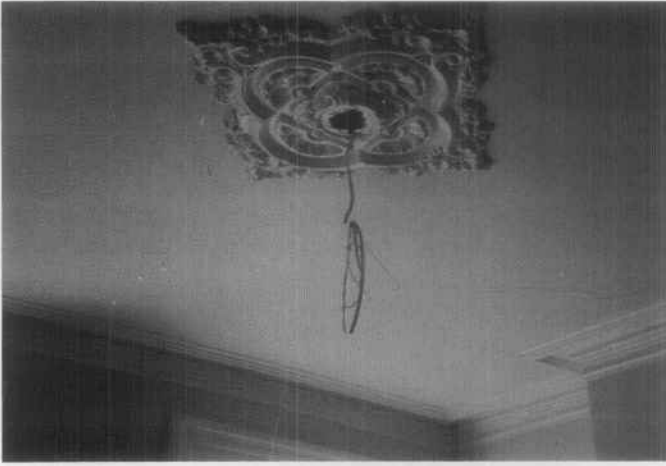
Figure 26. Deteriorated ceiling plaster was removed and a new drywall ceiling installed. The historic ceiling medallion was preserved, and the plaster cornices repaired in place. Photo: Landmarks Design Associates.

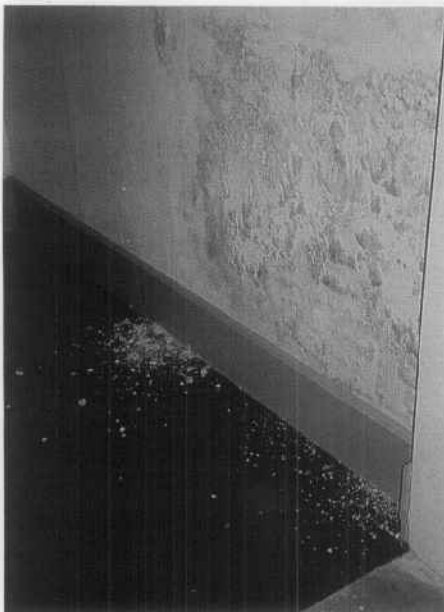
Figure 27. Wall leaks can cause historic surfaces to deteriorate, thereby exposing underlayers of lead-based paint. If painted surfaces show signs of deterioration, they should be repaired as soon as possible.

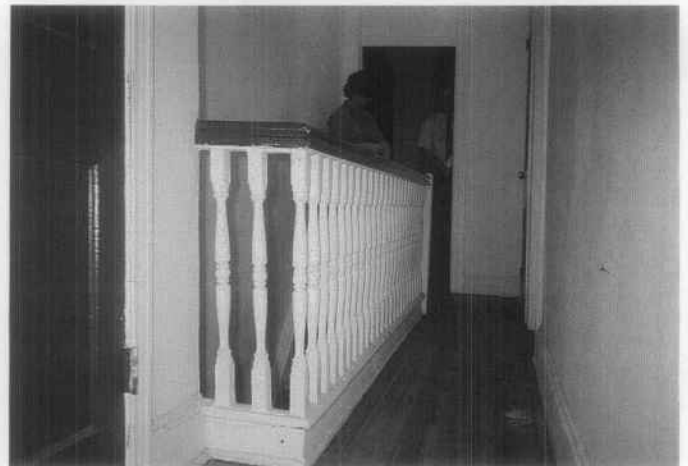
Figure 28. This recently completed housing, which is now lead-safe, could become re-contaminated from lead if safe conditions are not maintained. Damp mopping floor surfaces and regular dusting to keep the house clean will ensure its continuing safety.

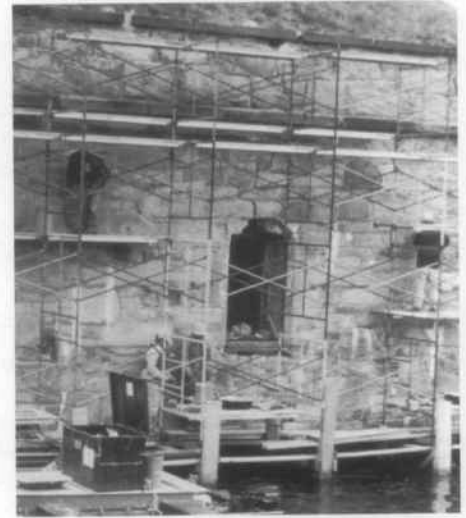
Regardless of who does the work, however, these are the principles that should guide treatment decisions:

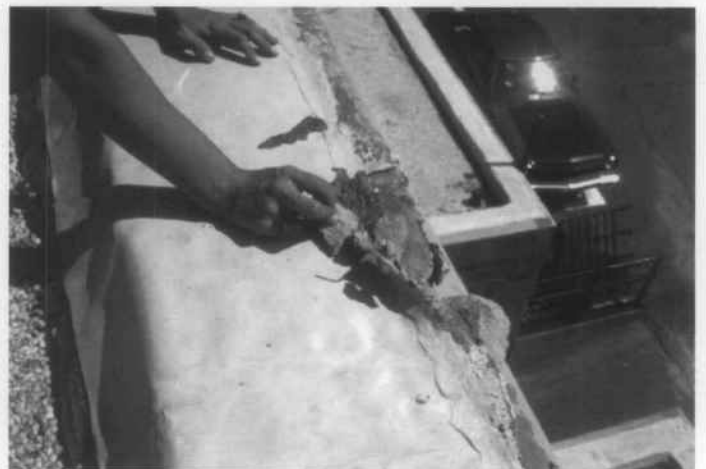
Fig. 1. Moisture problems, if not properly corrected, will increase damage to historic buildings. This waterproof coating trapped moisture from the leaking roof, causing portions of the masonry parapet to fail. Photo: NPS Files.

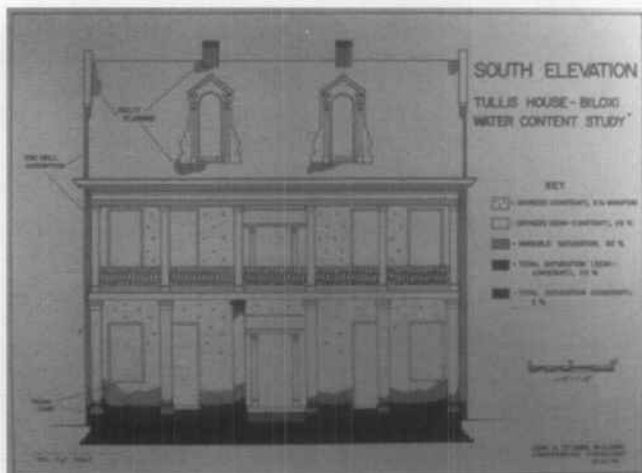
Fig. 2. Historic buildings plagued by dampness problems will benefit from systematic documentation to set a baseline against which moisture changes can be measured. Exterior areas with higher moisture levels may have algae growth or discoloration stains. Drawing: John H. Stubbs.

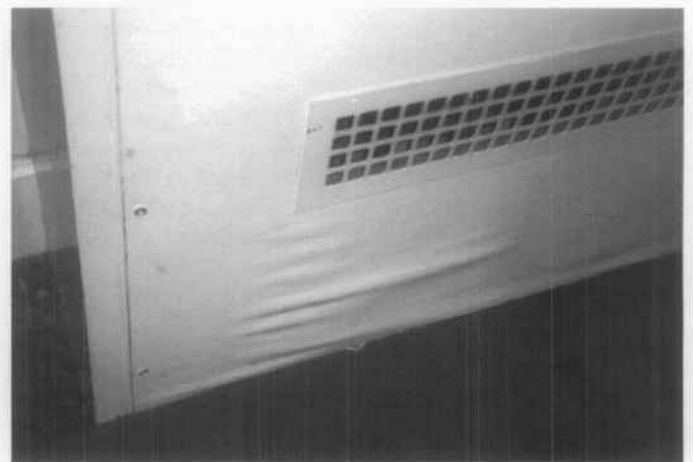
Fig. 3. The deterioration of this wooden cover was a sign that water was leaking from the fan coil unit behind. Photo: author.

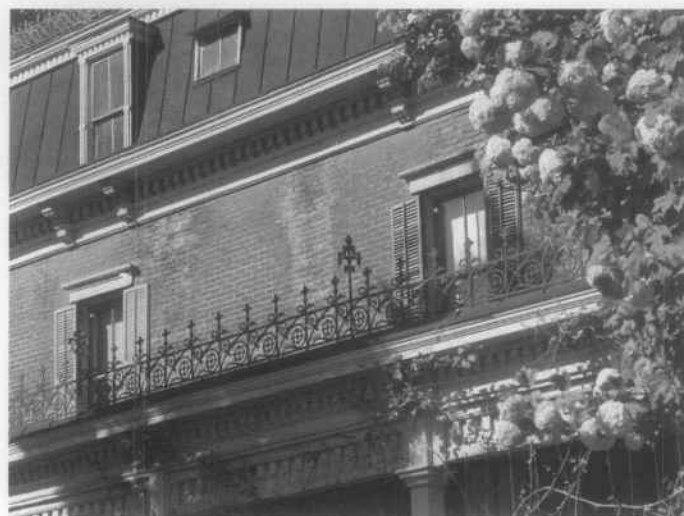
Fig. 4. Deferred maintenance often leads to blocked gutters and downspouts. This cracked gutter system allowed moisture to penetrate the upper exterior wall, erode mortar joints, and rot fascia boards. Photo: NPS files.

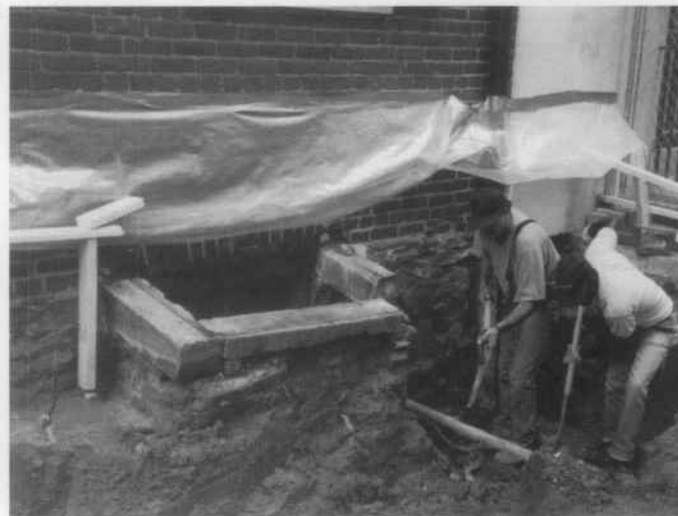
Fig. 5. Excavating this foundation revealed that the downspout pipe had corroded at the “u-trap” and was leaking moisture into the soil. Openings around the horizontal water supply line and cracks in the wall allowed moisture to penetrate the basement in multiple locations. Photo: author.

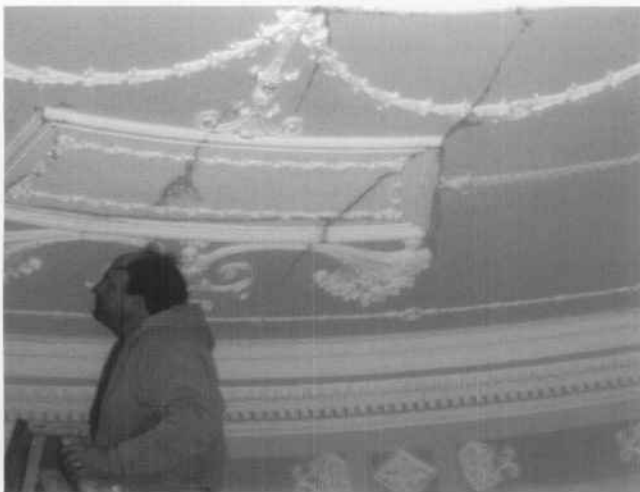
Fig. 6. Uninsulated plumbing pipes close to the exterior wall froze and cracked, wetting this ornamental plaster ceiling before the water supply line could be shut off. As a result, limited portions of the ceiling needed reattaching. Photo: author.

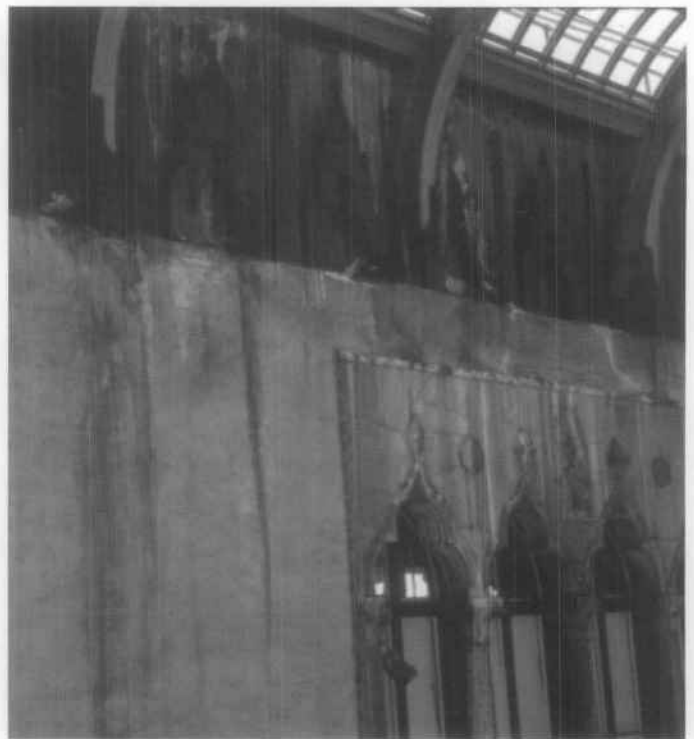
Fig. 7. Condensation dripping from the large overhead courtyard skylight was damaging the masonry in this museum. A new skylight with thermal glazing was installed, replacing the deteriorated single-glazed unit. A new climate control system monitors interior temperature and humidity. Photo: © Isabella Stewart Gardner Museum, Boston.

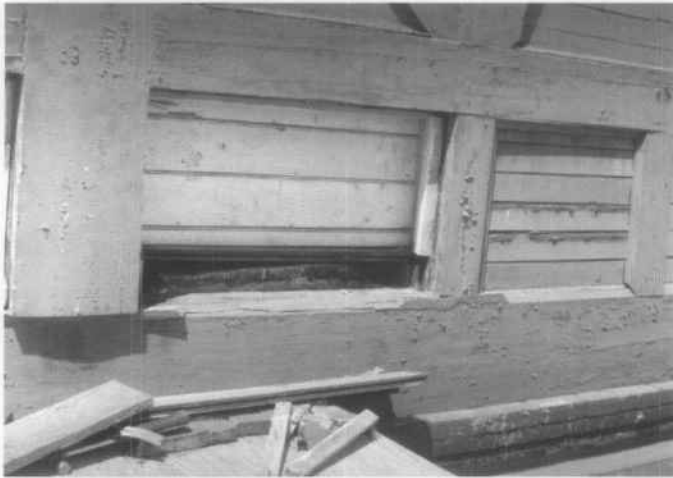
Fig. 8. Damaging moisture conditions can occur during construction. Peeling paint on this newly rehabilitated frame wall was attributed to wall insulation that had become wet during the project and was not discovered. Photo: NPS Files.

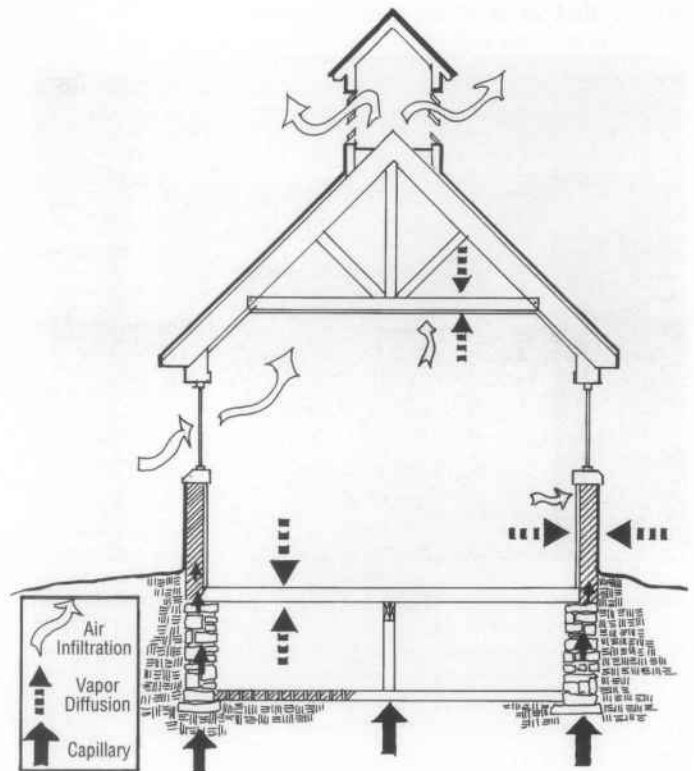
Fig. 9. The dynamic forces that move air and moisture through a building are important to understand particularly when selecting a treatment to correct a moisture problem. Air infiltration, capillary action, and vapor diffusion all affect the wetting and drying of materials. Drawing: NPS Files.

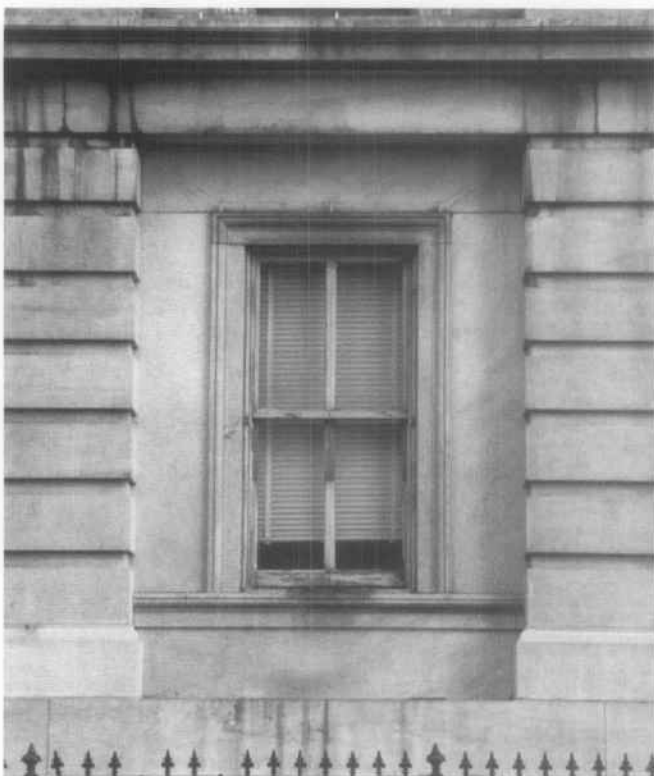
Fig. 10. Infiltration of damp air can occur around loose-fitting or deteriorated window sash and through cracks or open joints in building exteriors. Photo: Ann Brooks Prucher.

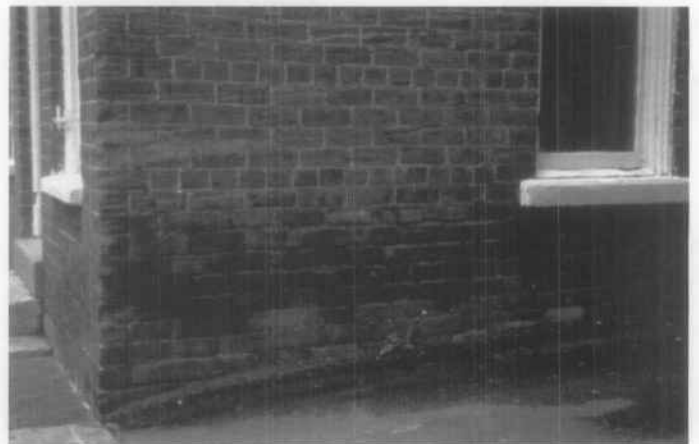
Fig. 11. Capillary rise of moisture in masonry is often accompanied with a horizontal tide-mark line several feet above the grade, as seen here. Removing or redirecting as much ground moisture as possible usually helps reduce moisture within a wall. Photo: NPS Files.

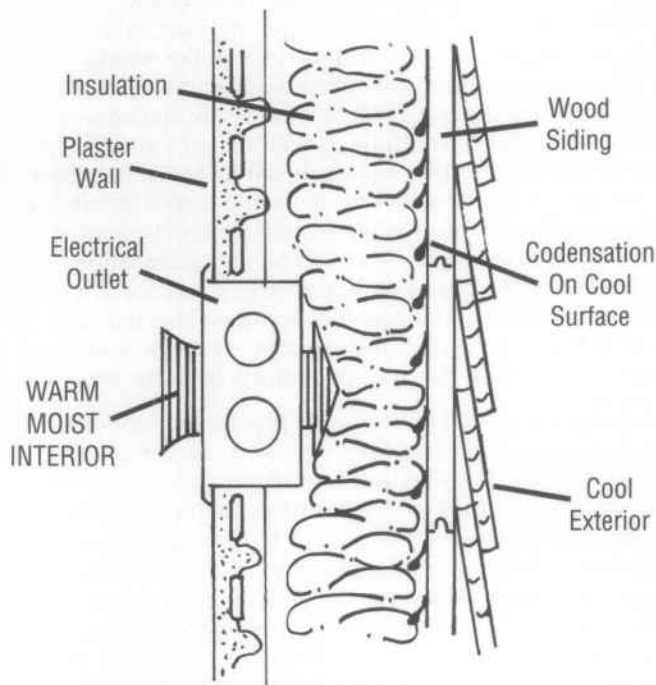
Fig. 12. Vapor diffusion can result in damp air migrating into absorbent materials and condensing on colder surfaces, thereby wetting insulation, damaging electrical conduits, and causing deterioration of the wooden framing. Drawing: NPS Files.

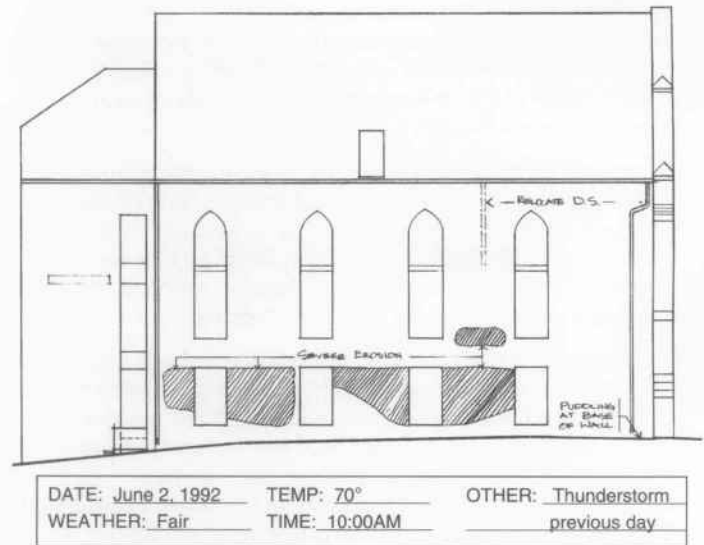
Fig. 13. Using sketch plans and elevation drawings to record the moisture damage along with the date, time, and weather conditions will show how moisture is affecting buildings over time. Drawing: Courtesy, Quinn Evans Architects.

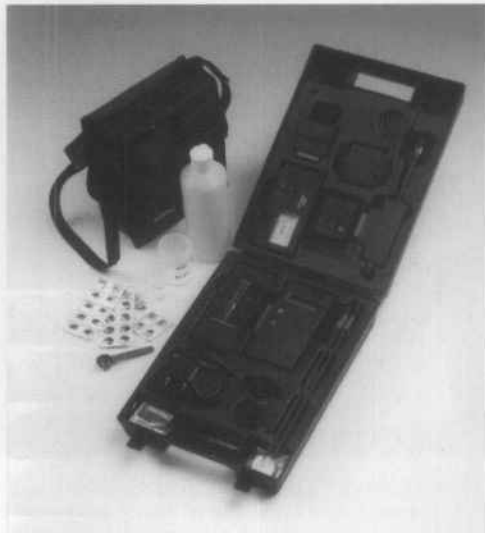
Fig. 14. Using instruments in this damp-check kit can help determine the relative change in wet conditions over time. This involves readings of air temperature, computing dewpoint temperatures, and tracking the moisture content of materials to indicate if they are drying properly. Photo: Dell Corporation.

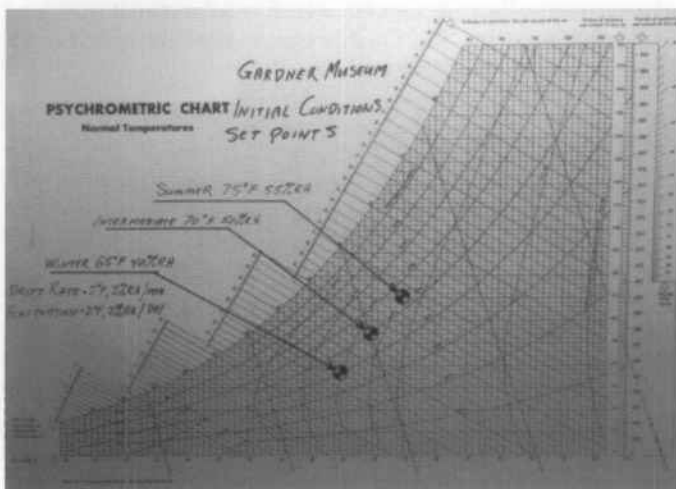
Fig. 15. Psychrometric charts quantify the amount of relative humidity a building can tolerate before dewpoint condensation occurs. This is important when the range of temperature and humidity are critical to both collections management and historic building preservation. Chart: Landmark Facilities Group.

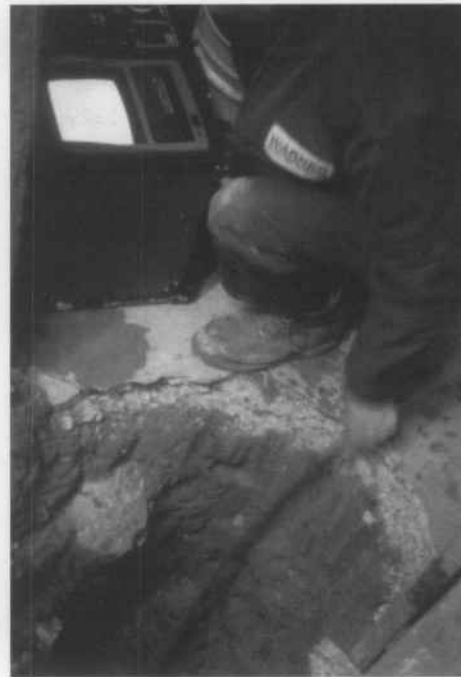
Fig. 16. Contractors specializing in building diagnostics often have video cameras or fiber optic equipment that allow the viewing of inaccessible areas. This is particularly helpful in chimney flues or subsurface drains, as shown here. In the past, these areas would need to be excavated for visual inspection. Photo: author.

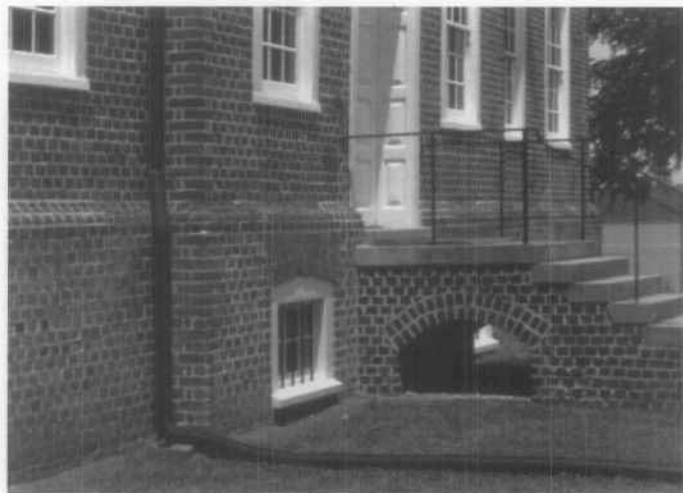
Fig. 17. In testing a theory for the cause of basement wetness, the owner used long black extender pipes to direct roof run-off away from the foundation. This test established that the owner did not need expensive waterproofing of the foundation, but a better drainage system. Photo: Baird M. Smith.

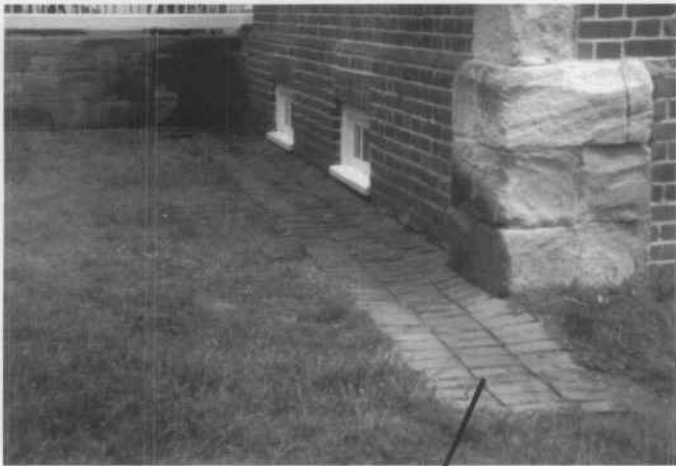
Ongoing maintenance and vigilance to situations that could potentially cause moisture damage must become a routine part of the everyday life of a building. The owner or staff responsible for the upkeep of the building should inspect the property weekly and note any leaks, mustiness, or blocked drains. Again, observing the building during a rain will test whether ground and gutter drainage are working well.

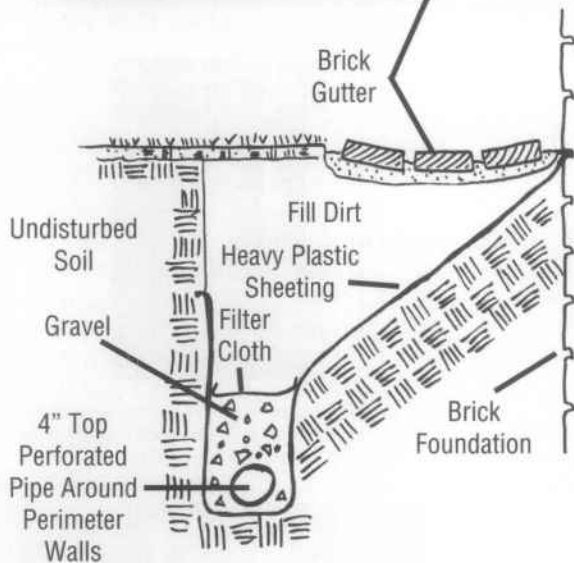
Fig. 18. This detail drawing shows a sub-surface perimeter drain in conjunction with a historic brick ground gutter system to help control roof run-off moisture from entering the historic foundation. Detail: Courtesy, Gunston Hall Plantation. Photo: Elizabeth Sasser.

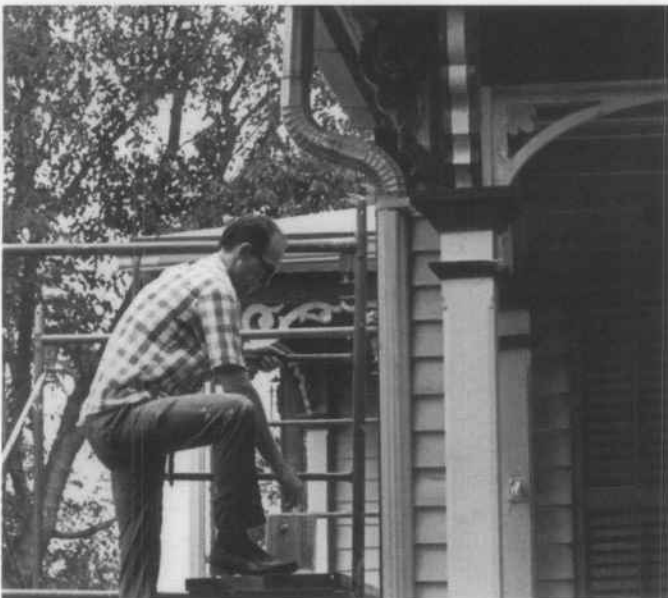
Fig. 19. Maintaining gutters and downspouts in good operable condition, repairing exteriors to keep water out, redirecting damaging moisture away from foundations and controlling interior moisture and condensation are all important when holding the line on moisture deterioration. Photo: Nebraska State Historical Society.

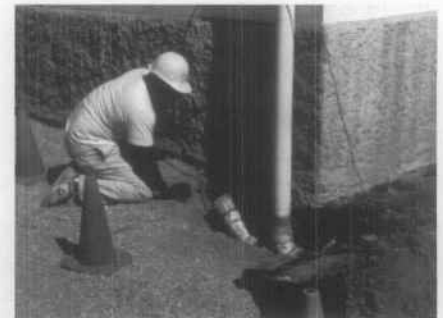
C. Cleaning out gutters and downspouts should be done at least twice a year. Photo: WPTC, NPS.

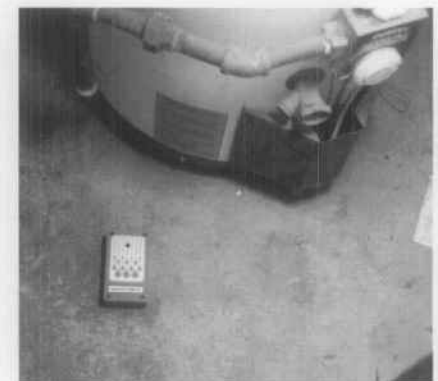
D. Protect the building from damage by maintaining equipment and using alarms, like this floor water sensor. Photo: Dell Corporation.

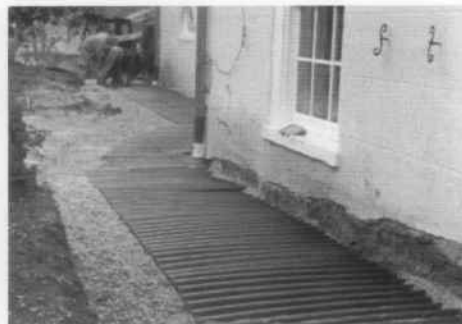
A. Mitigate poor drainage with gravel, filter cloth, or the use of subsurface drainage mats under finished paving. Photo: Larry D. Dermody.

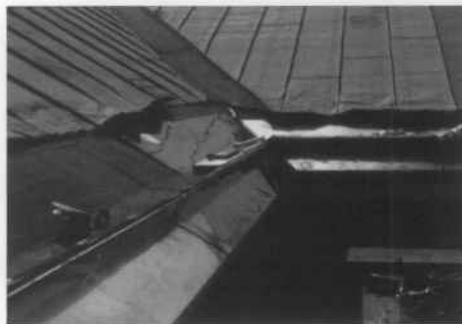
B. Repair roofs and add ice and water shields at eaves and under valleys in cold climates. Photo: Larry D. Dermody.

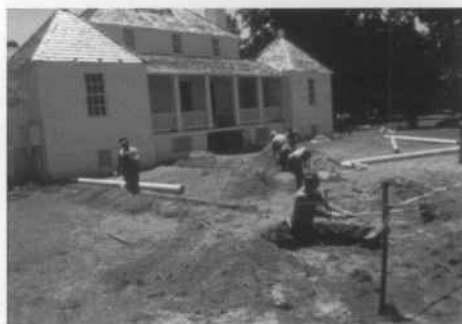
C. Develop new drainage systems for roof run-off that remove moisture from the base of the building. Photo: WPTC, NPS.

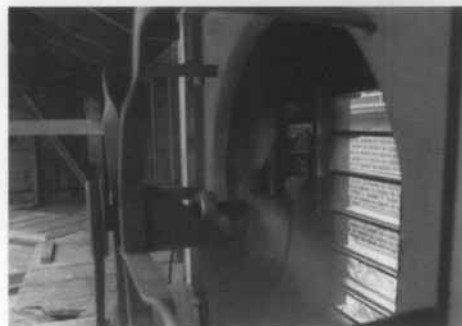
D. Install ventilating fans when additional air circulation will improve damp conditions in buildings or reduce cooling loads. Photo: Ernest A. Conrad, P. E.

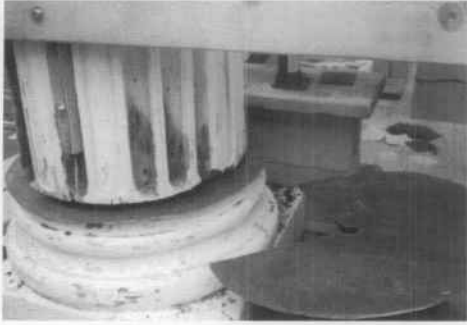
A. This lead sheet was installed at the base of the replacement column to stop rising damp. Photo: Bryan Blundell.

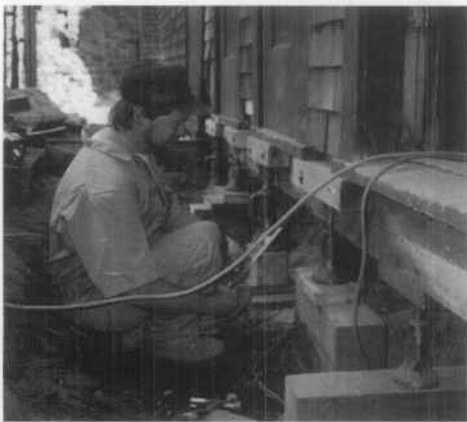
B. Wood sills set on grade were replaced with concrete pier foundation and new wooden sill plates. Changes were not visible on the exterior (see C). Photo: WPTC, NPS.

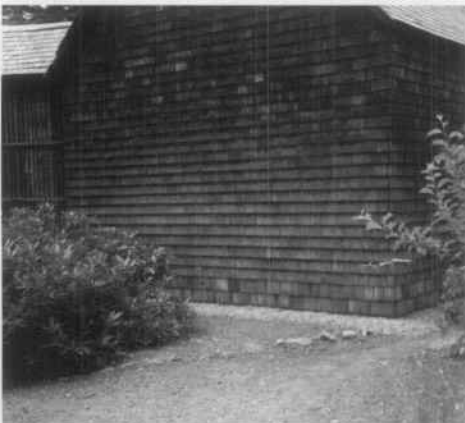
C. The new ground gutter gravel base helps drainage around the concrete foundation (see B above) which is not visible behind the replaced wooden wall shingles. Photo: WPTC, NPS.

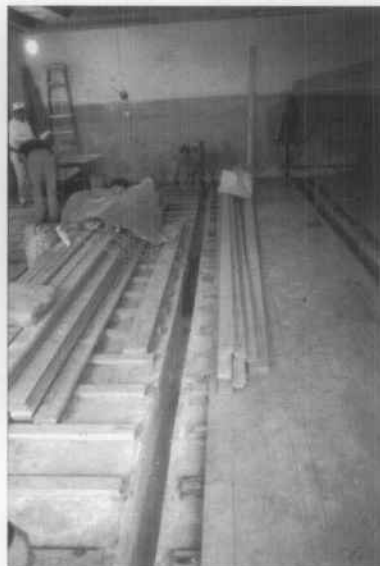
D. In a flood plain, rotted joists were replaced with a concrete slab and sleepers designed to drain water. Spaced flooring allowed drainage and room for damp wood to swell without buckling. Harper's Ferry Center, NPS.

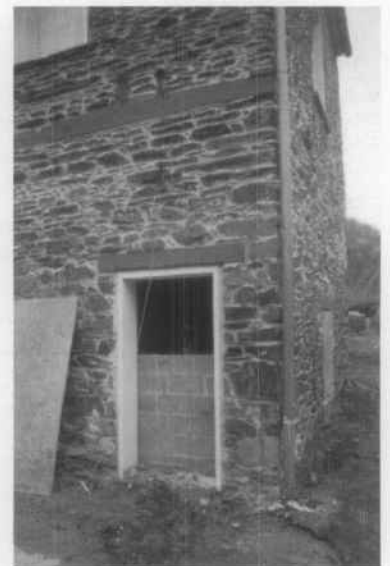
E. Mechanical systems on the lower level were placed on platforms above the flood line. Harper's Ferry Center, NPS.

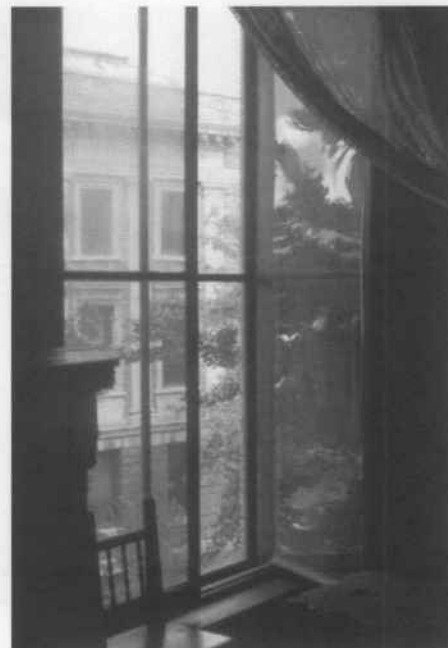
F. Triple glazed windows replaced the originals to control condensation. Photo: © Isabella Stewart Gardner Museum, Boston.

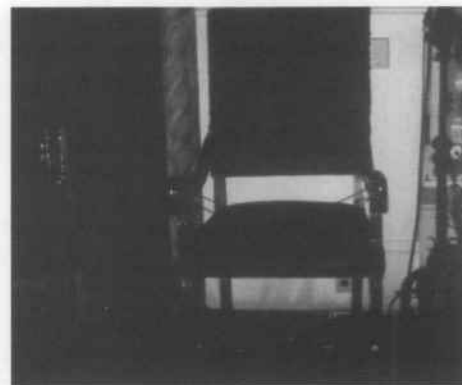
G. New sensors which monitor temperature and relative humidity are located throughout this museum and tied to a computer that controls the climate control system. Photo: © Isabella Stewart Gardner Museum, Boston.

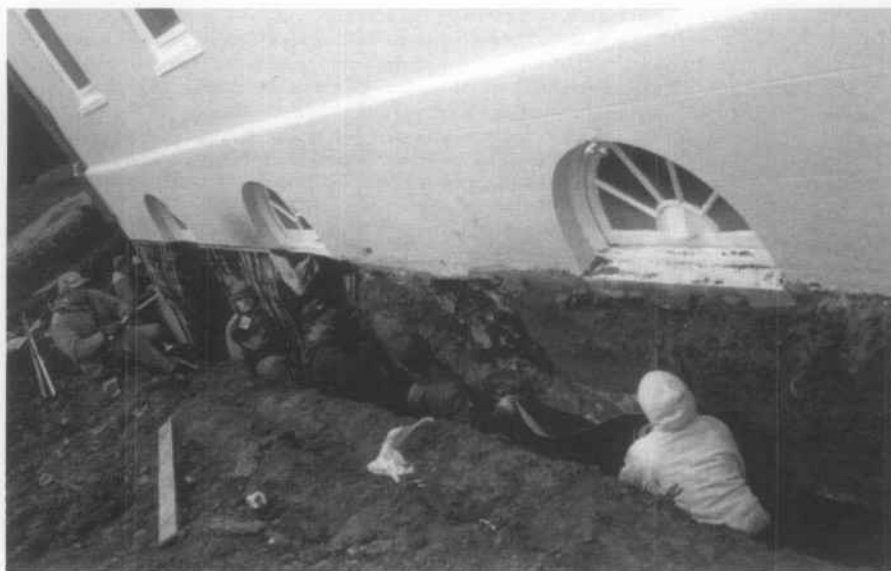
I. Critically damp foundation walls were protected with a layer of bentonite clay to reduce moisture penetration. This work was in combination with new downspouts that were connected to drainage boots that deposited captures roof run-off away from the foundation. Photo: Courtesy, Larry D. Dermody and the National Trust for Historic Preservation.

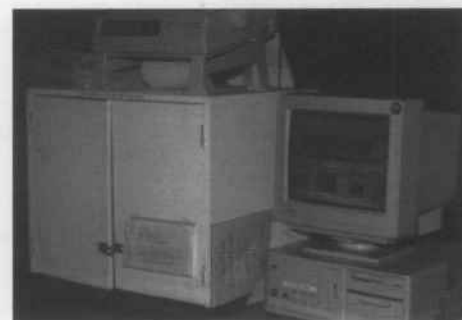
H. New computers tie a variety of monitoring and security features into a comprehensive system which provides warning and backup alerts when any of the system components are not functioning properly. Photo: © Isabella Stewart Gardner Museum, Boston.

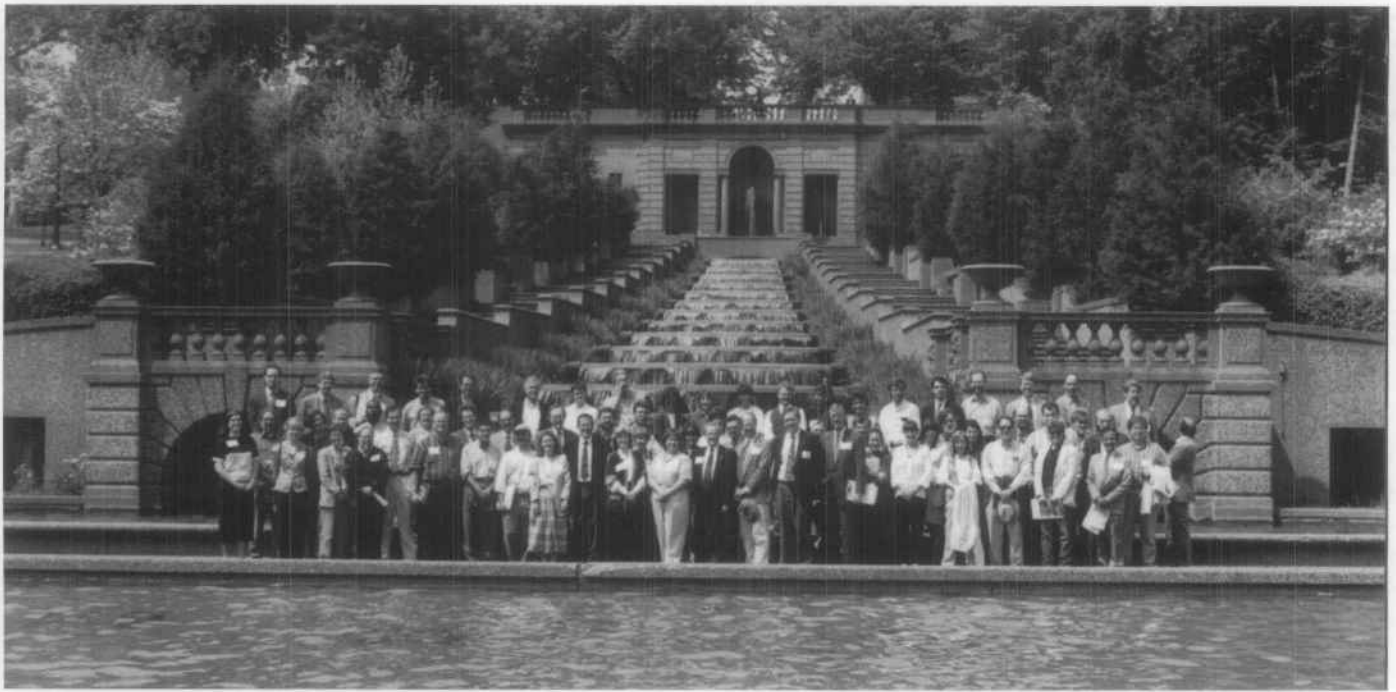
Back Cover: The Diagnosing Moisture in Historic Building Symposium held in Washington, DC, May, 1996, brought together practitioners in the field of historic preservation to discuss the issues contained in this Preservation Brief. Attendees are standing in front of the cascading fountains at Meridian Hill Park, a National Historic Landmark. Photo: Eric Avner.

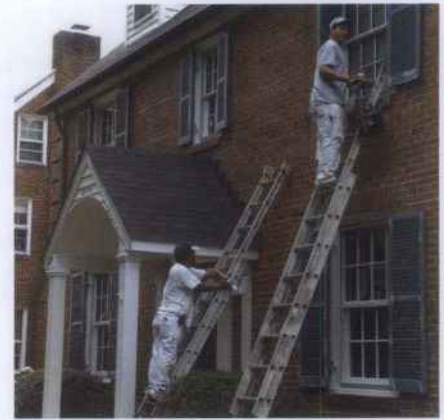
Preservation is defined as “the act or process of applying measures necessary to sustain the existing form, integrity, and materials of an historic property. Work, including preliminary measures to protect and stabilize the property, generally focuses upon the *ongoing maintenance and repair* of historic materials and features rather than extensive replacement and new construction.”¹

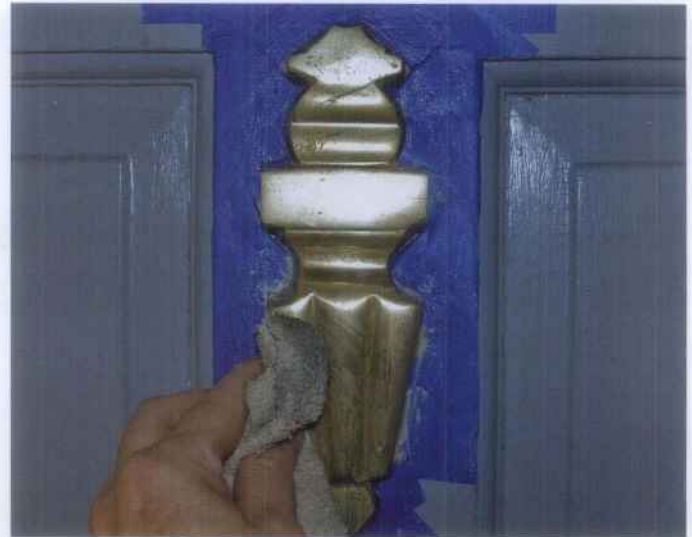
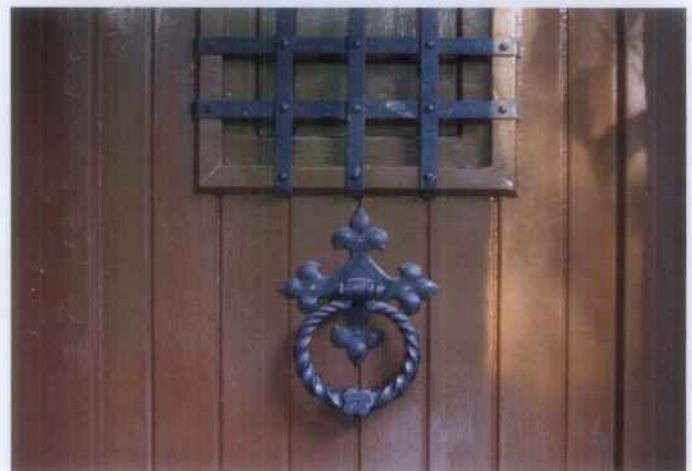
Cautions During Maintenance Work

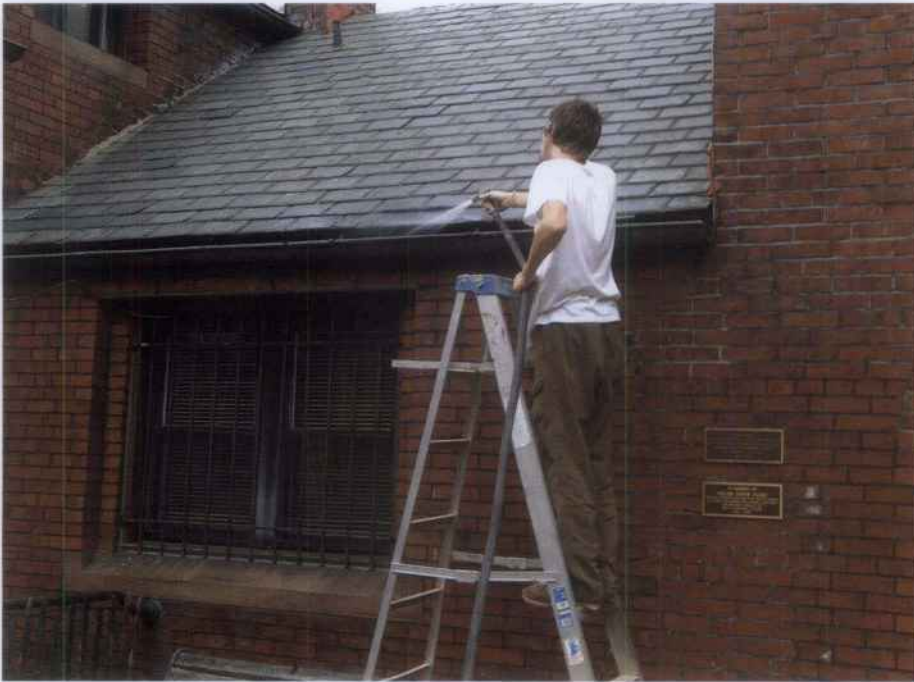
Figure 3. Keeping gutters clean of debris can be one of the most important cyclical maintenance activities. On this small one-story addition, a garden hose is being used to flush out the trough to ensure that the gutter and downspouts are unobstructed. Gutters on most small and medium size buildings can be reached with an extension ladder and a garden hose. Photo: Bryan Blundell.

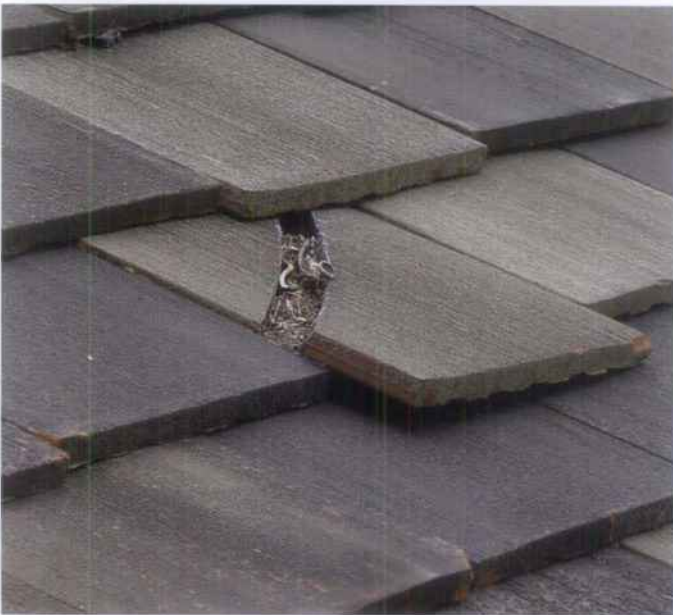
Figure 4. Damage to roofs often requires immediate attention. As a temporary measure, this damaged roof tile could be replaced with a brown aluminum sheet wedged between the existing tiles. Photo: Chad Randl.
