APR 21 2022

BOARD OF RECREATION
AND PARK COMMISSIONERS

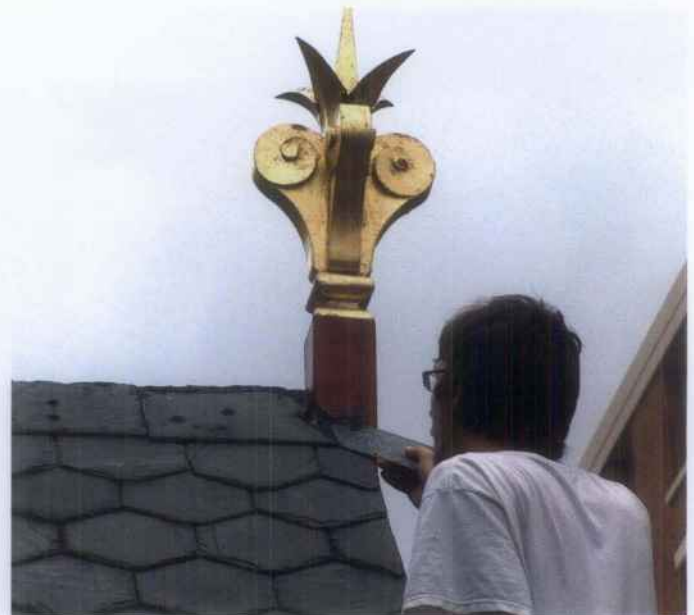
Figure 5. The use of a sealant to close an exposed joint is not always an effective long-term solution. Where this decorative wood element connects to the slate roof, the sealant has failed within a short time and a proper metal flashing collar is being fitted instead. Photo: Bryan Blundell.

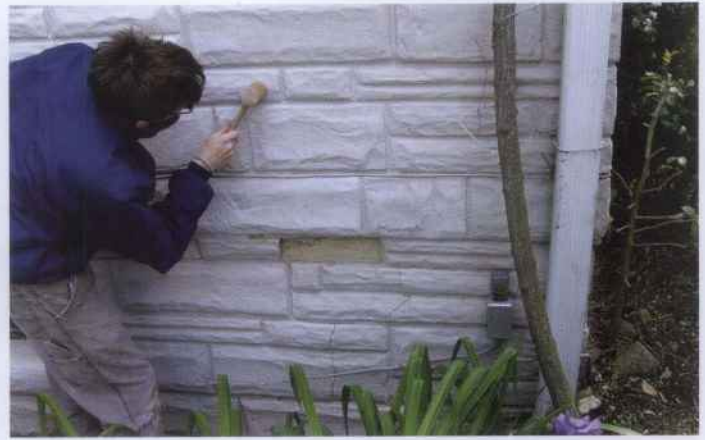
Figure 6. Stucco applied to an exterior wall or foundation was intended to function as a watertight surface. Unless maintained, rainwater will penetrate open joints and cracks that may occur over time. A spalled section of stucco indicates some damage has occurred and a wooden mallet is being used to tap the surface to determine whether the immediate stucco has lost adhesion. Photo: Bryan Blundell.

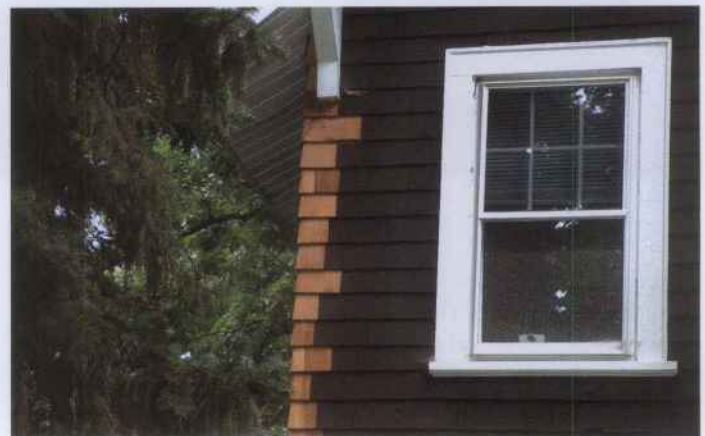
Figure 7. One of the advantages of wood shingles as a wall covering is that individual shingles that are damaged can easily be replaced. On this highly exposed corner, worn shingles have been selectively replaced to help safeguard against water damage. The new shingles will be stained to match the existing shingles.

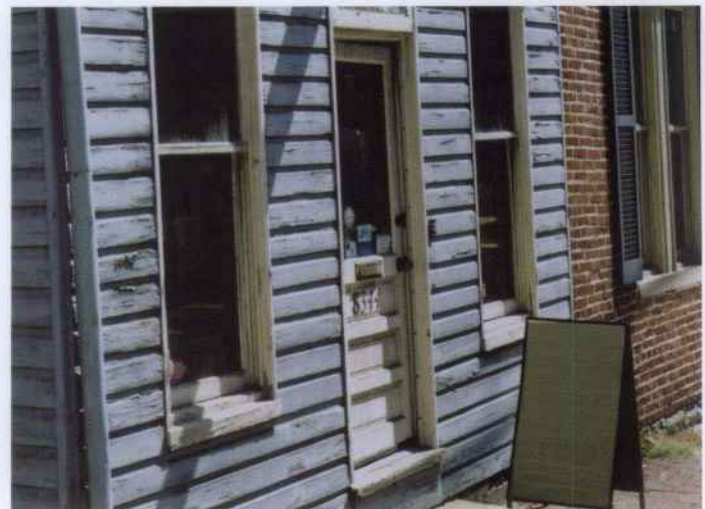
Figure 8. The paint on the siding of this south-facing wall needs to be scraped, sanded, primed and repainted. Postponing such work will lead to further paint failure, require greater preparatory costs, and could even result in the need to replace some siding. Photo: Charles Fisher.

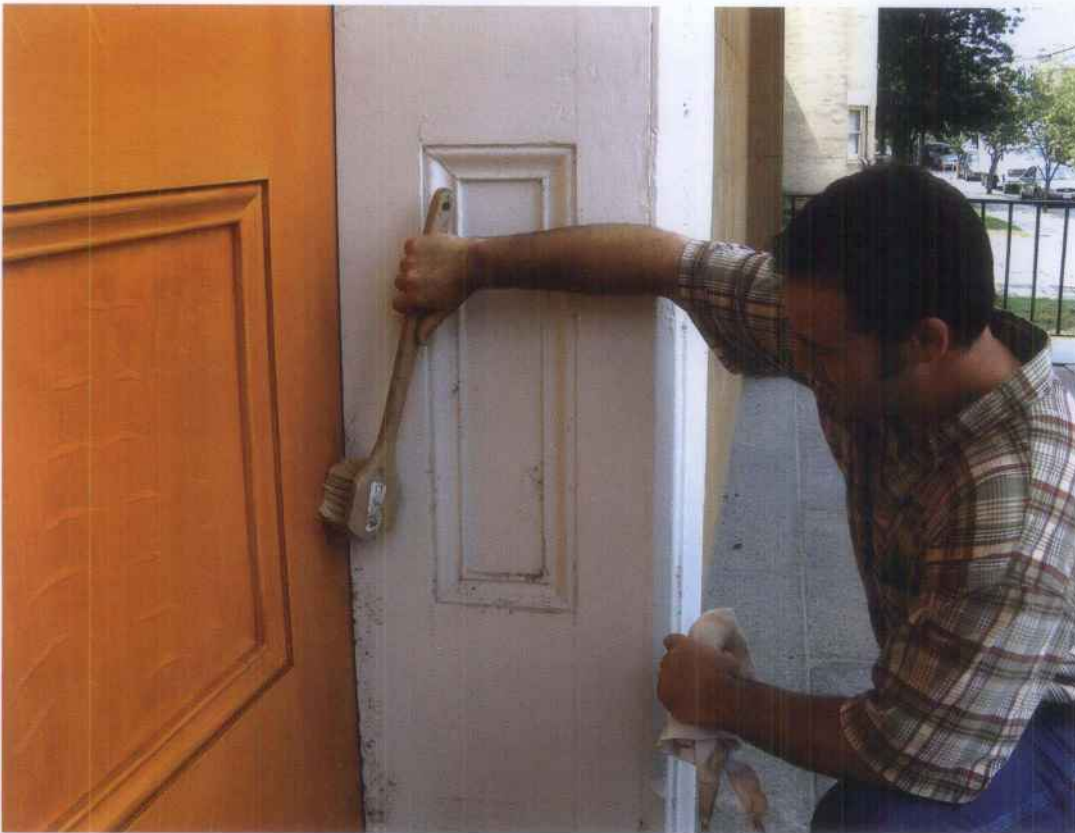
Figure 9. To help extend a repainting cycle, dirt and spider webs should be removed before permanent staining occurs. In this case, a natural bristle brush and a soft damp cloth are being used to remove insect debris and refresh the surface appearance.

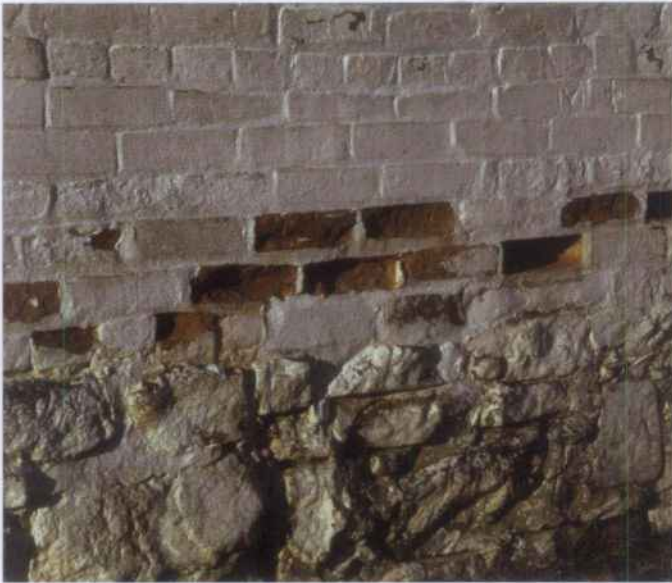
Figure 10. Repointing of masonry should usually be approached as repair rather than maintenance work in part because of the need for a skilled mason familiar with historic mortar. In this case, a moisture condition was not corrected and the use of a waterproof coating and off-the-shelf Portland cement mortar trapped water and resulted in further damage to these 19th century bricks. Photo: NPS files.

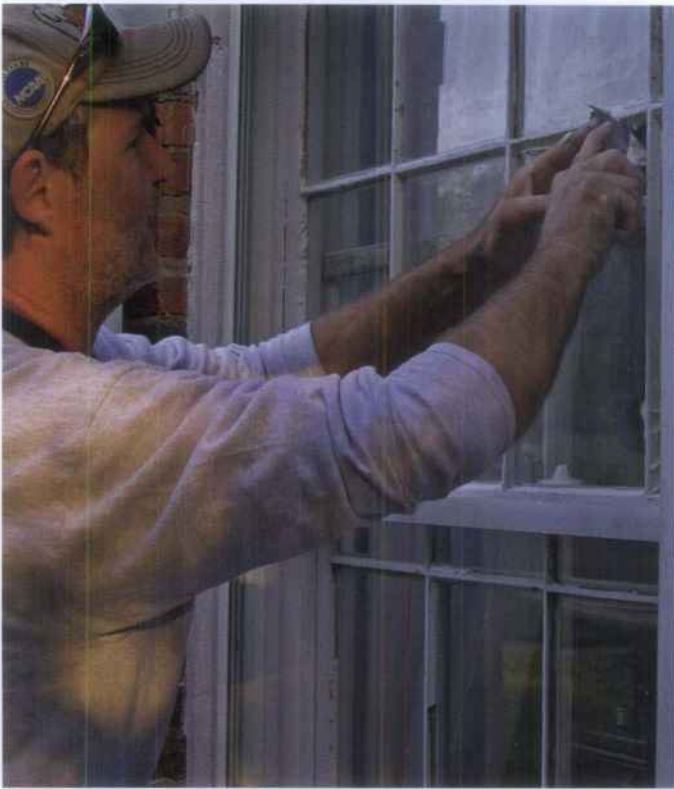
Figure 11. Glazing putty should be maintained in sound condition to prevent unwanted air infiltration and water damage. New glazing putty should be pulled tight to the glass and edge of the wood, creating a clean bevel that matches the historic glazing.

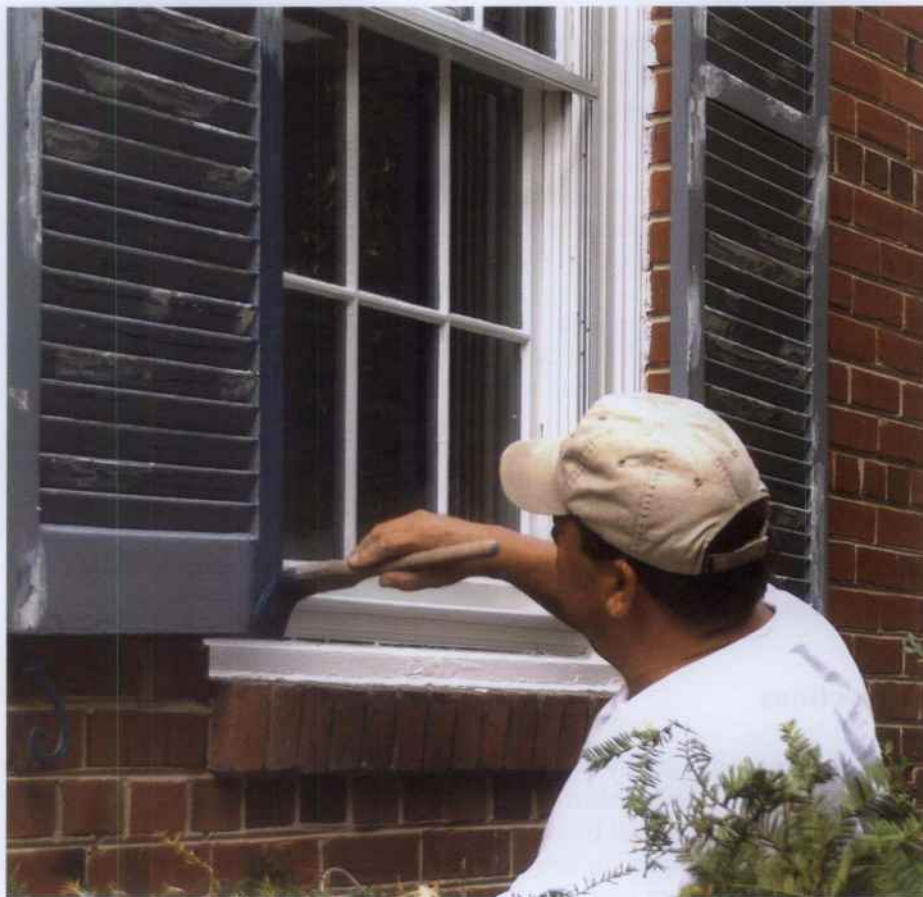
Figure 12. Good surface preparation is essential for long lasting paint. Scraping loose paint, filling nail holes and cracks, sanding, and wiping with a damp cloth prior to repainting are all important steps whether touching up small areas or repainting an entire feature. Always use a manufacturer's best quality paint. Windows and shutters may need repainting every five to seven years, depending on exposure and climate.

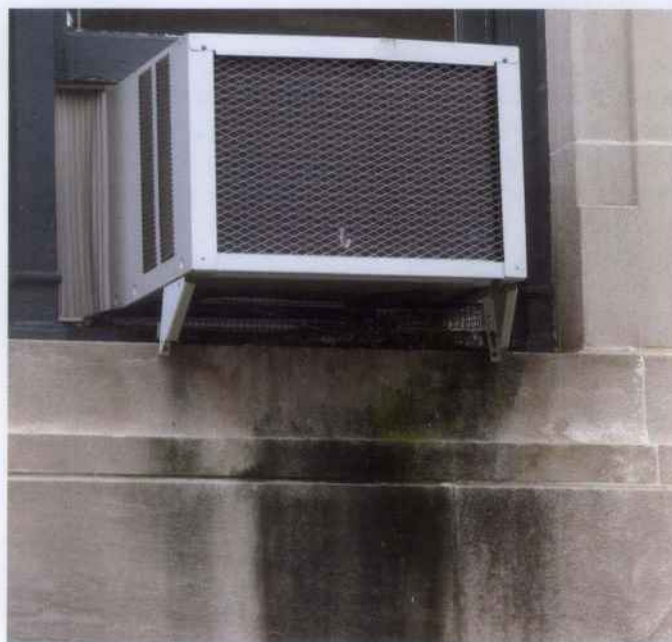
Figure 13. Window air conditioning units can cause damage to surfaces below when condensation drips in an uncontrolled manner. Drip extension tubes can sometimes be added to direct the discharge.

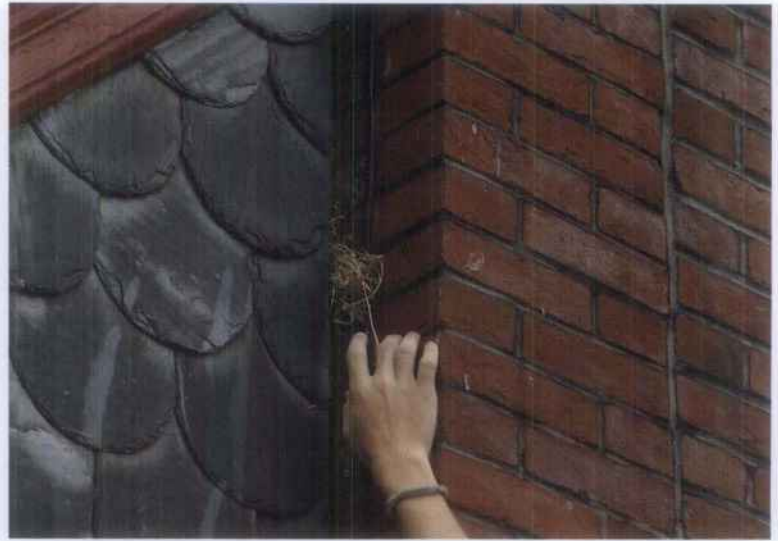
Figure 14. When inspecting connections between projections and the main building, look for areas where birds, bees and pests may enter or nest. Birds have been nesting in this porch roof and the area is being cleaned of their debris. Where an opening exists, it may be necessary to cover it with a trim piece, screening, or sealant. Photo: Bryan Blundell.

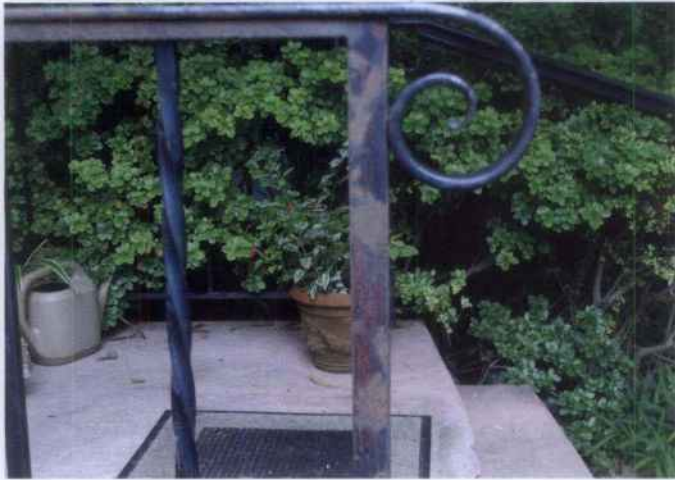
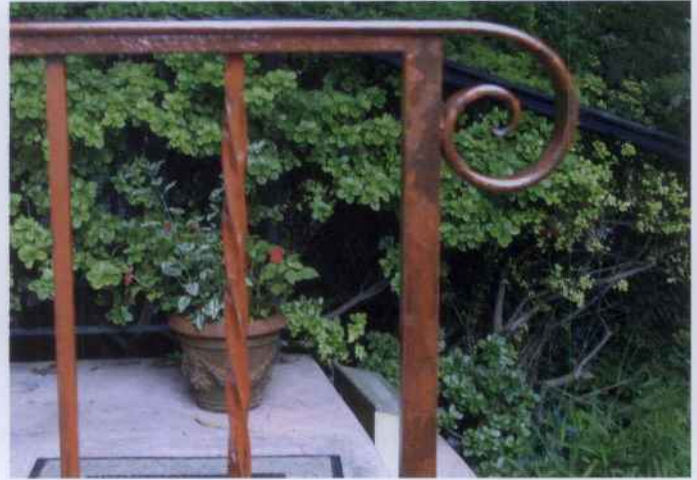
Figure 15. Metal projecting elements on a building, such as sign armatures and railings, are easily subject to rust and decay. Proper surface preparation to remove rust is essential. Special metal primers and topcoats should be used.

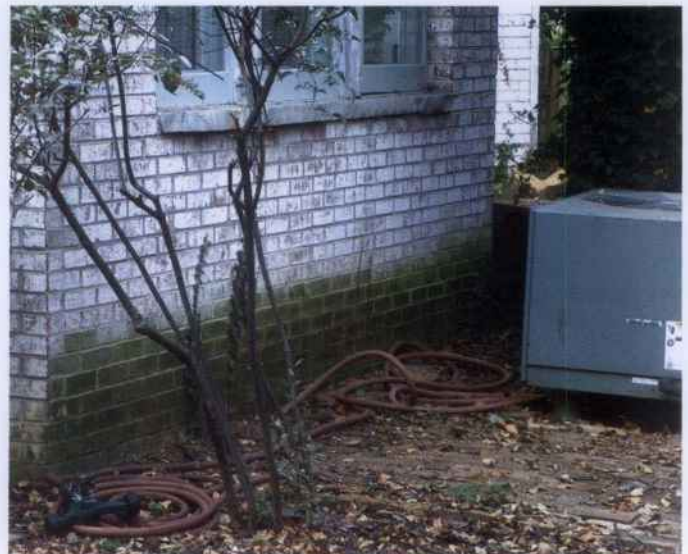
Figure 16. This chronically wet area has a mildew bloom brought on by heat generated from the air-conditioning condenser unit. The dampness could be caused by a clogged roof gutter, improper grading, or a leaking hose bibb.

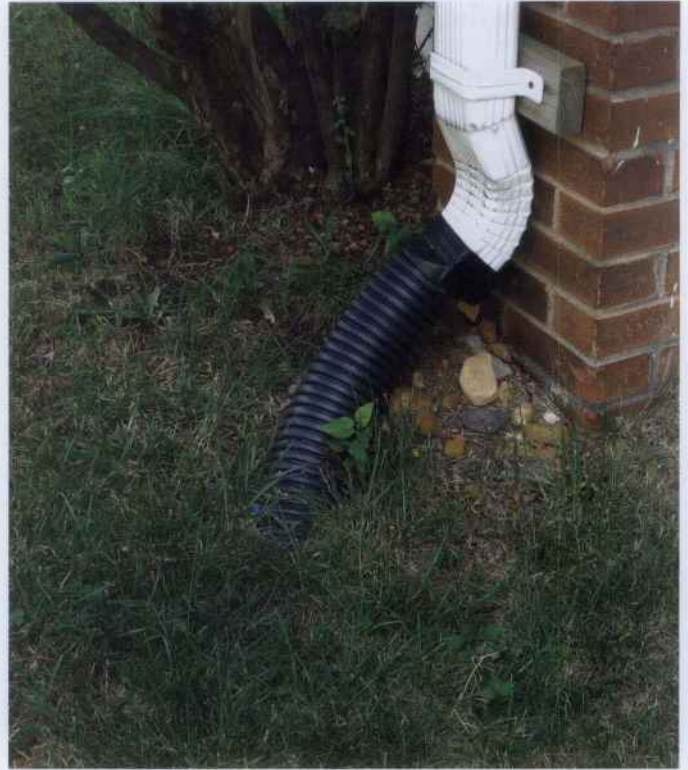
Figure 17. Extending downspouts at their base is one of the basic steps to reduce dampness in basements, crawl spaces and around foundations. Extensions should be buried, if possible, for aesthetics, ease of lawn care, and to avoid creating a tripping hazard. Photo: NPS files.
