# Griffith Park Pony Ride Site Historic Structures Report

*Architecture  
Planning  
Conservation*

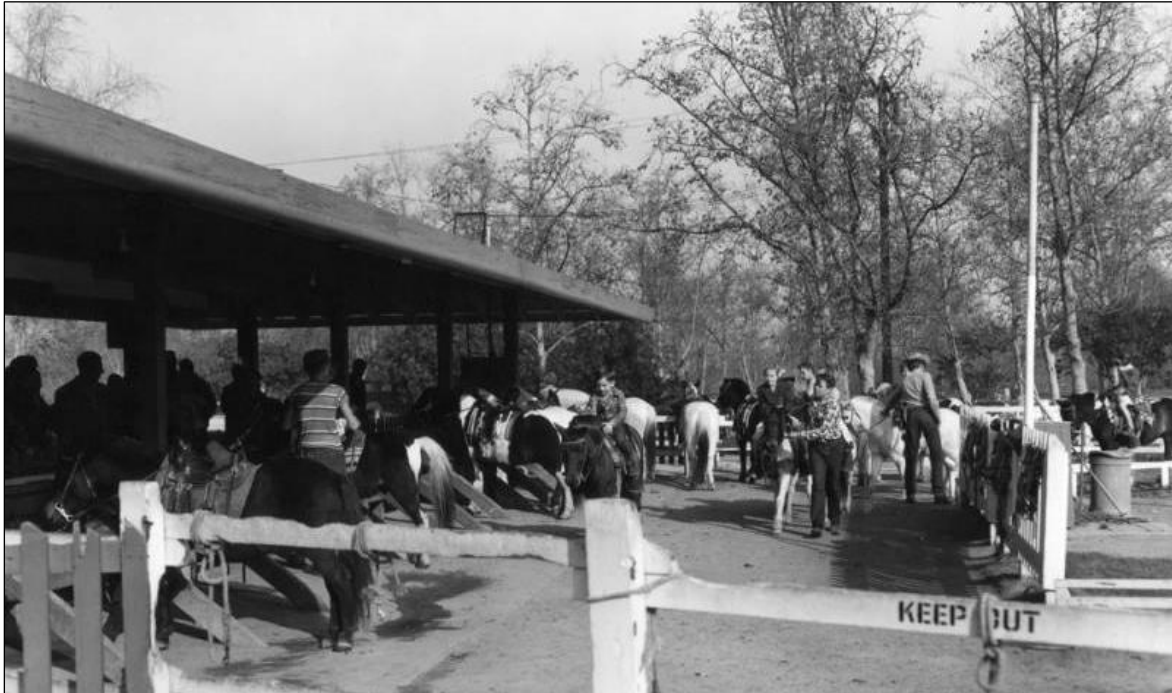
*Pony Ride pergola and riding ring, no date but likely 1950s. Note sycamore trees in background (replaced by carrotwood trees, date unknown) (Los Angeles Public Library).*

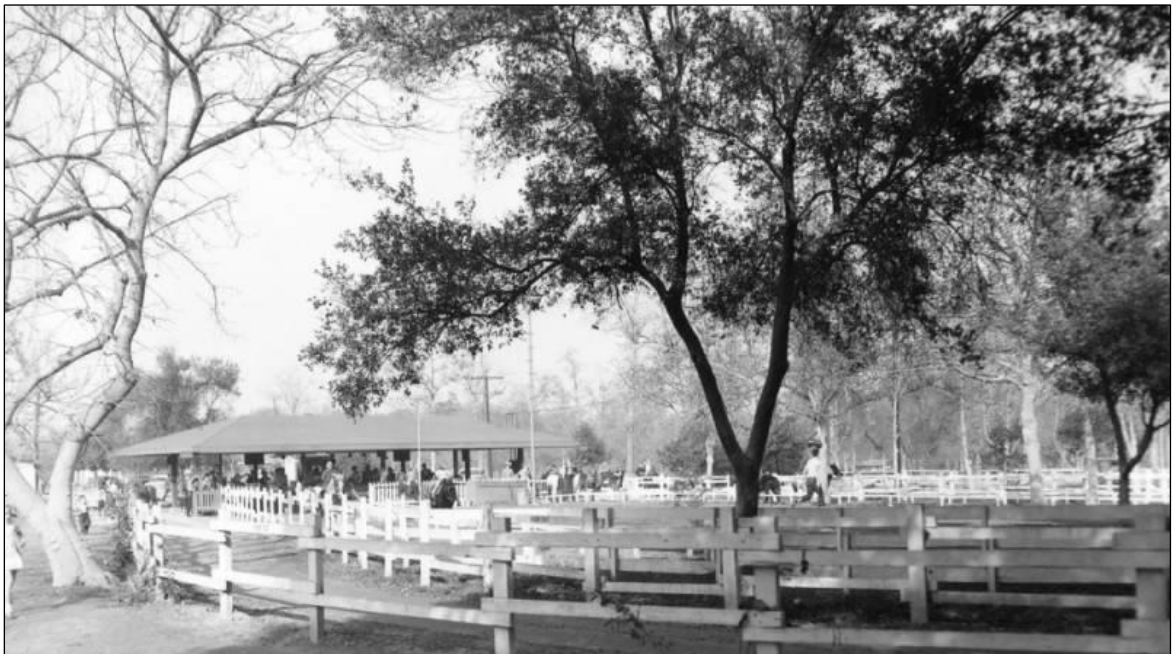
*Pony Ride riding ring with pergola in the background, no date but likely 1950s. Note sycamore trees within and surrounding ring (removed at unknown date) (Los Angeles Public Library).*

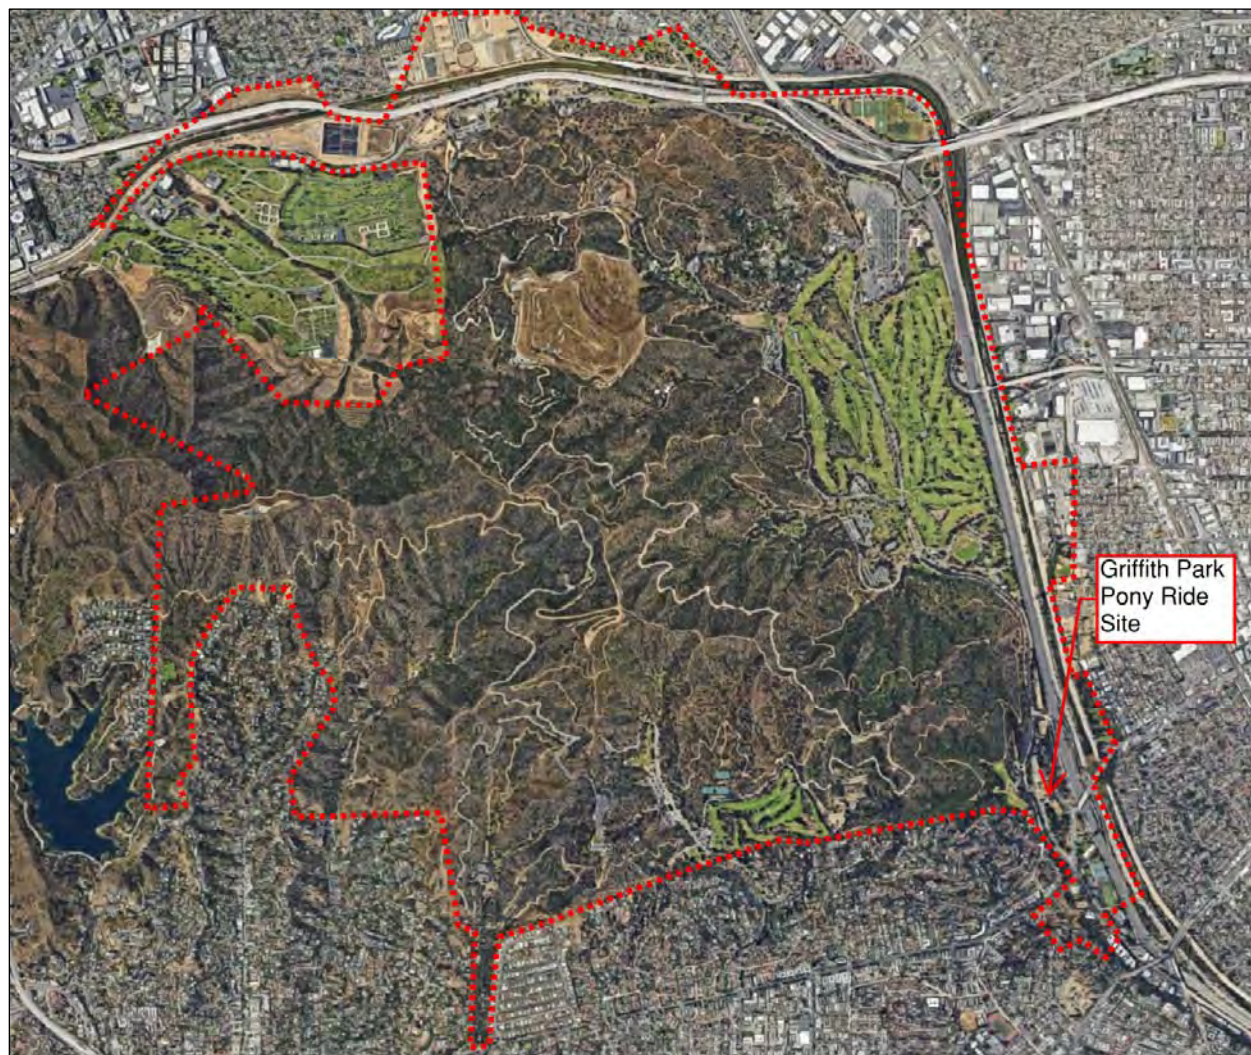
Aerial view of Griffith Park (boundary outlined in dashed red line), with location of the Pony Ride Site noted (Google Maps, adapted by ARG, 2023).

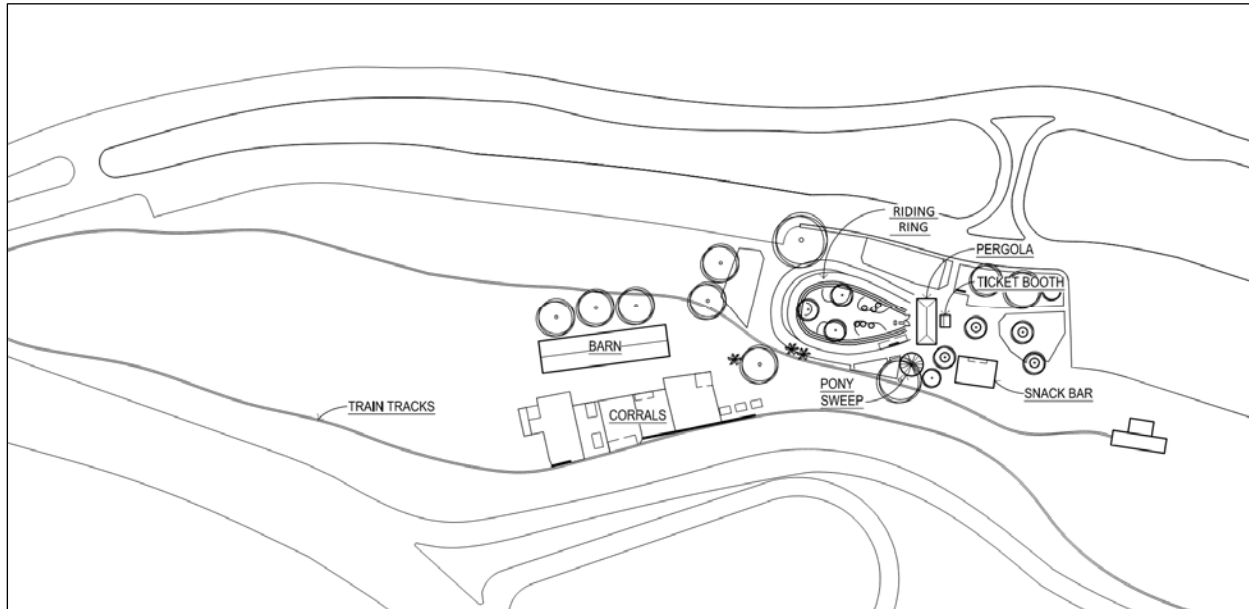
Griffith Park Pony Ride Context Site Plan (ARG, 2023).

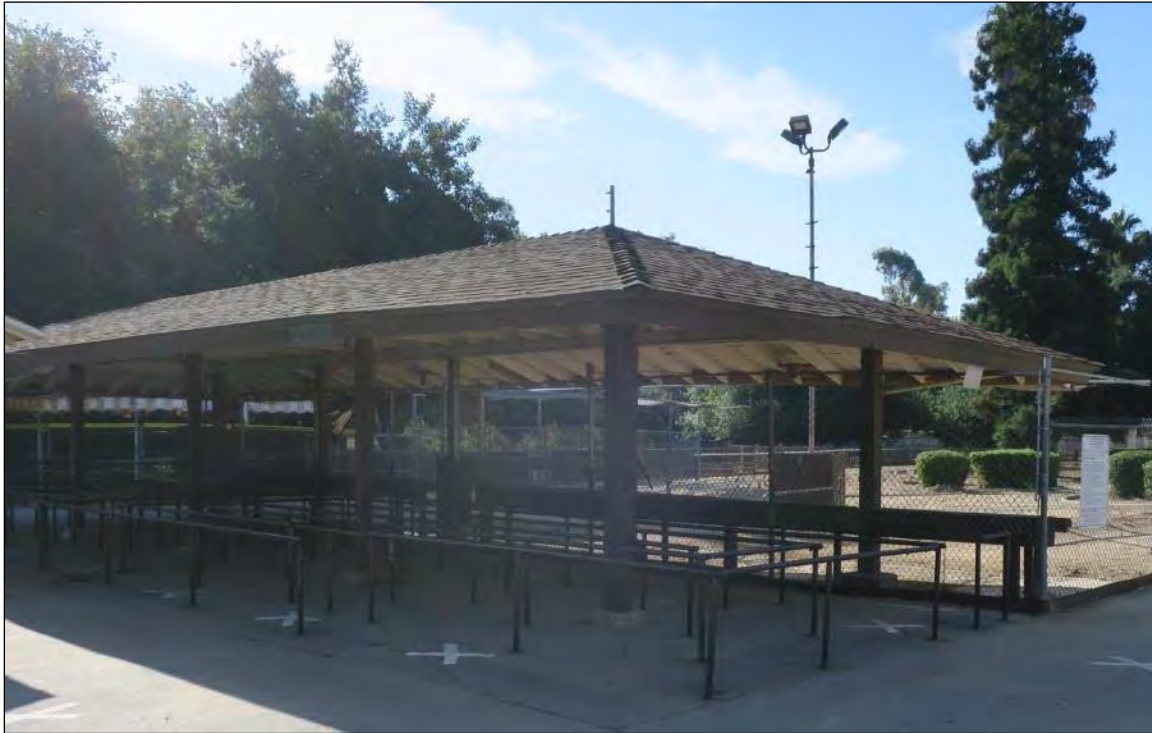
*View southeast of the pergola (ARG, 2023).*

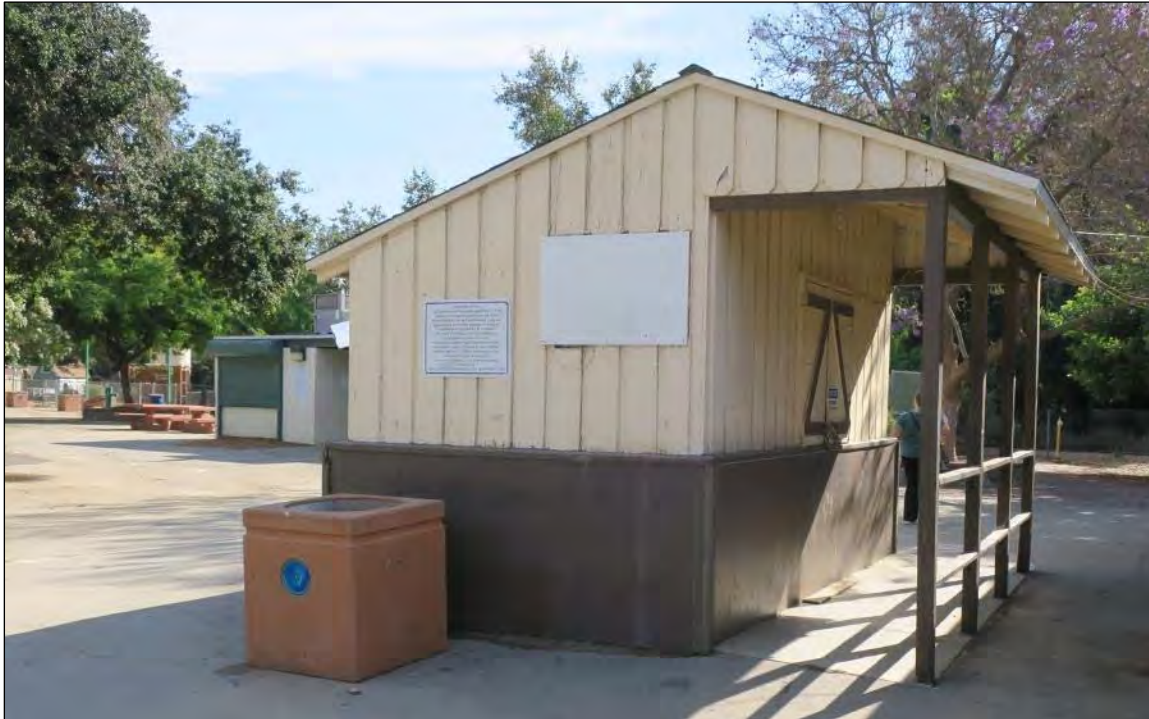
*View west of the ticket booth (ARG, 2023).*

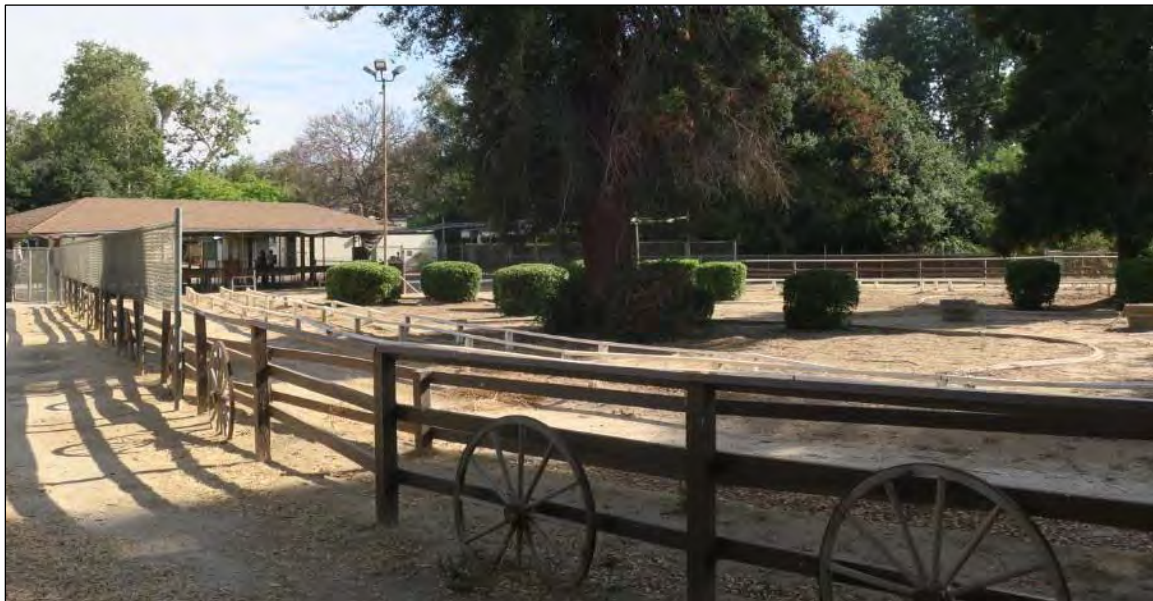
*View northeast of the riding ring towards the pergola (ARG, 2023).*

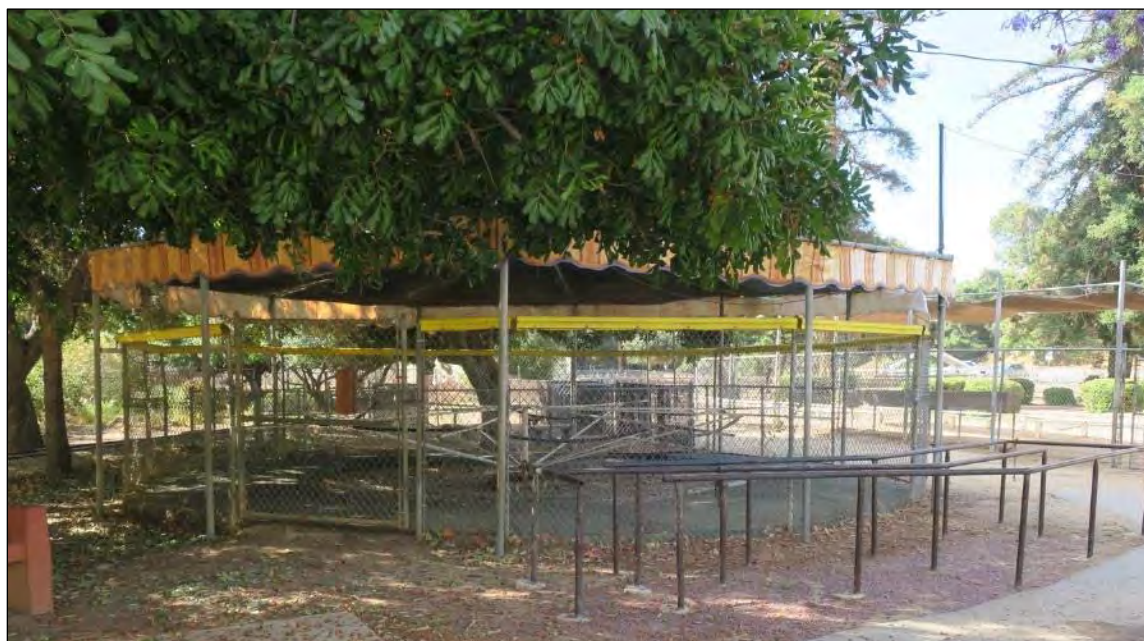
*View south of the pony sweep (ARG, 2023).*

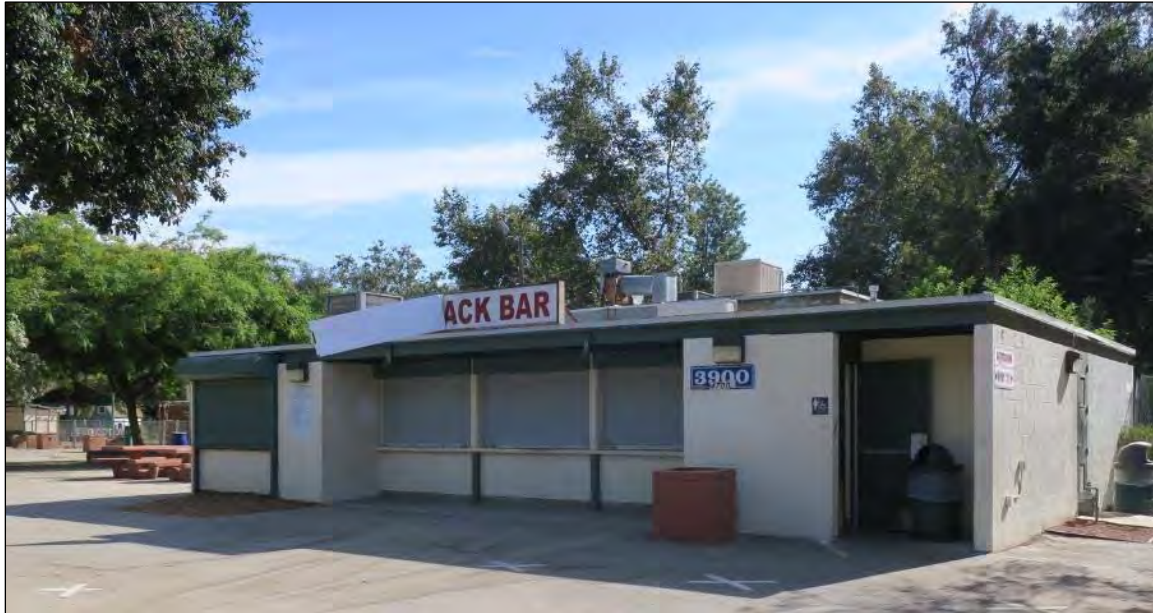
*View northeast of the snack stand and restroom building (ARG, 2023).*

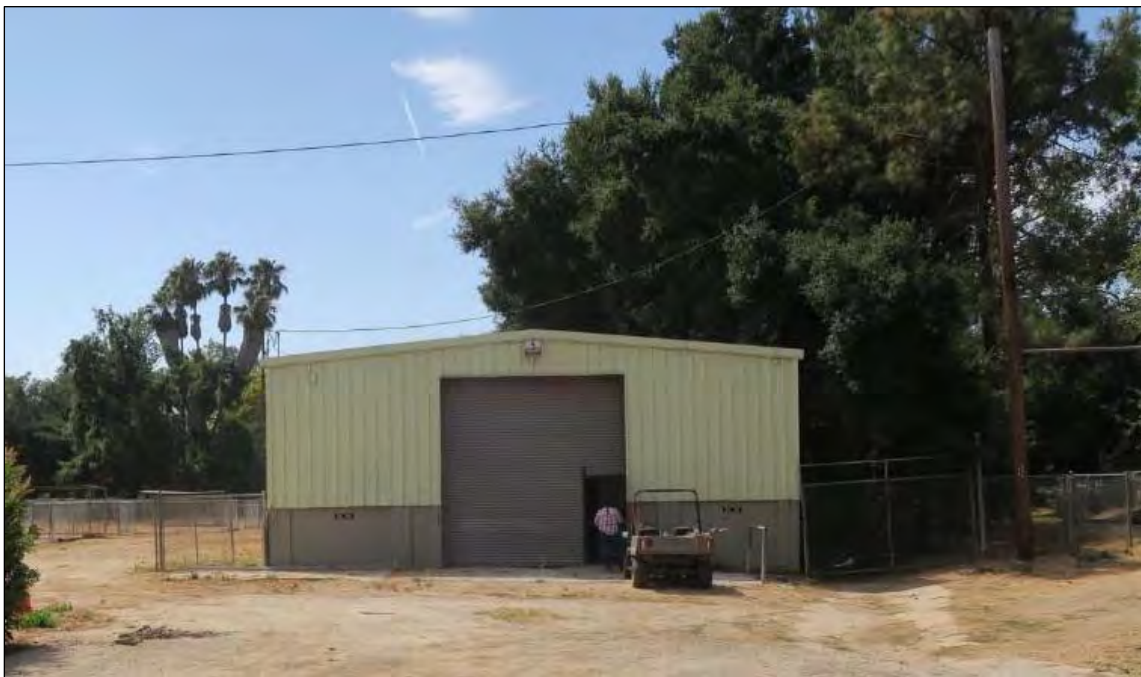
*View south of the barn (ARG, 2023).*

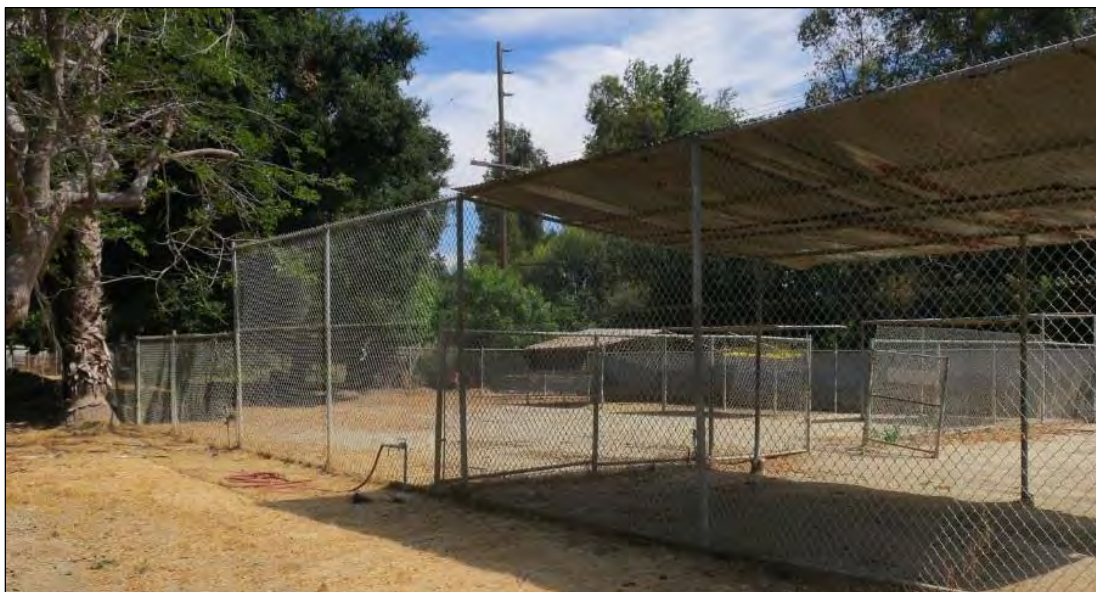
*View northeast of the corrals (ARG, 2023).*

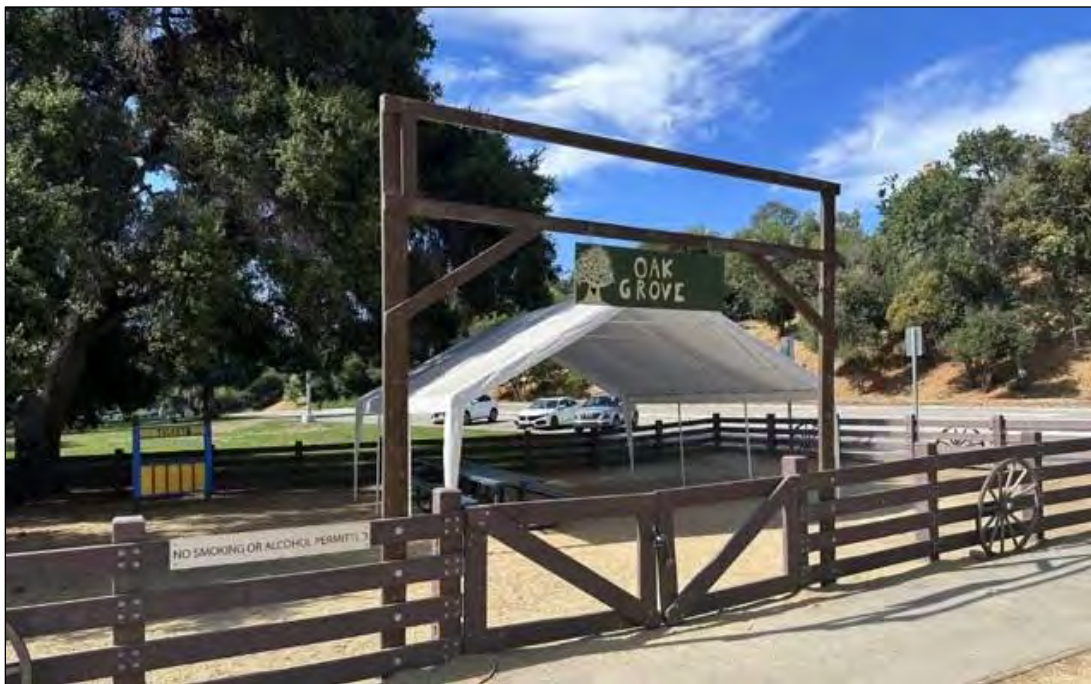
View southeast of the south “Oak Grove” birthday pavilion (ARG, 2023).

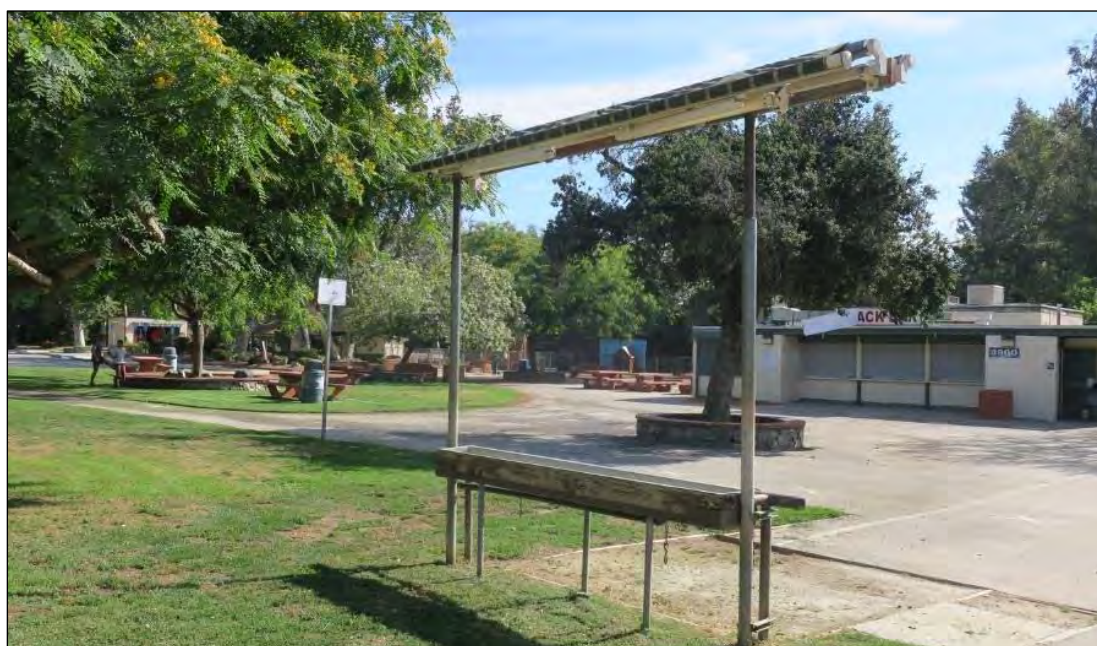
*View of the freestanding shade structure (ARG, 2023).*

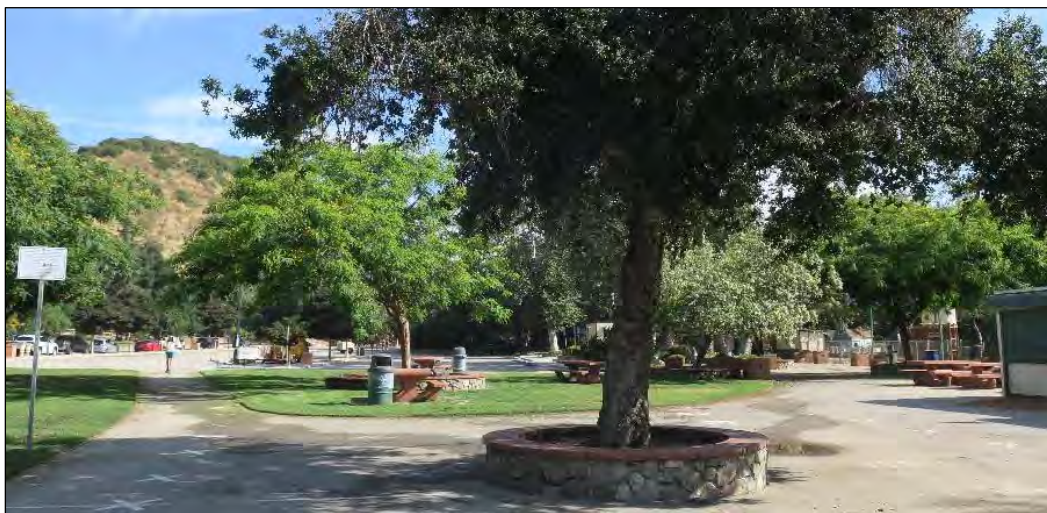
*View of the masonry planter and historic coast live oak tree (ARG, 2023).*

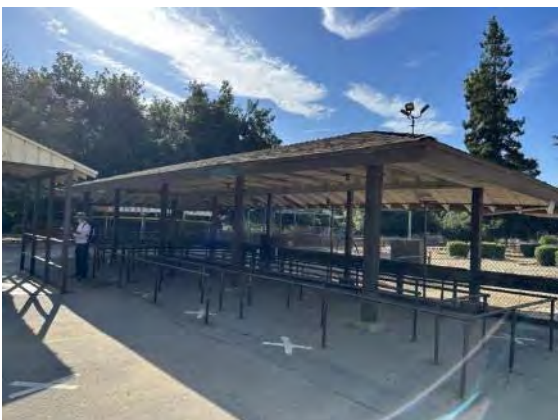
View looking southeast showing pergola and stanchions (ARG, 2023).

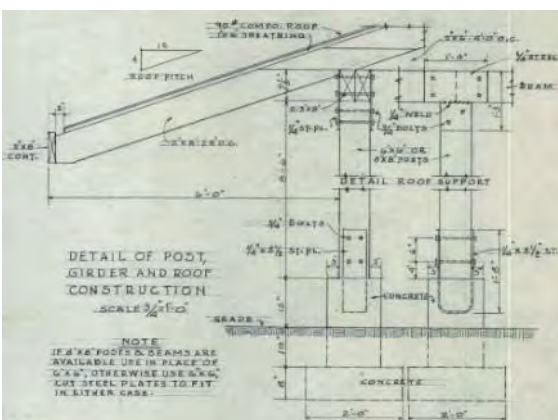
Section detail through pergola showing roof/column framing and foundation (Department of Parks, City of Los Angeles, Board of Park Commissioners, 1946).

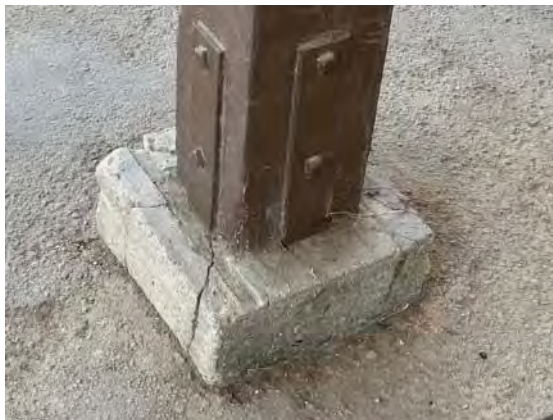
Detail at typical column base; note cracks in concrete footing (ARG, 2023).

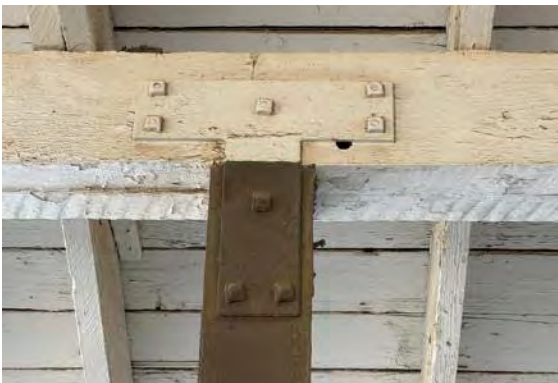
Detail at typical column/beam connection with T-shaped steel plates and bolts (ARG, 2023).

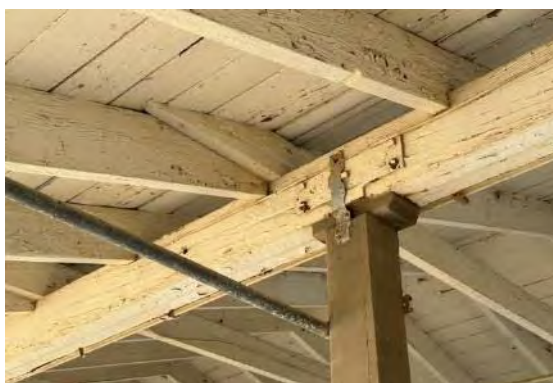
Detail at column; note metal strap repair at connection plate (ARG, 2023).

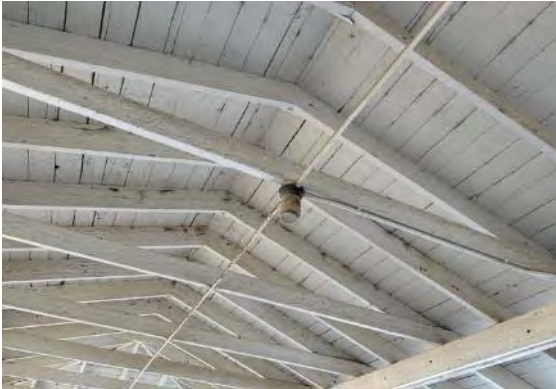
View of pergola ceiling; note light fixture and exposed conduit (ARG, 2023).

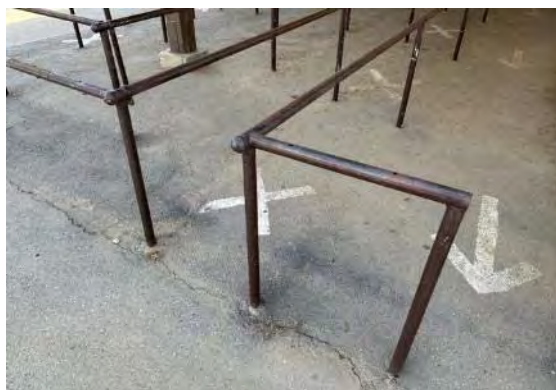
Stanchions and directional markings at asphalt pavement; note cracks and missing end cap (ARG, 2023).

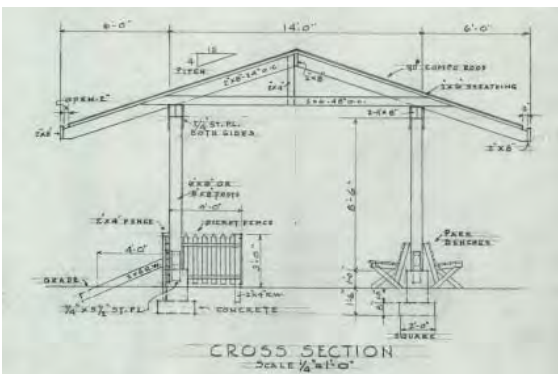
*Cross section through pergola; note benches, picket fence, and stall divider (Department of Parks, City of Los Angeles, Board of Park Commissioners, 1946).*

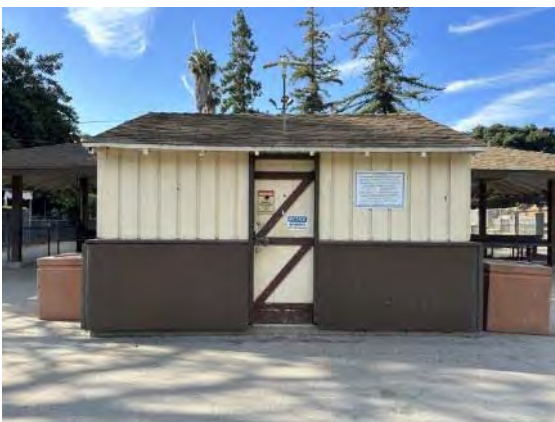
*North façade of ticket booth (ARG, 2023).*

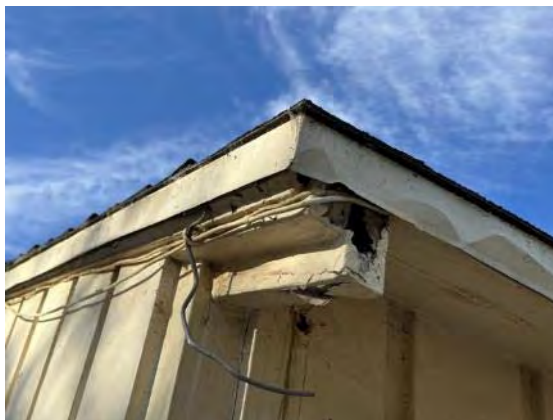
Detail at northeast corner of roof; note heavy wood rot at rafter tail and dented sheet metal edge flashing (ARG, 2023).

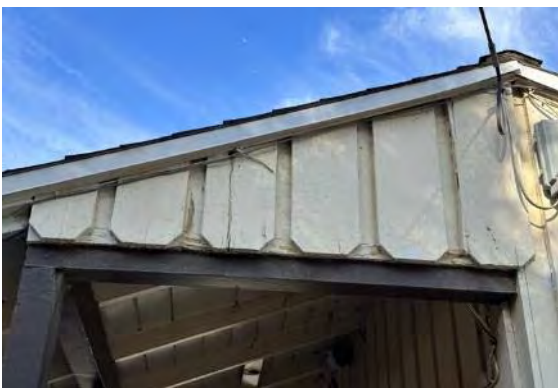
Detail at east façade over porch; note splits in vertical siding (ARG, 2023).

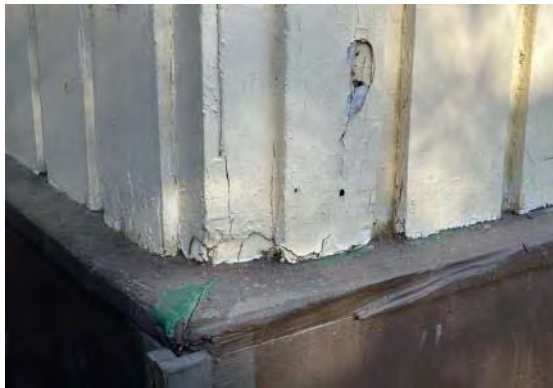
Detail at northeast corner; note wood decay and peeling paint at base of siding; also note loss at wood sill (ARG, 2023).

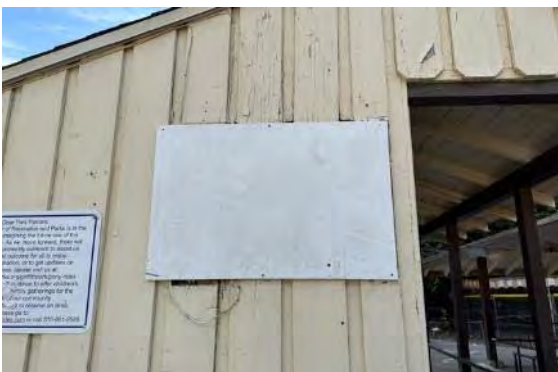
Detail at west façade; note infill panel covering hole for A/C unit (ARG, 2023).

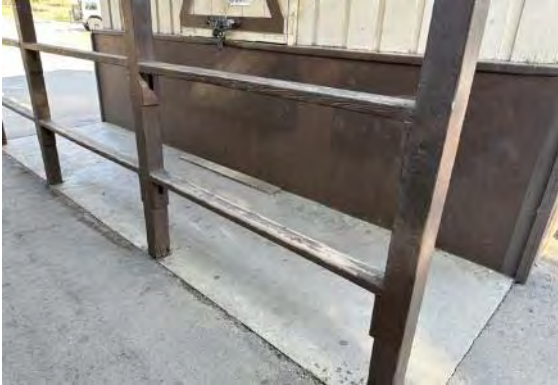
*Porch railings; note heavy wear damage and paint loss (ARG, 2023).*

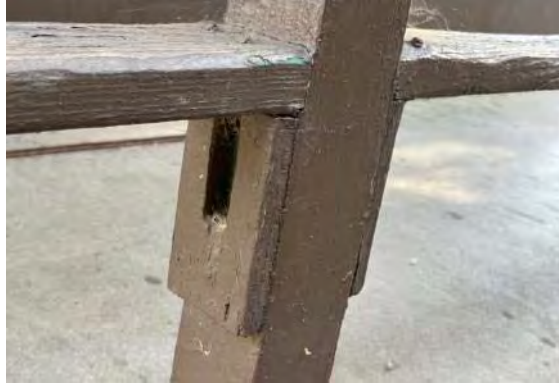
*Detail at porch top rail; note wood bracket from previous railing (ARG, 2023).*

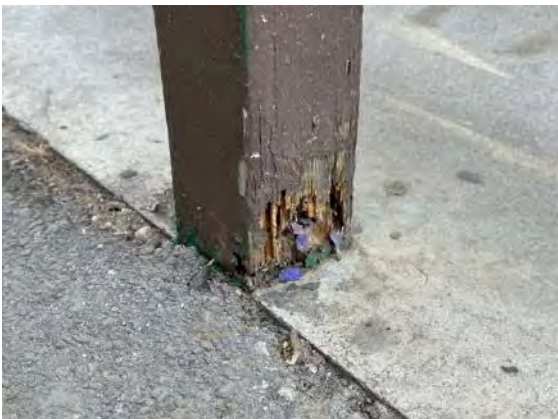
*Detail at base of porch column; note wood decay/rot (ARG, 2023).*

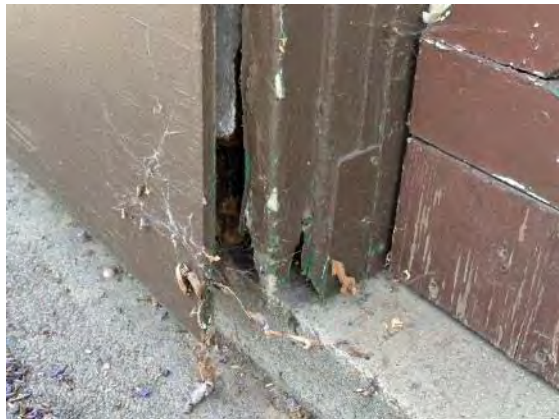
*Detail at door frame; note heavy wood decay/loss at frame and wall (ARG, 2023).*

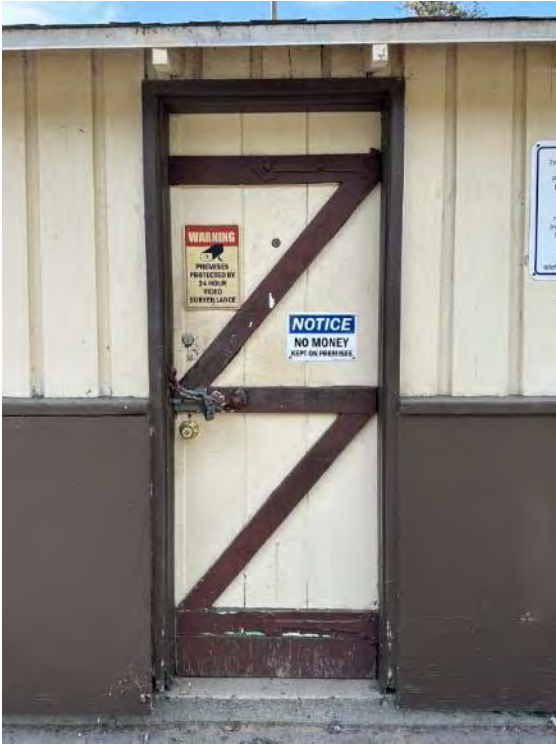
*View of door exterior; note added base trim (ARG, 2023).*

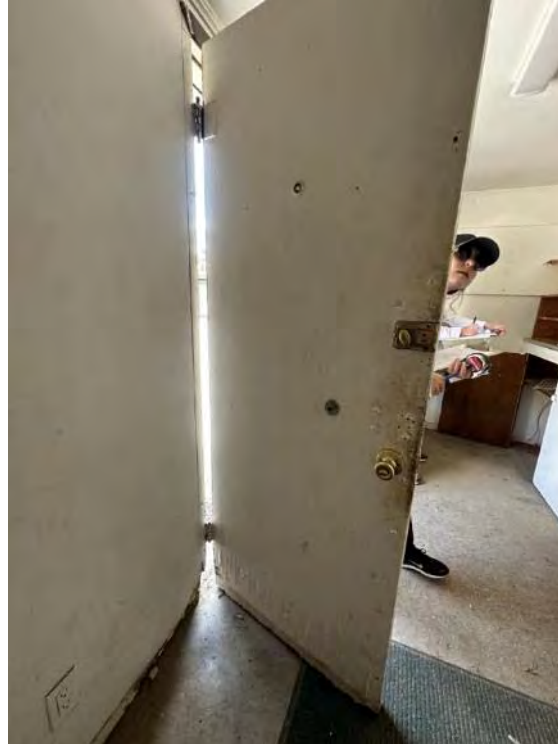
*View of door interior; note overall wear (ARG, 2023).*

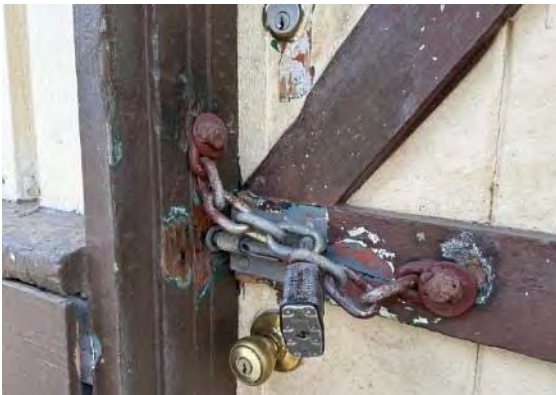
*Detail of door hardware (ARG, 2023).*

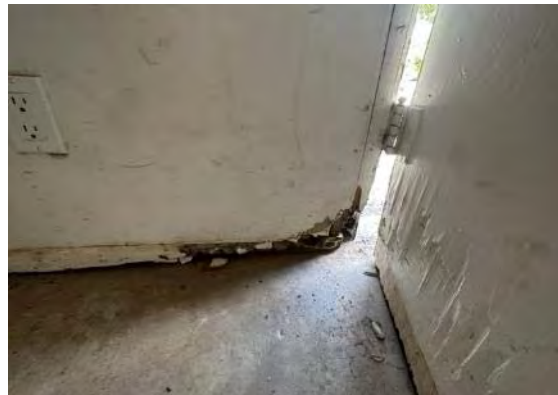
*Detail at base of door interior; note door and wall damage (ARG, 2023).*

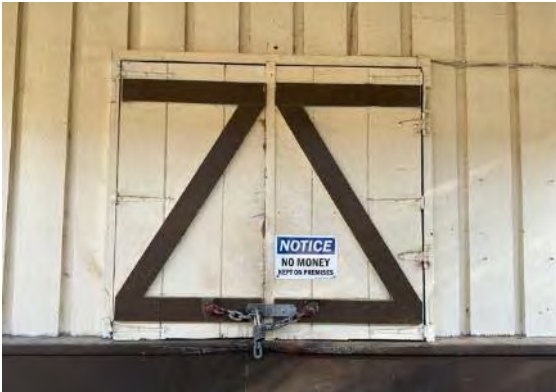
View of ticket window exterior shutters (ARG, 2023).

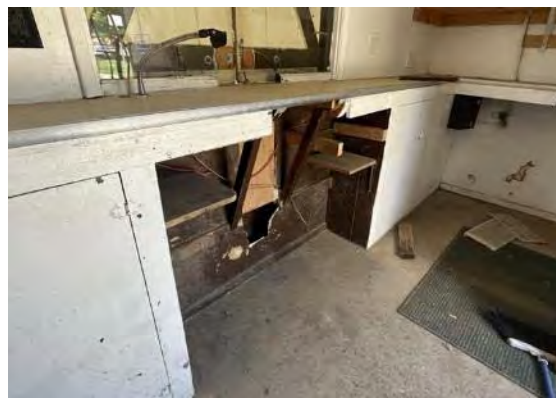
Detail of wall damage below ticket window (ARG, 2023).

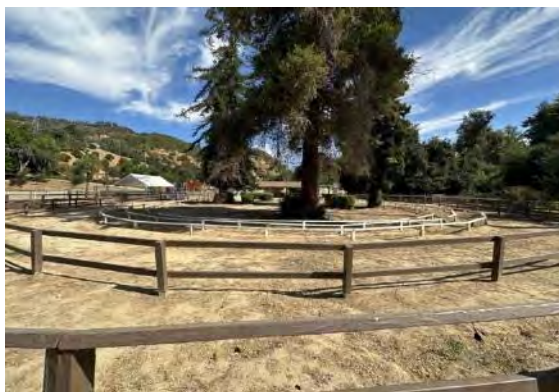
*View of riding rings looking north to pergola (ARG, 2023).*

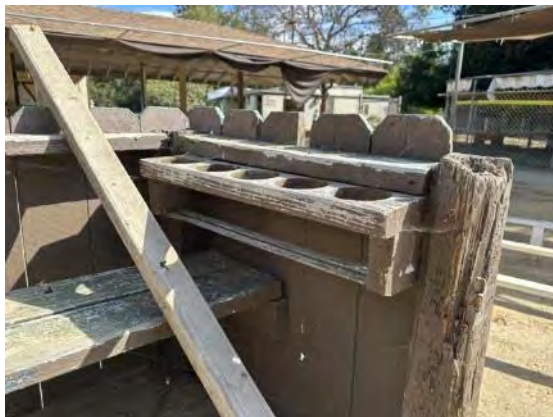
*Detail of cup holders at stand; note termite damage at wood post (ARG, 2023).*

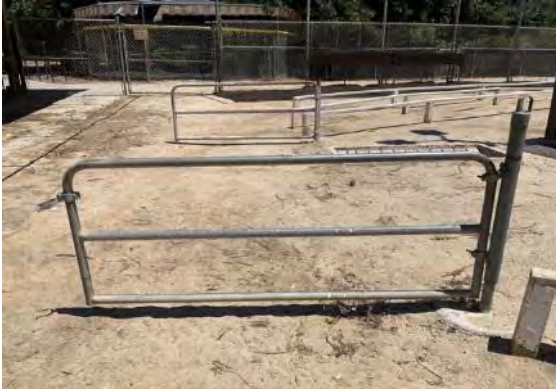
*Metal gates at north end of riding ring (ARG, 2023).*

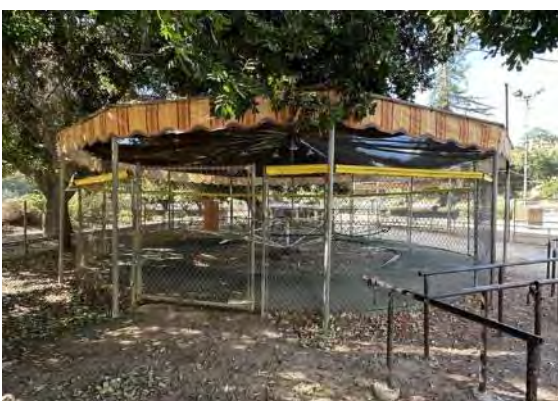
*View of north side of pony sweep; note gate entry and stanchions (ARG, 2023).*

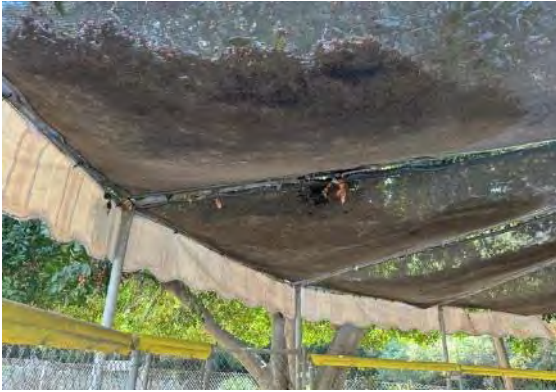
*Detail at roof awning; note heavy collections of leaves/debris, and stained and sagging mesh panels (ARG, 2023).*

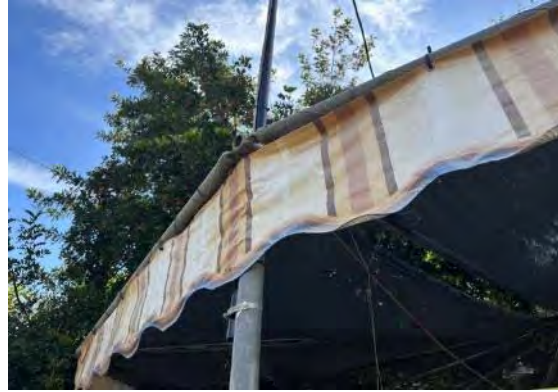
*Detail at valance; note faded colors (ARG, 2023).*

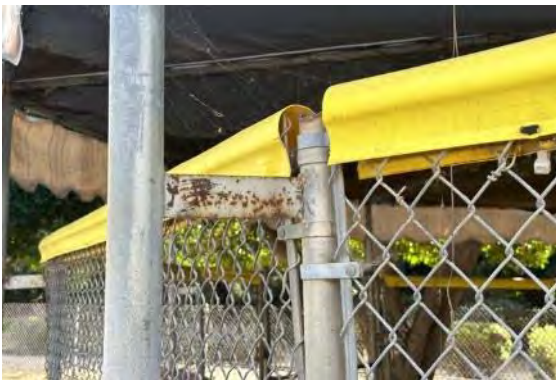
*Detail at pipe framing and chain-link fence; note corrosion (ARG, 2023).*

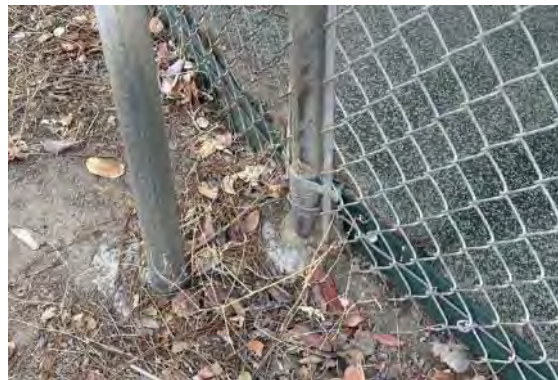
*Detail at base; note pipe framing set in cement and raised interior floor (ARG, 2023).*

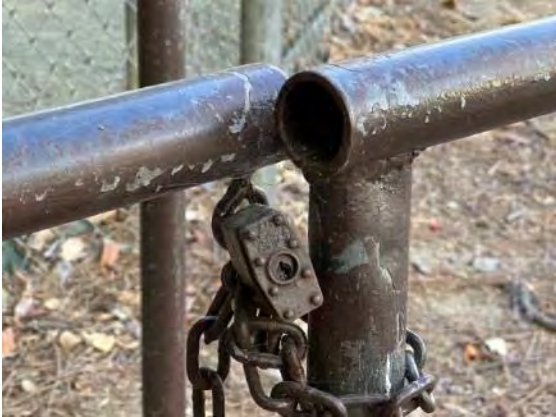
*Detail at metal stanchions; note paint loss and missing end cap (ARG, 2023).*

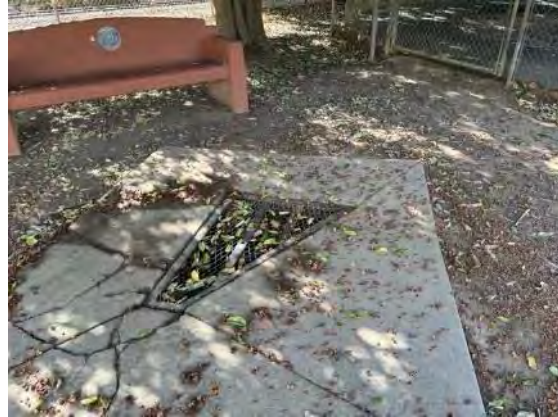
*Concrete drainage structure near pony sweep; note cracking and debris (ARG, 2023).*

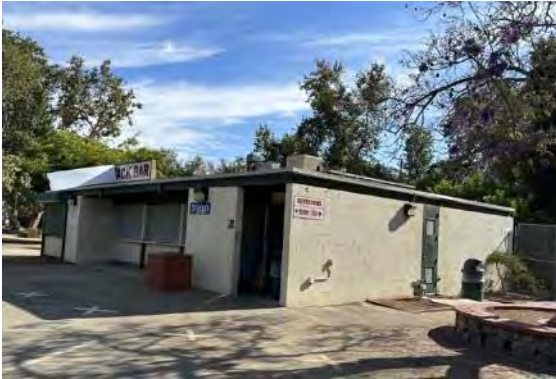
View of snack stand looking northeast (ARG, 2023).

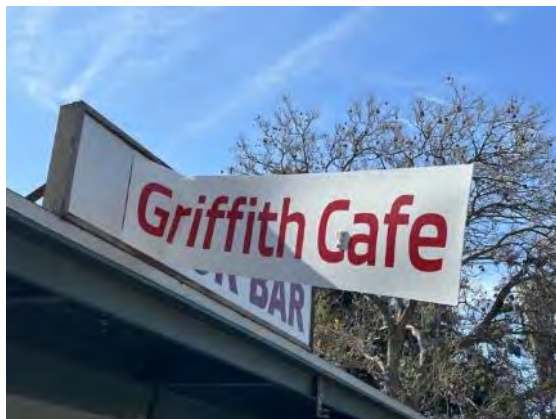
Loose temporary sign over existing illuminated sign (ARG, 2023).

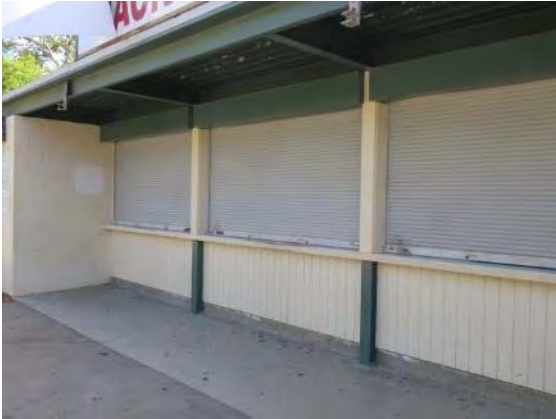
View of snack bar order/pick-up windows with roll-up shutters (ARG, 2023).

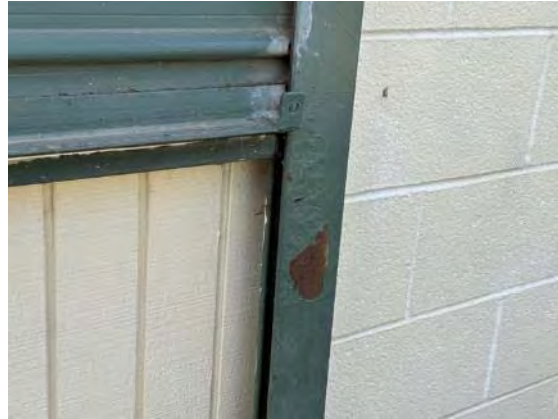
Detail of paint loss and corrosion at metal frame (ARG, 2023).

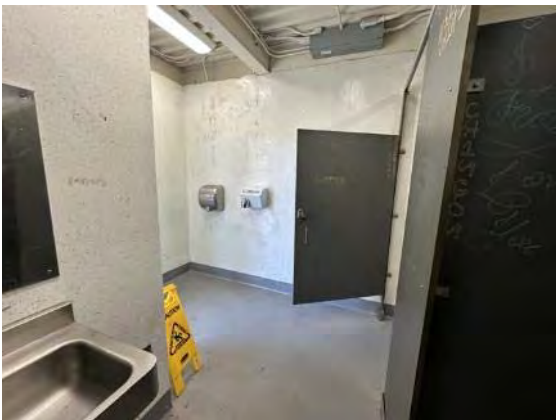
Interior view of women's restroom looking north (ARG, 2023).

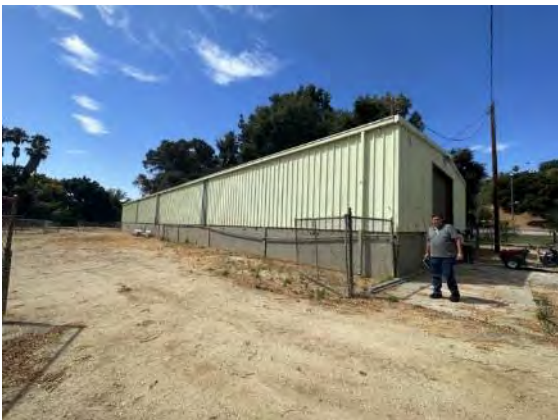
View of barn looking southwest (ARG, 2023).

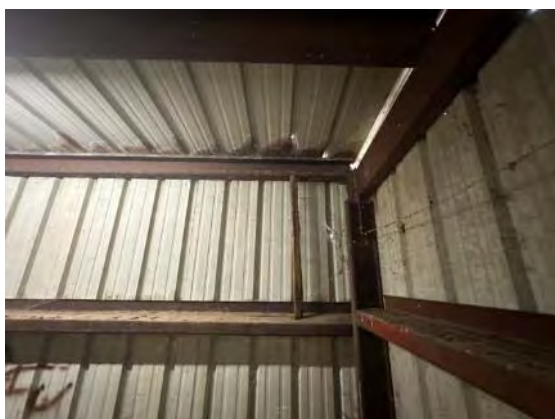
Interior detail at upper northwest corner; note corrosion at roof edge (ARG, 2023).

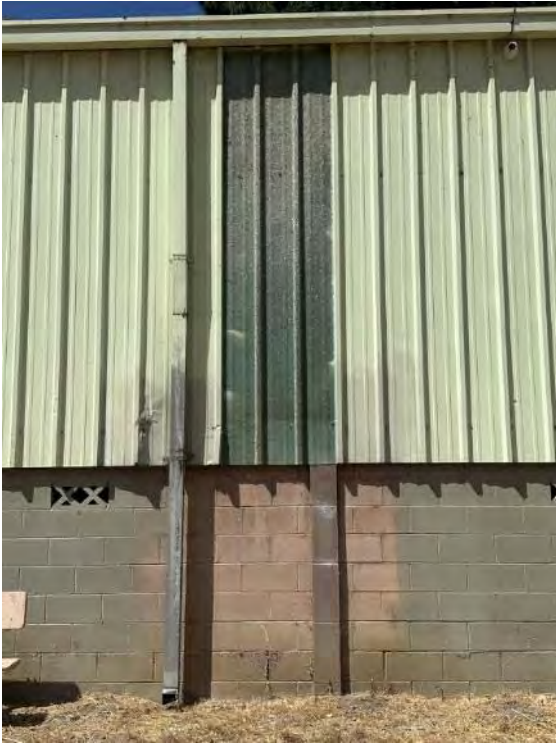
Detail at east exterior wall; note corrugated polycarbonate "window" panel (ARG, 2023).

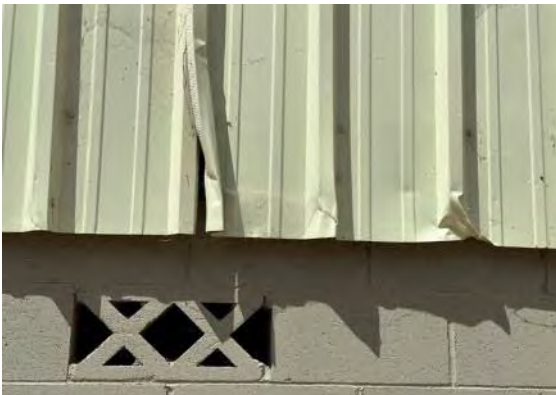
Typical damage at base of metal cladding (ARG, 2023).

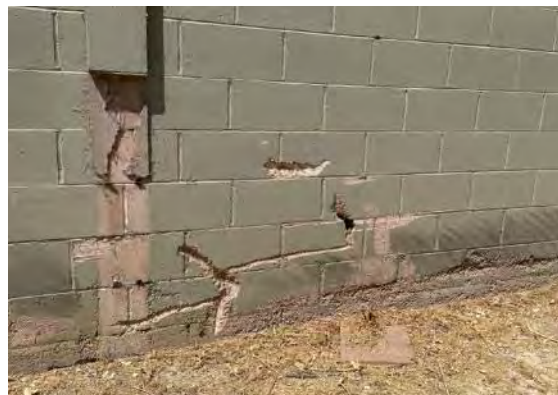
Gouges at base of CMU wall (ARG, 2023).

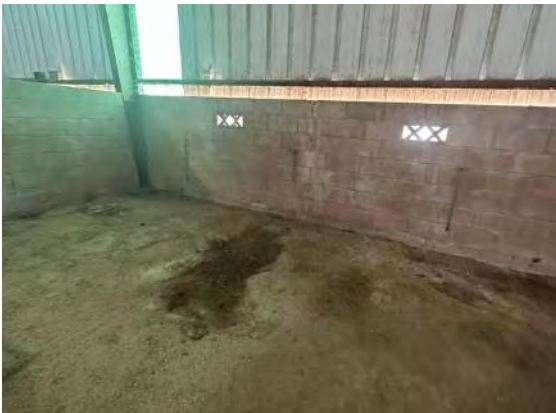
Detail at open area at south end; note staining and efflorescence (ARG, 2023).

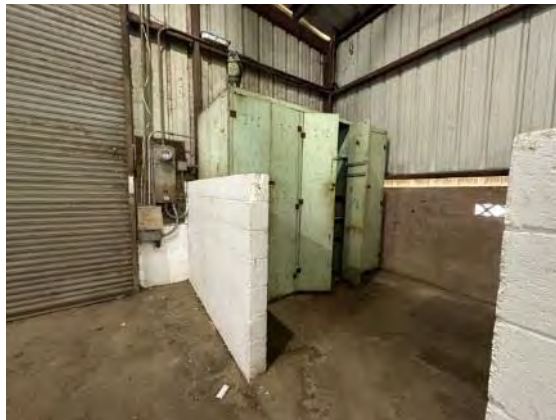
View of employee break area at northeast corner (ARG, 2023).

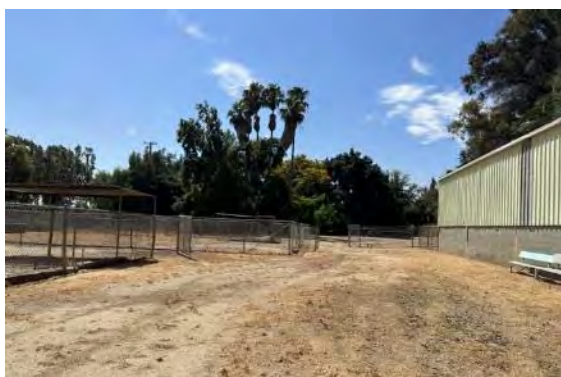
*Overall view of corrals (ARG, 2023).*

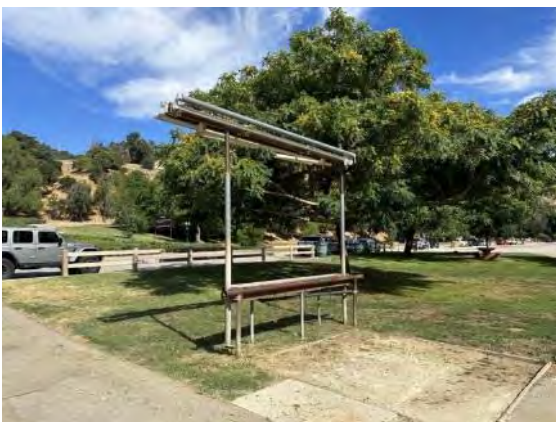
*View of freestanding shade structure (ARG, 2023).*
