# Griffith Park Pony Ride Site Historic Structures Report

*Architecture  
Planning  
Conservation*

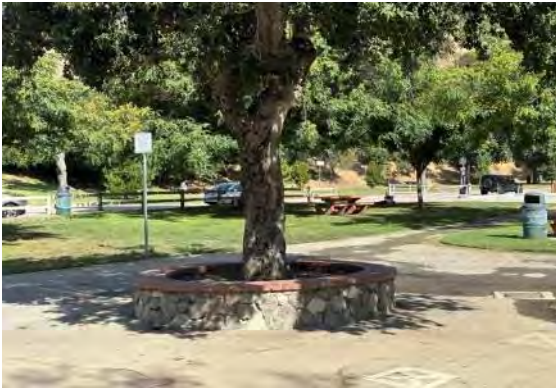
*Circular planter to north of ticket booth (ARG, 2023).*

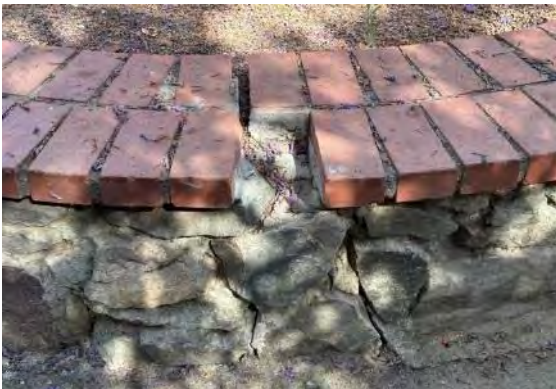
*View of planter wall; note cracking and missing paver (ARG, 2023).*

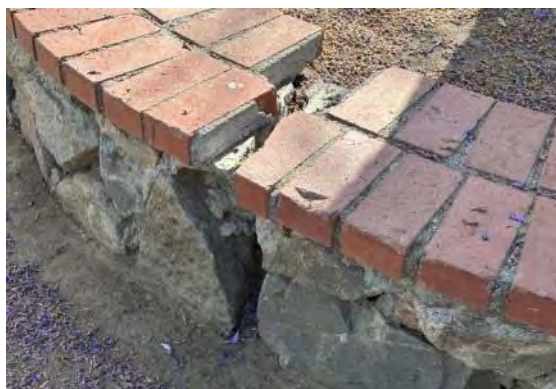
*Detail at planter wall; note large separation and missing paver (ARG, 2023).*

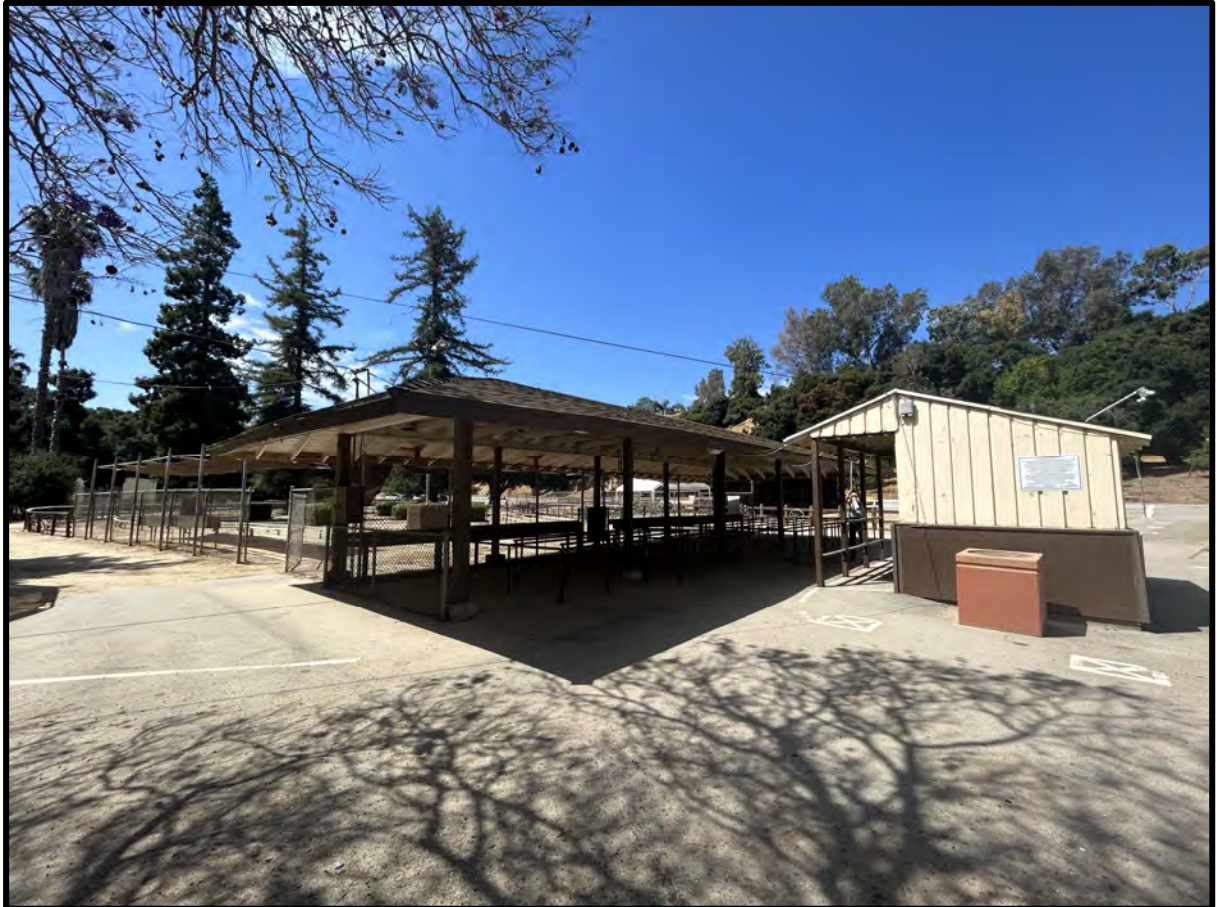
## Griffith Park Pony Ride Facility Structural Condition Assessment

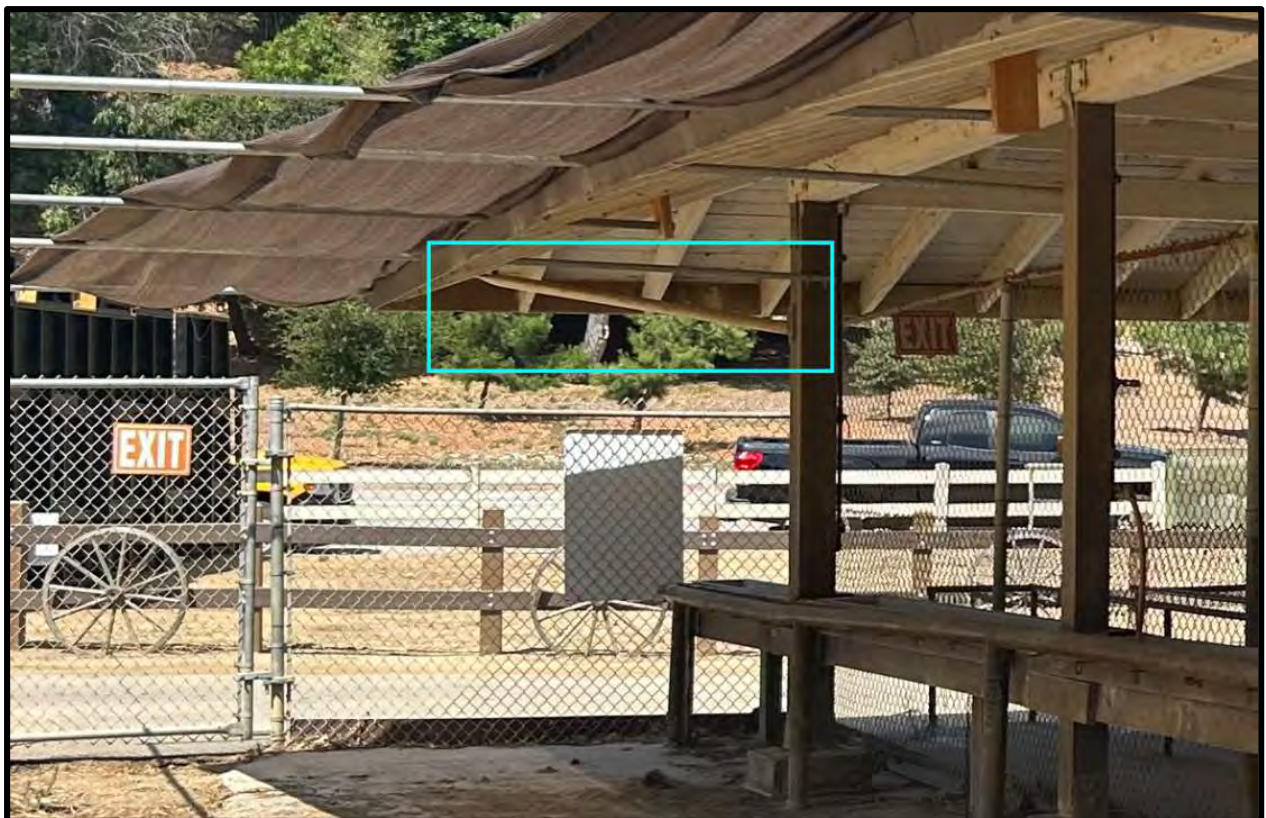
**Figure 2** Steel tubes that appear to have been added to the Pergola.

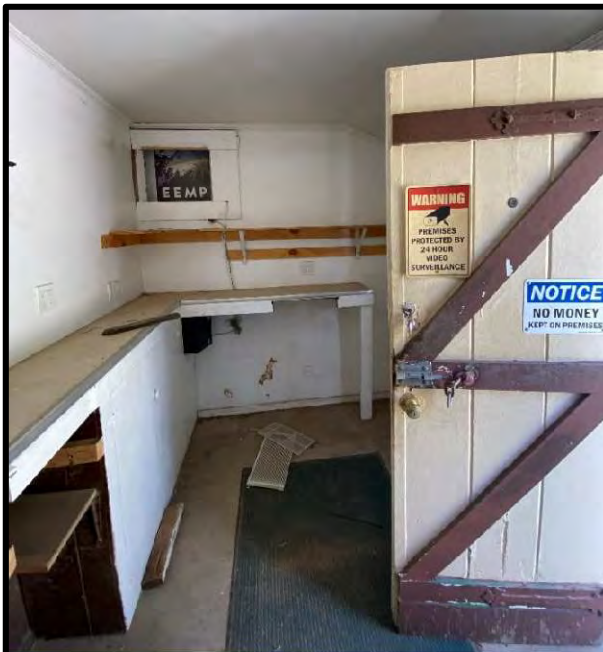
**Figure 4** Interior view of the Ticket Booth showing the interior finishes.

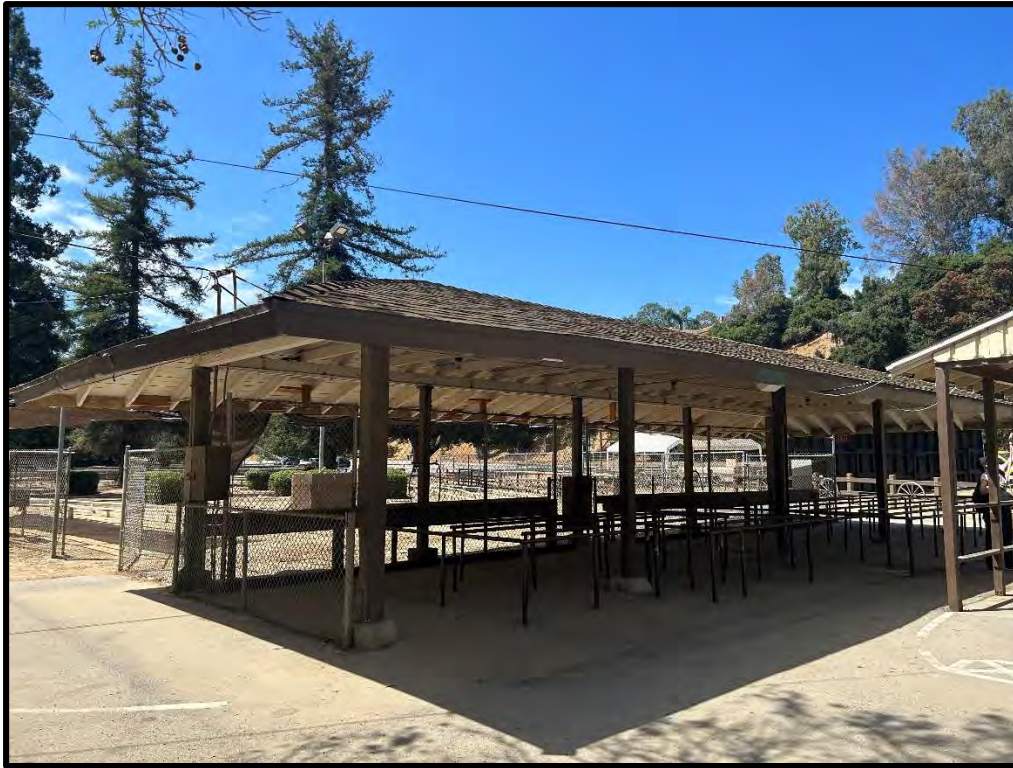
**Figure 7** View of the Pergola.

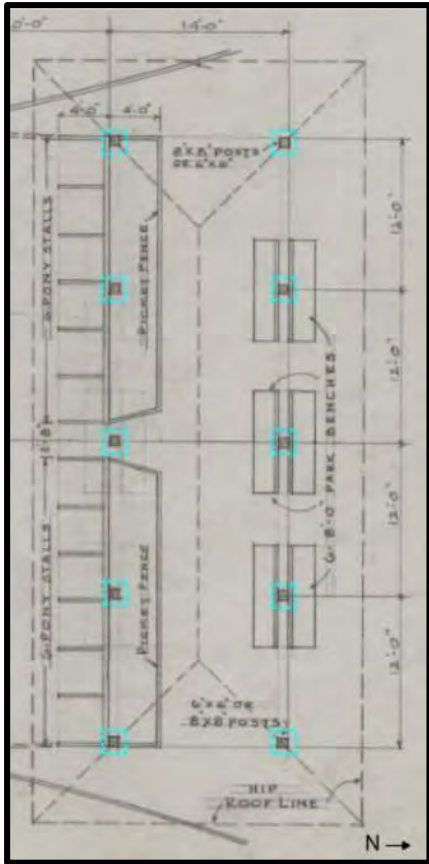
**Figure 8** Plan view illustrating the locations of the Pergola column foundations (1946 Department of Parks, City of Los Angeles drawing of the Pergola).

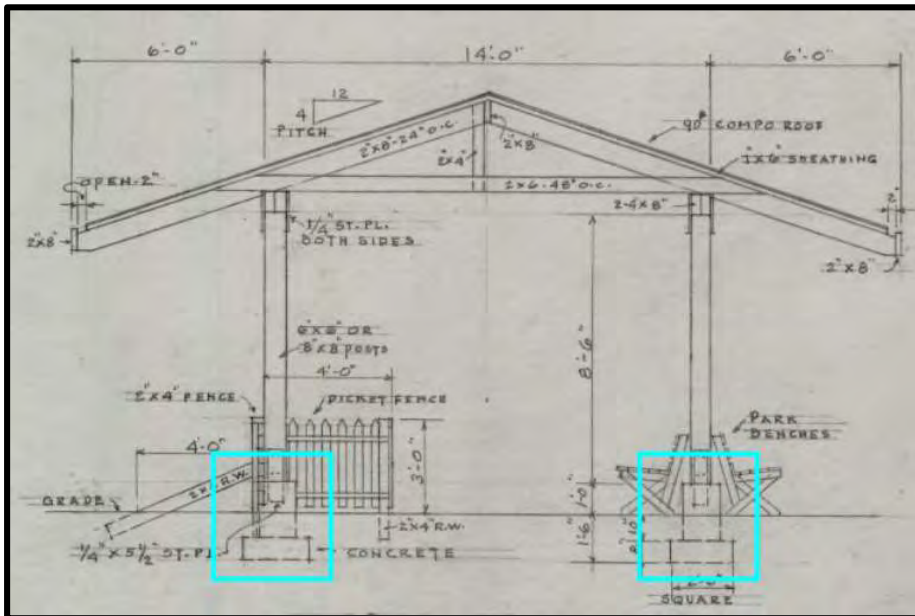
**Figure 9** Section through the Pergola showing the assumed foundation (1946 Department of Parks, City of Los Angeles drawing of the Pergola).

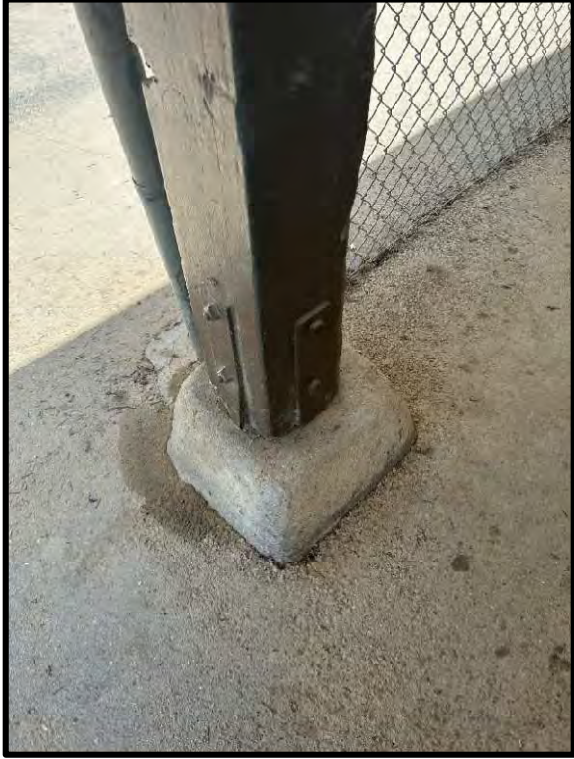
**Figure 10** View of the top of the foundation.

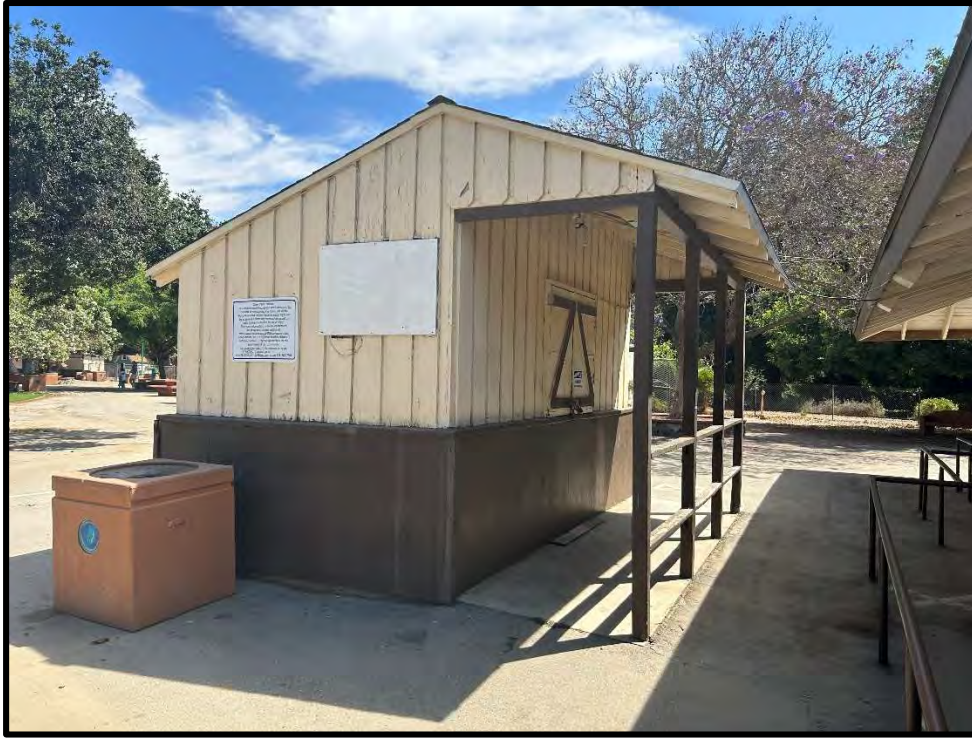
**Figure 18** View of the Ticket Booth.

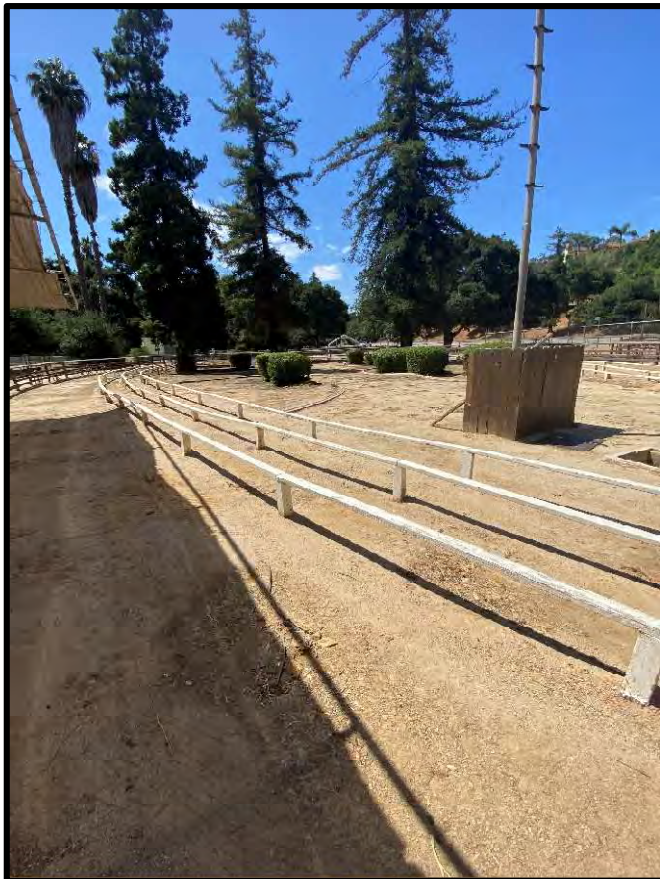
**Figure 25** View of the Internal Guide Rails.

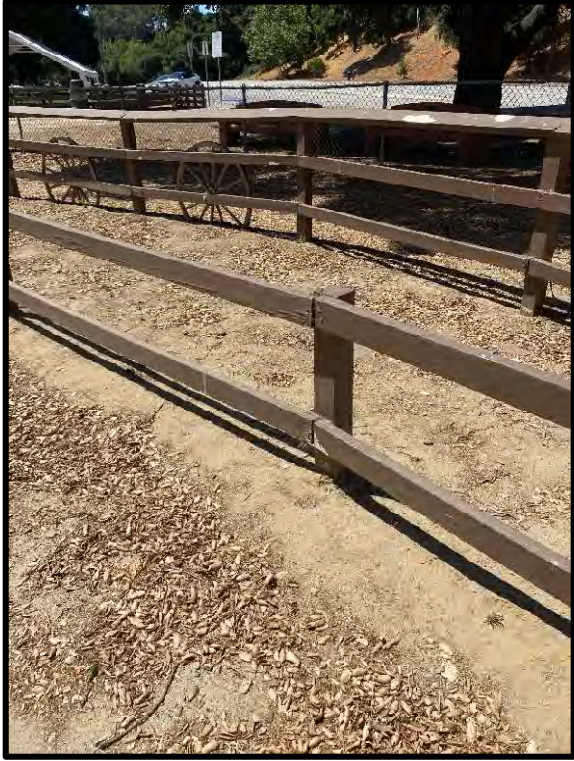
**Figure 27** View of the Running Guide Rail.

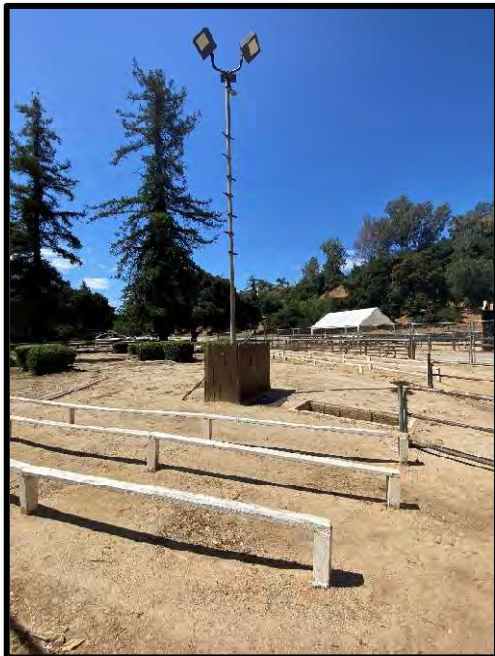
**Figure 31** View of the light post.

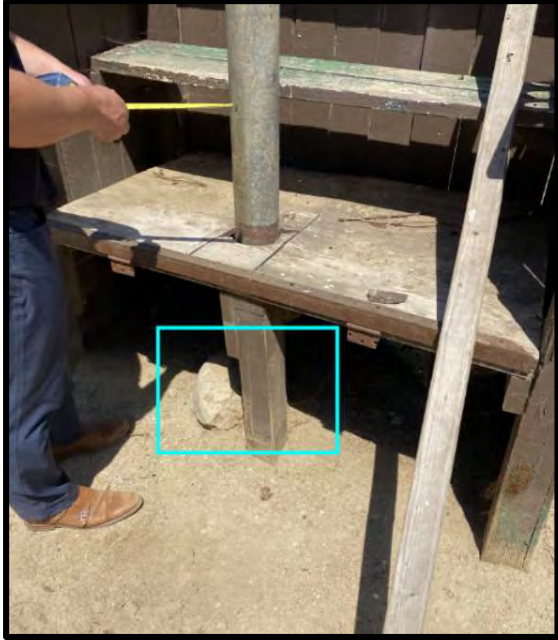
**Figure 32** View of the light post foundation.

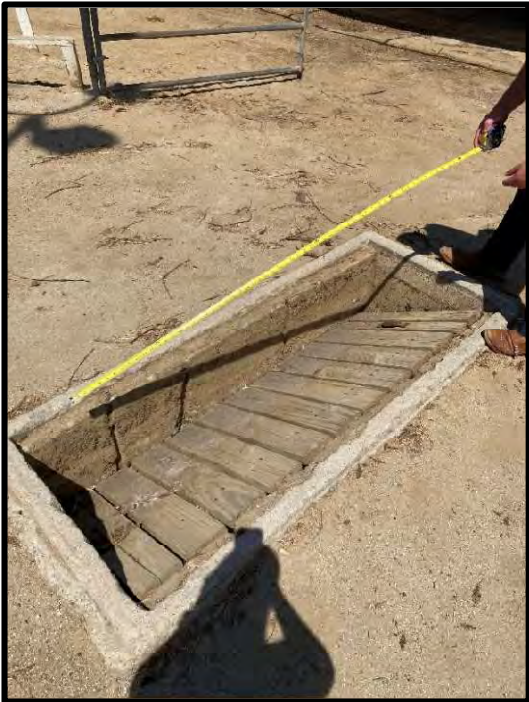
**Figure 33** View of the trench.

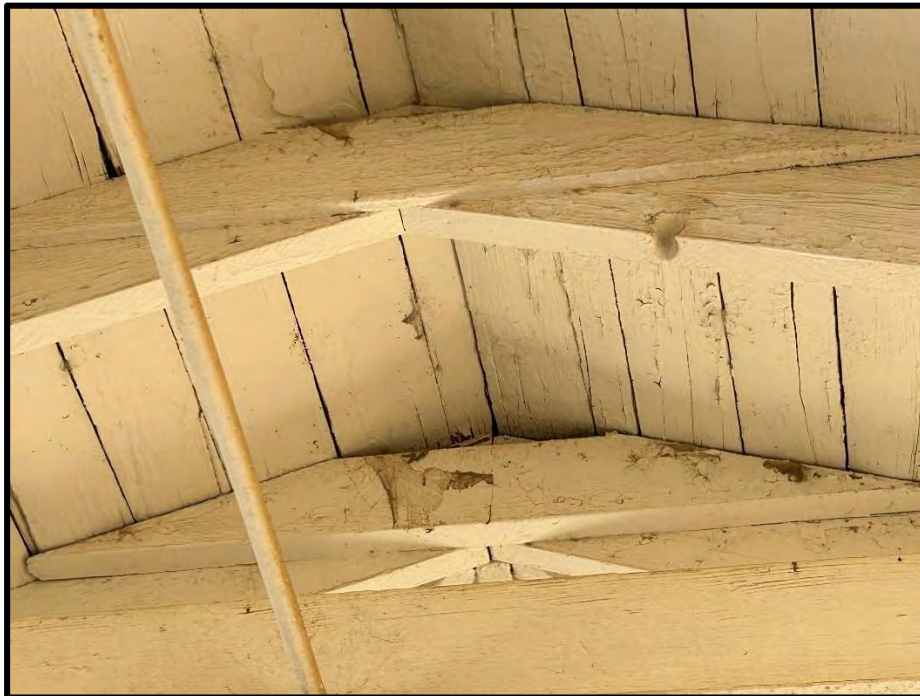
**Figure 34** View of straight board sheathing deterioration.

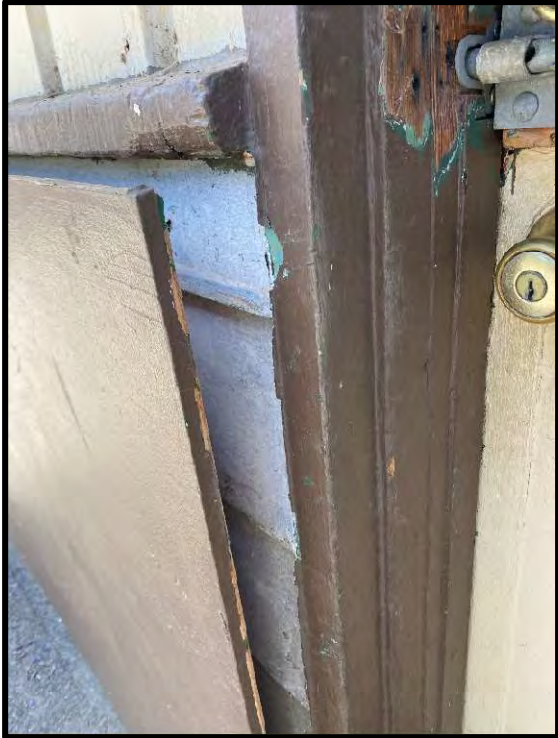
**Figure 36** Close up of the top of the wood panels concealing the horizontal siding.

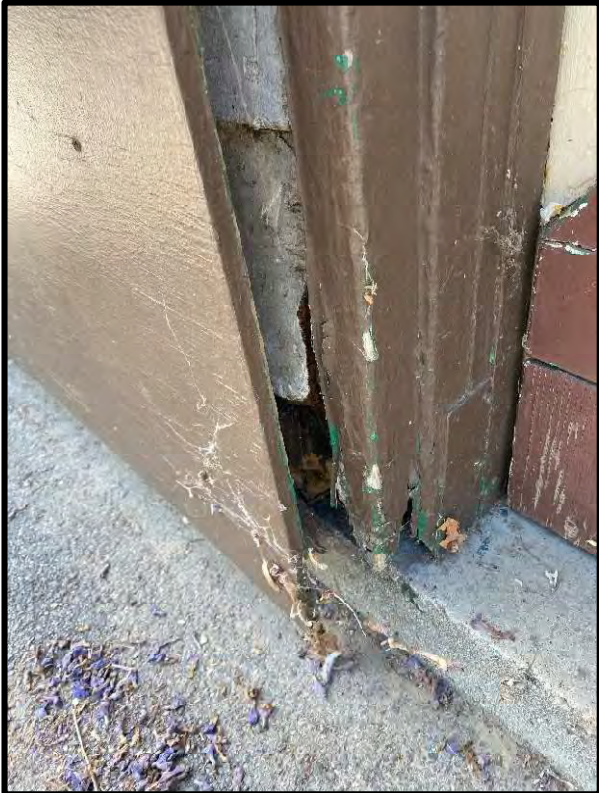
**Figure 37** Close up of the deteriorated, original horizontal siding.

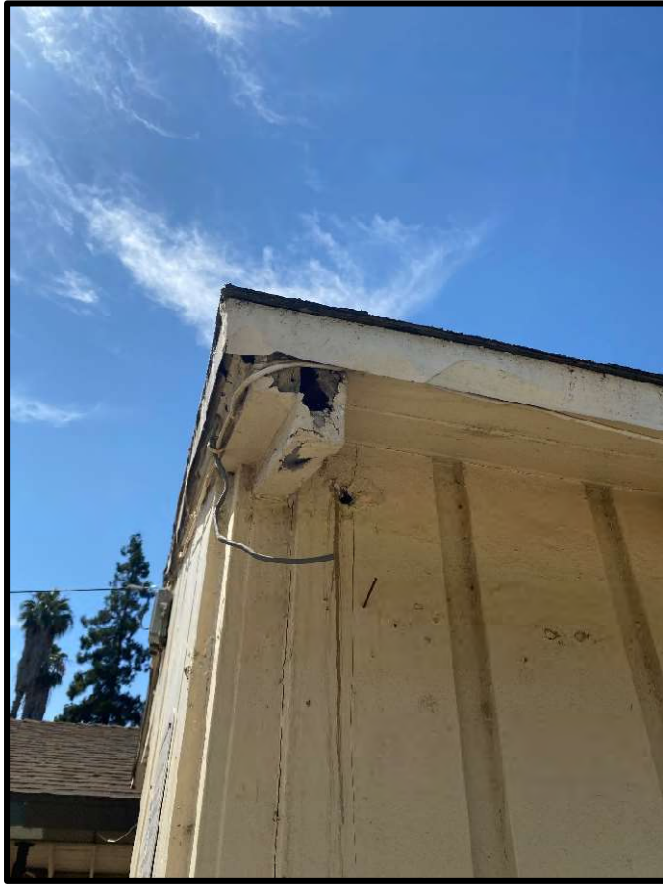
**Figure 38** View of the roof rafter deterioration at the ends of the member.

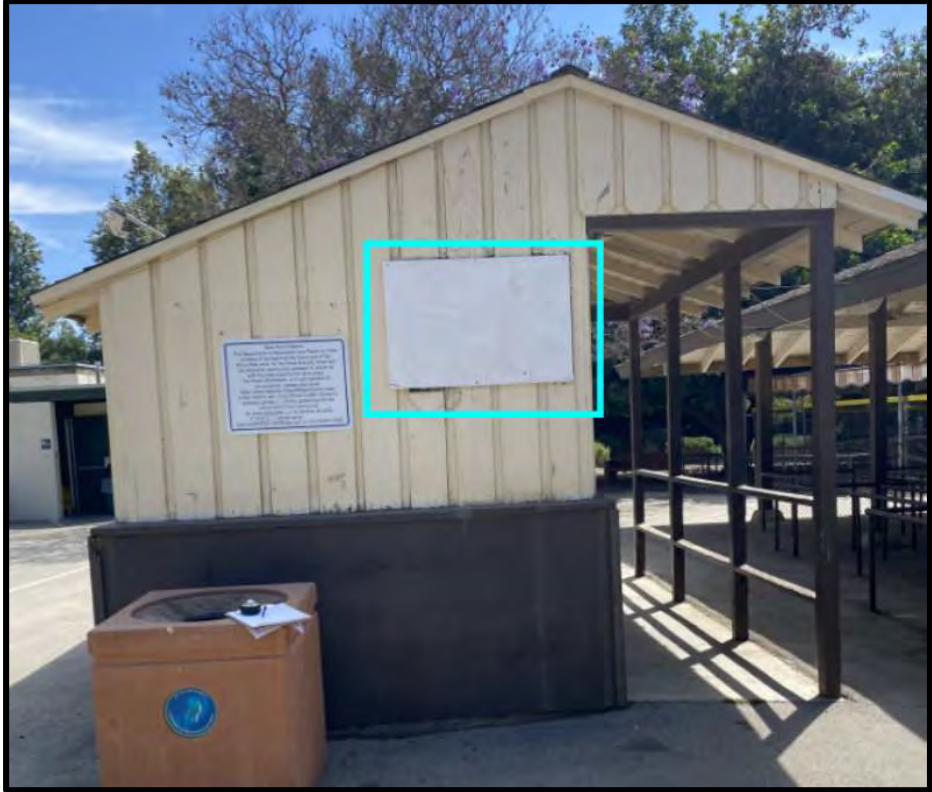
**Figure 39** View of the improperly patched opening at the west wall of the Ticket Booth.

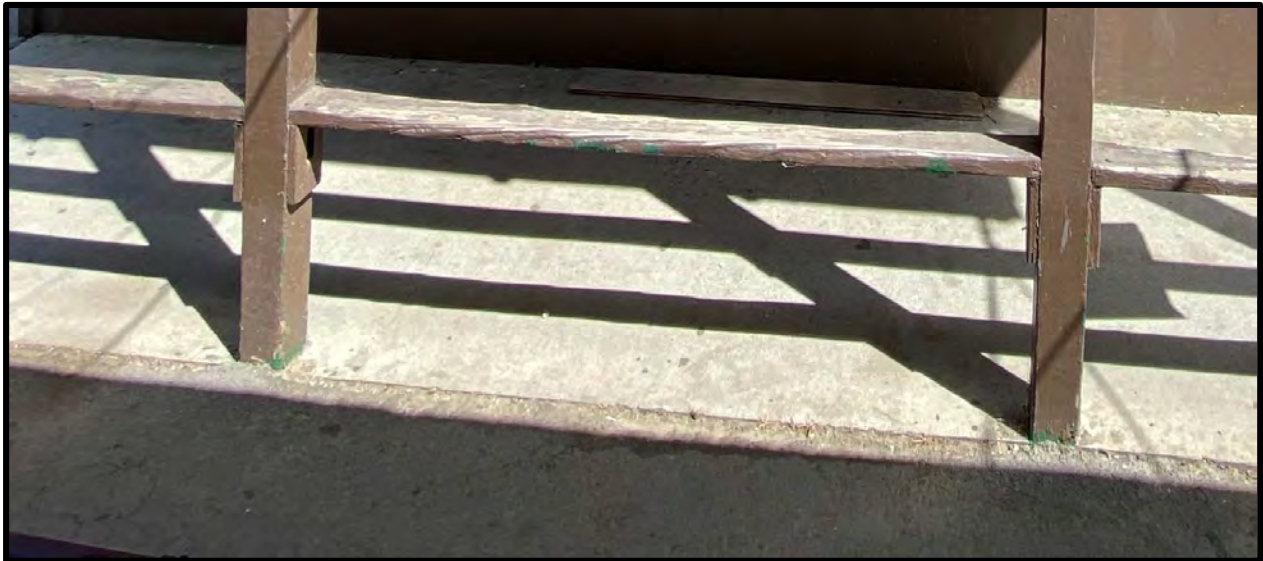
**Figure 40** View of minor biological growth and insect damage at the base of the Ticket Booth columns.

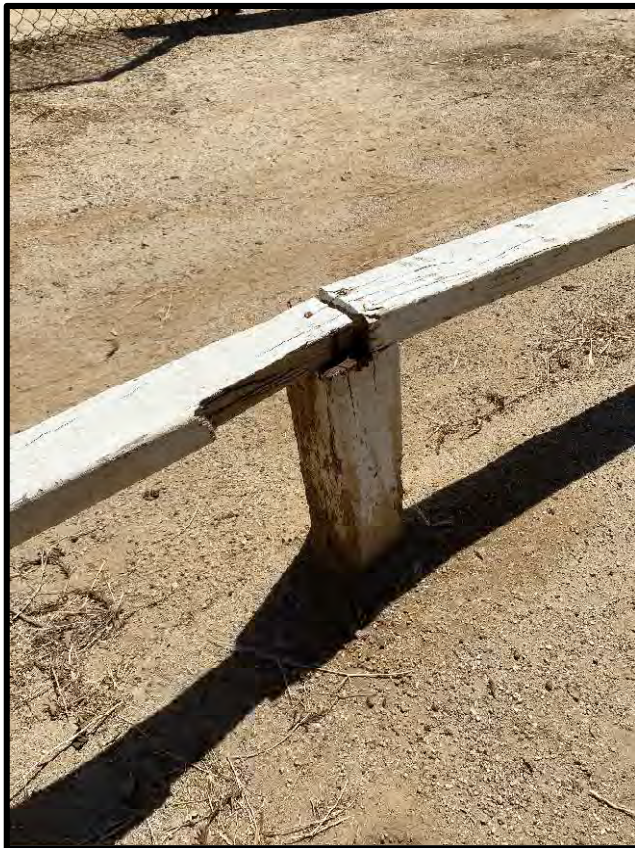
**Figure 41** View of significant wood deterioration at the Internal Guide Rails.

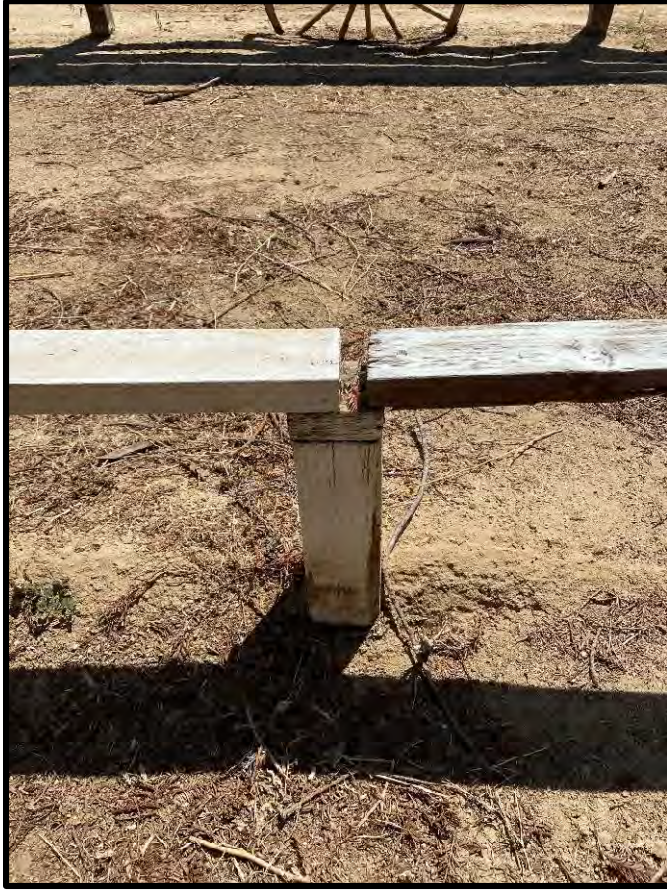
**Figure 42** Deteriorated connection at the Internal Guide Rails.

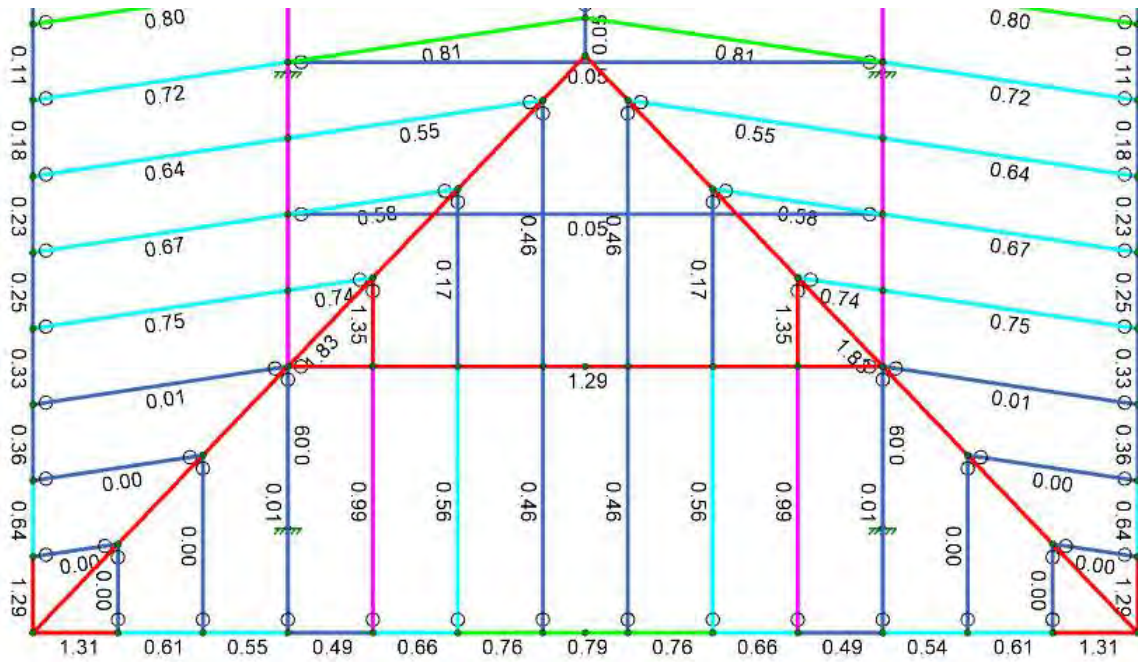
**Figure 44** Close up of the analytical model showing the hip rafters are 83 percent overstressed.

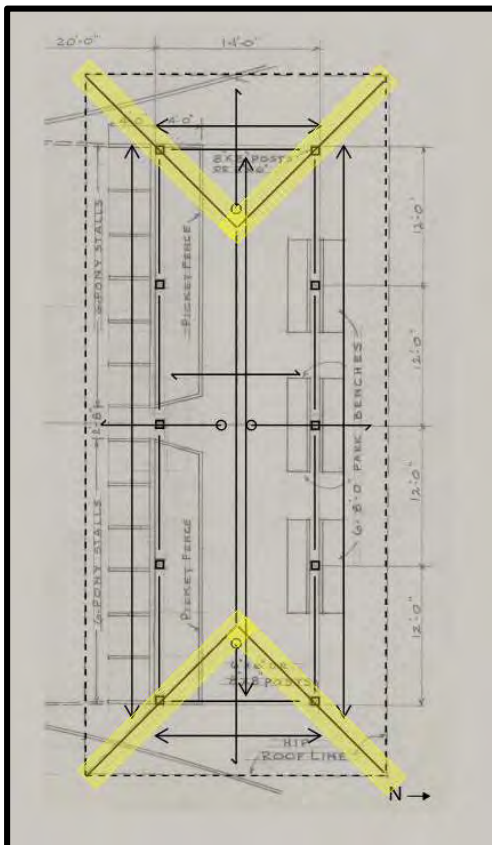
**Figure 45** Plan view of the Pergola roof highlighting which members should be replaced with larger framing (illustrated on top of the 1946 Department of Parks, City of Los Angeles drawing of the Pergola).

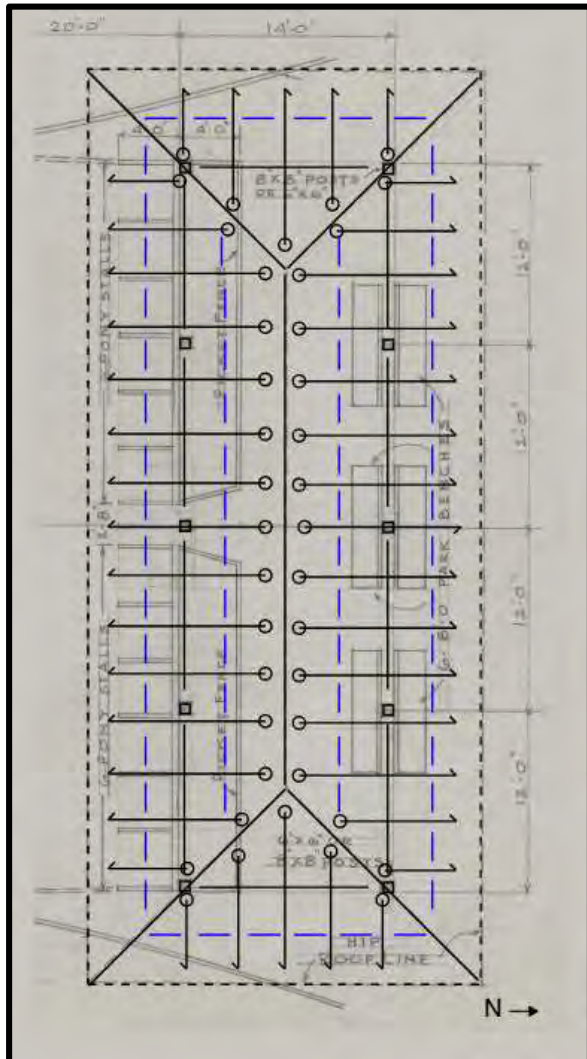
**Figure 46** Plan view of the Pergola roof framing showing the potential location of blocking (illustrated on the 1946 Department of Parks, City of Los Angeles drawing of the Pergola).

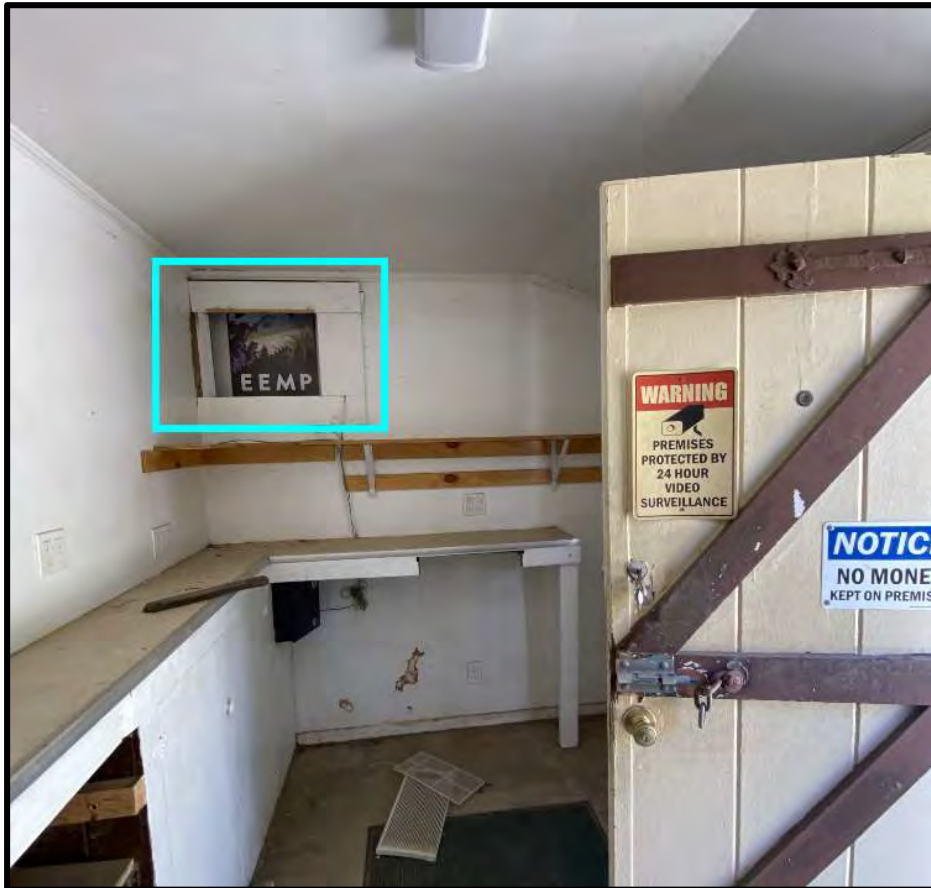
**Figure 47** Interior view of the opening in the west wall of the Ticket Booth.

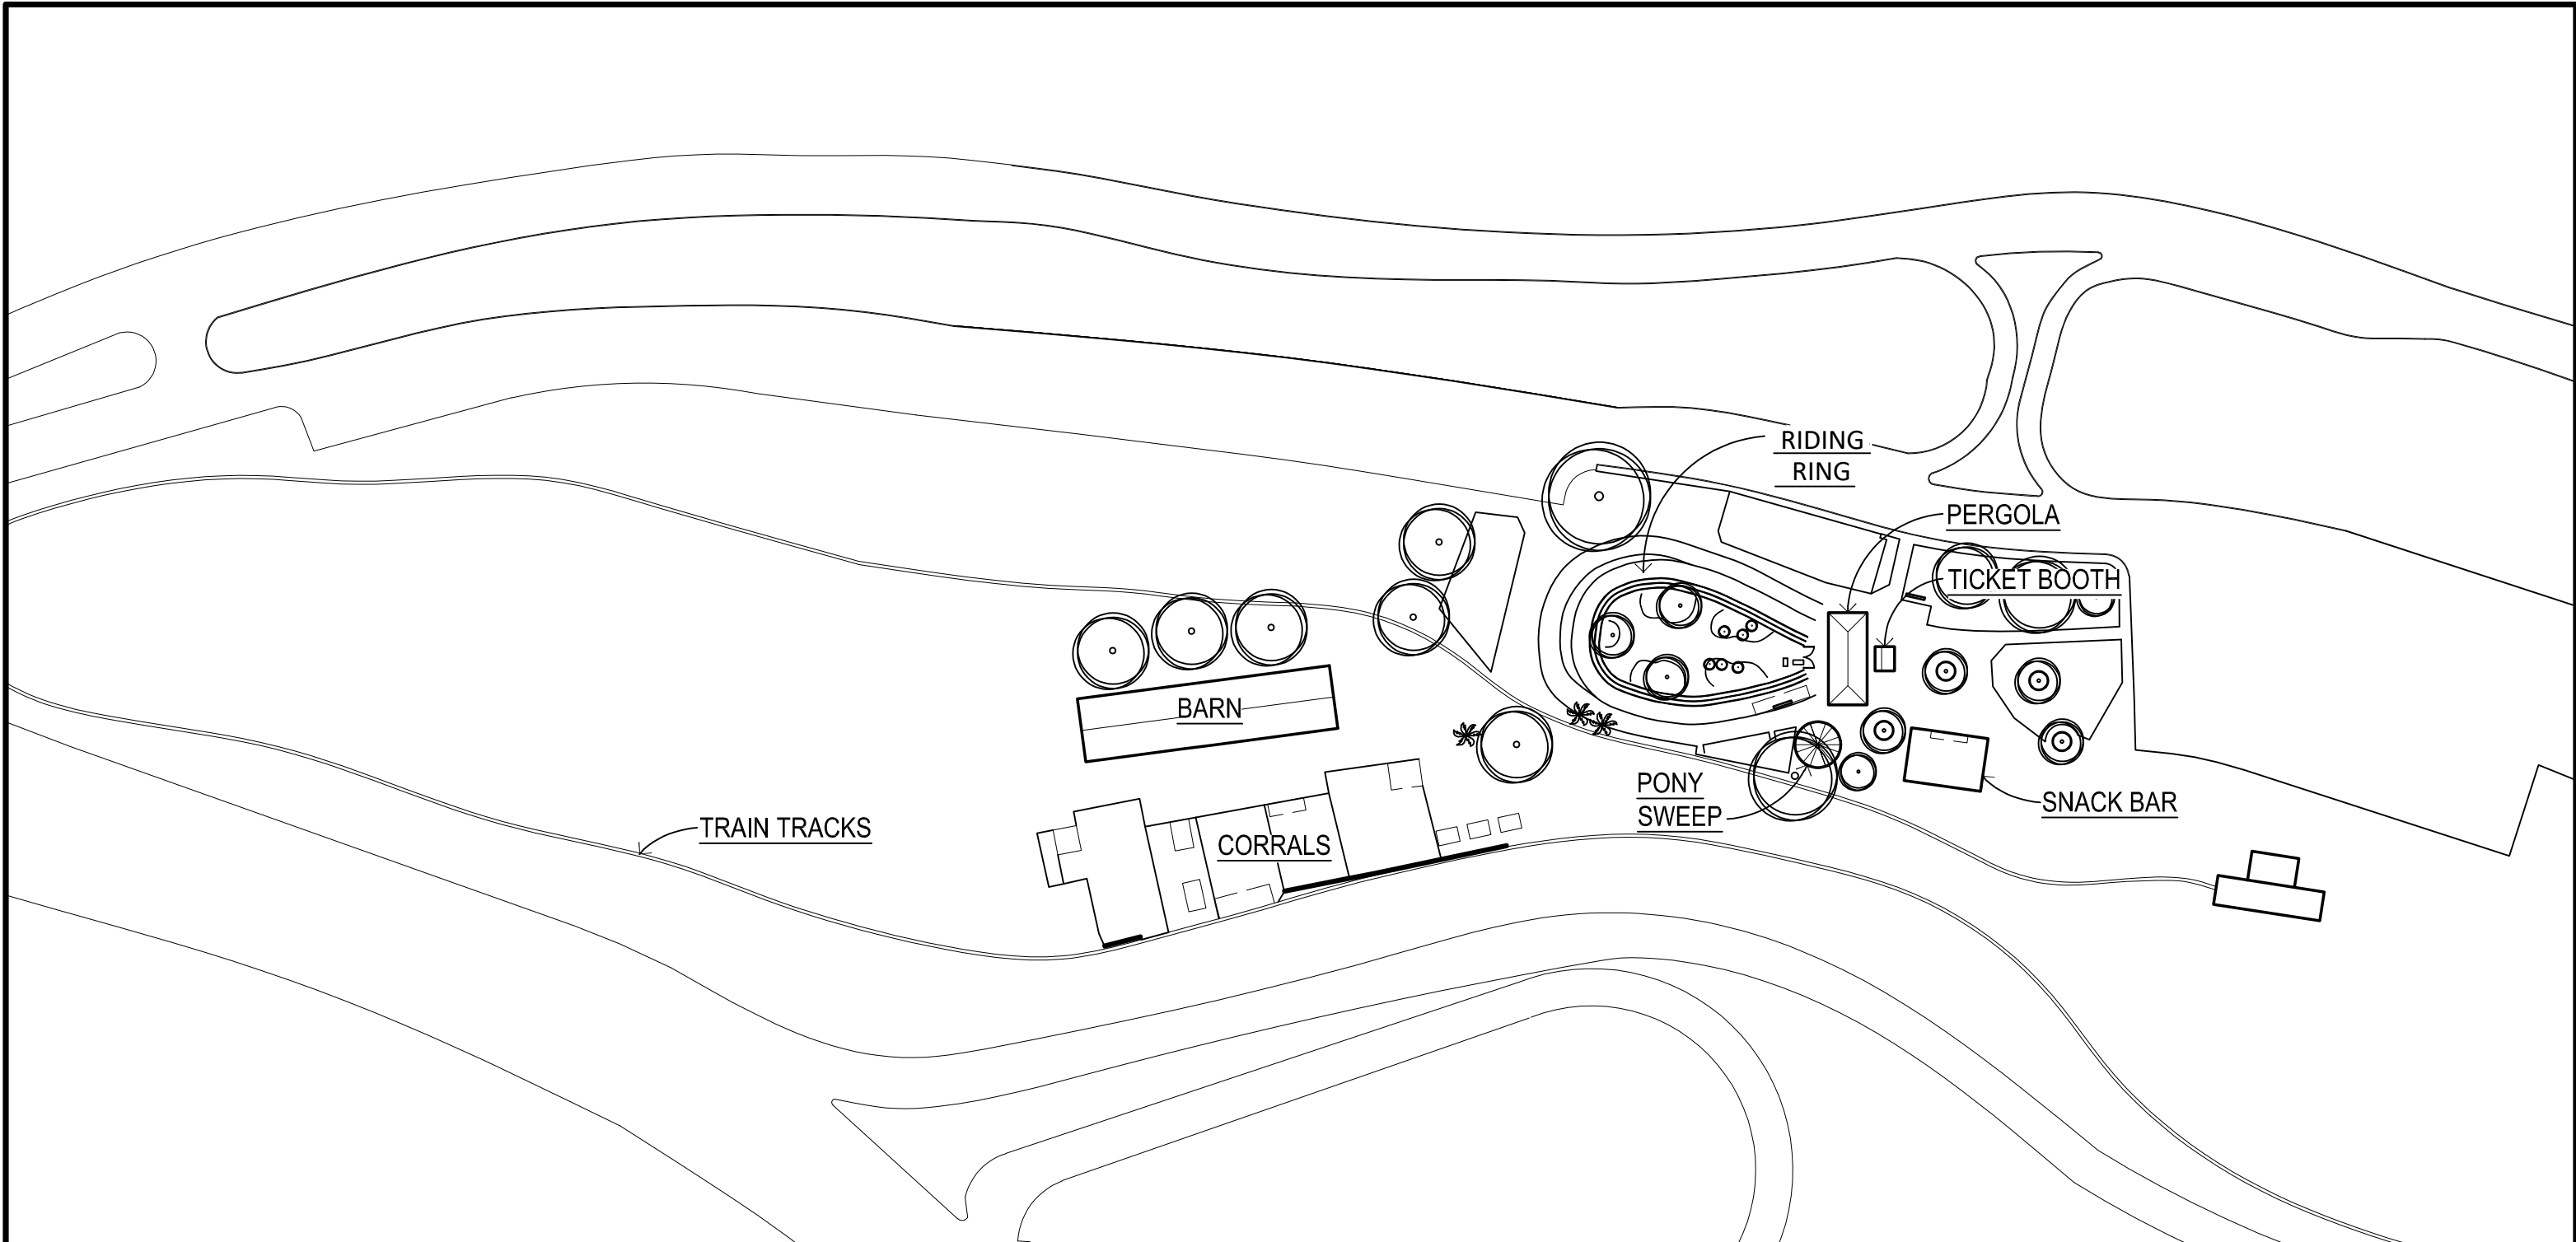
## CONTEXT SITE PLAN
