NO. 25-166

SUBJECT: CHATSWORTH PARK SOUTH – OUTDOOR PARK IMPROVEMENTS (PRJ21885) PROJECT – COMMITMENT OF PARK FEES – CATEGORICALLY EXEMPT FROM THE PROVISIONS OF THE CALIFORNIA ENVIRONMENTAL QUALITY ACT (CEQA) PURSUANT TO ARTICLE 19, SECTION 15301(d) [RESTORATION OR REHABILITATION OF DETERIORATED OR DAMAGED STRUCTURES, FACILITIES, OR MECHANICAL EQUIPMENT TO MEET CURRENT STANDARDS OF PUBLIC HEALTH AND SAFETY] AND SECTION 15330 [MINOR CLEANUP ACTIONS TAKEN TO PREVENT, MINIMIZE, STABILIZE, MITIGATE, OR ELIMINATE THE RELEASE OR THREAT OF RELEASE OF A HAZARDOUS WASTE OR SUBSTANCE WHICH ARE SMALL OR MEDIUM REMOVAL ACTIONS COSTING \$1 MILLION OR LESS] OF CALIFORNIA CEQA GUIDELINES AS WELL AS ARTICLE III, SECTION 1, CLASS 1(4) OF CITY CEQA GUIDELINES

Roux conducted this Five-Year Review on behalf of the City of Los Angeles Department of Recreation and Parks (LARAP) pursuant to the Comprehensive Environmental Response, Compensation, and Liability Act (CERCLA) Section 121 (c), the National Oil and Hazardous Substances Pollution Contingency Plan (NCP) Section 300.400 (f) (11), and the Office of Solid Waste and Emergency Response (OSWER) directive 9355.7-03B-P.

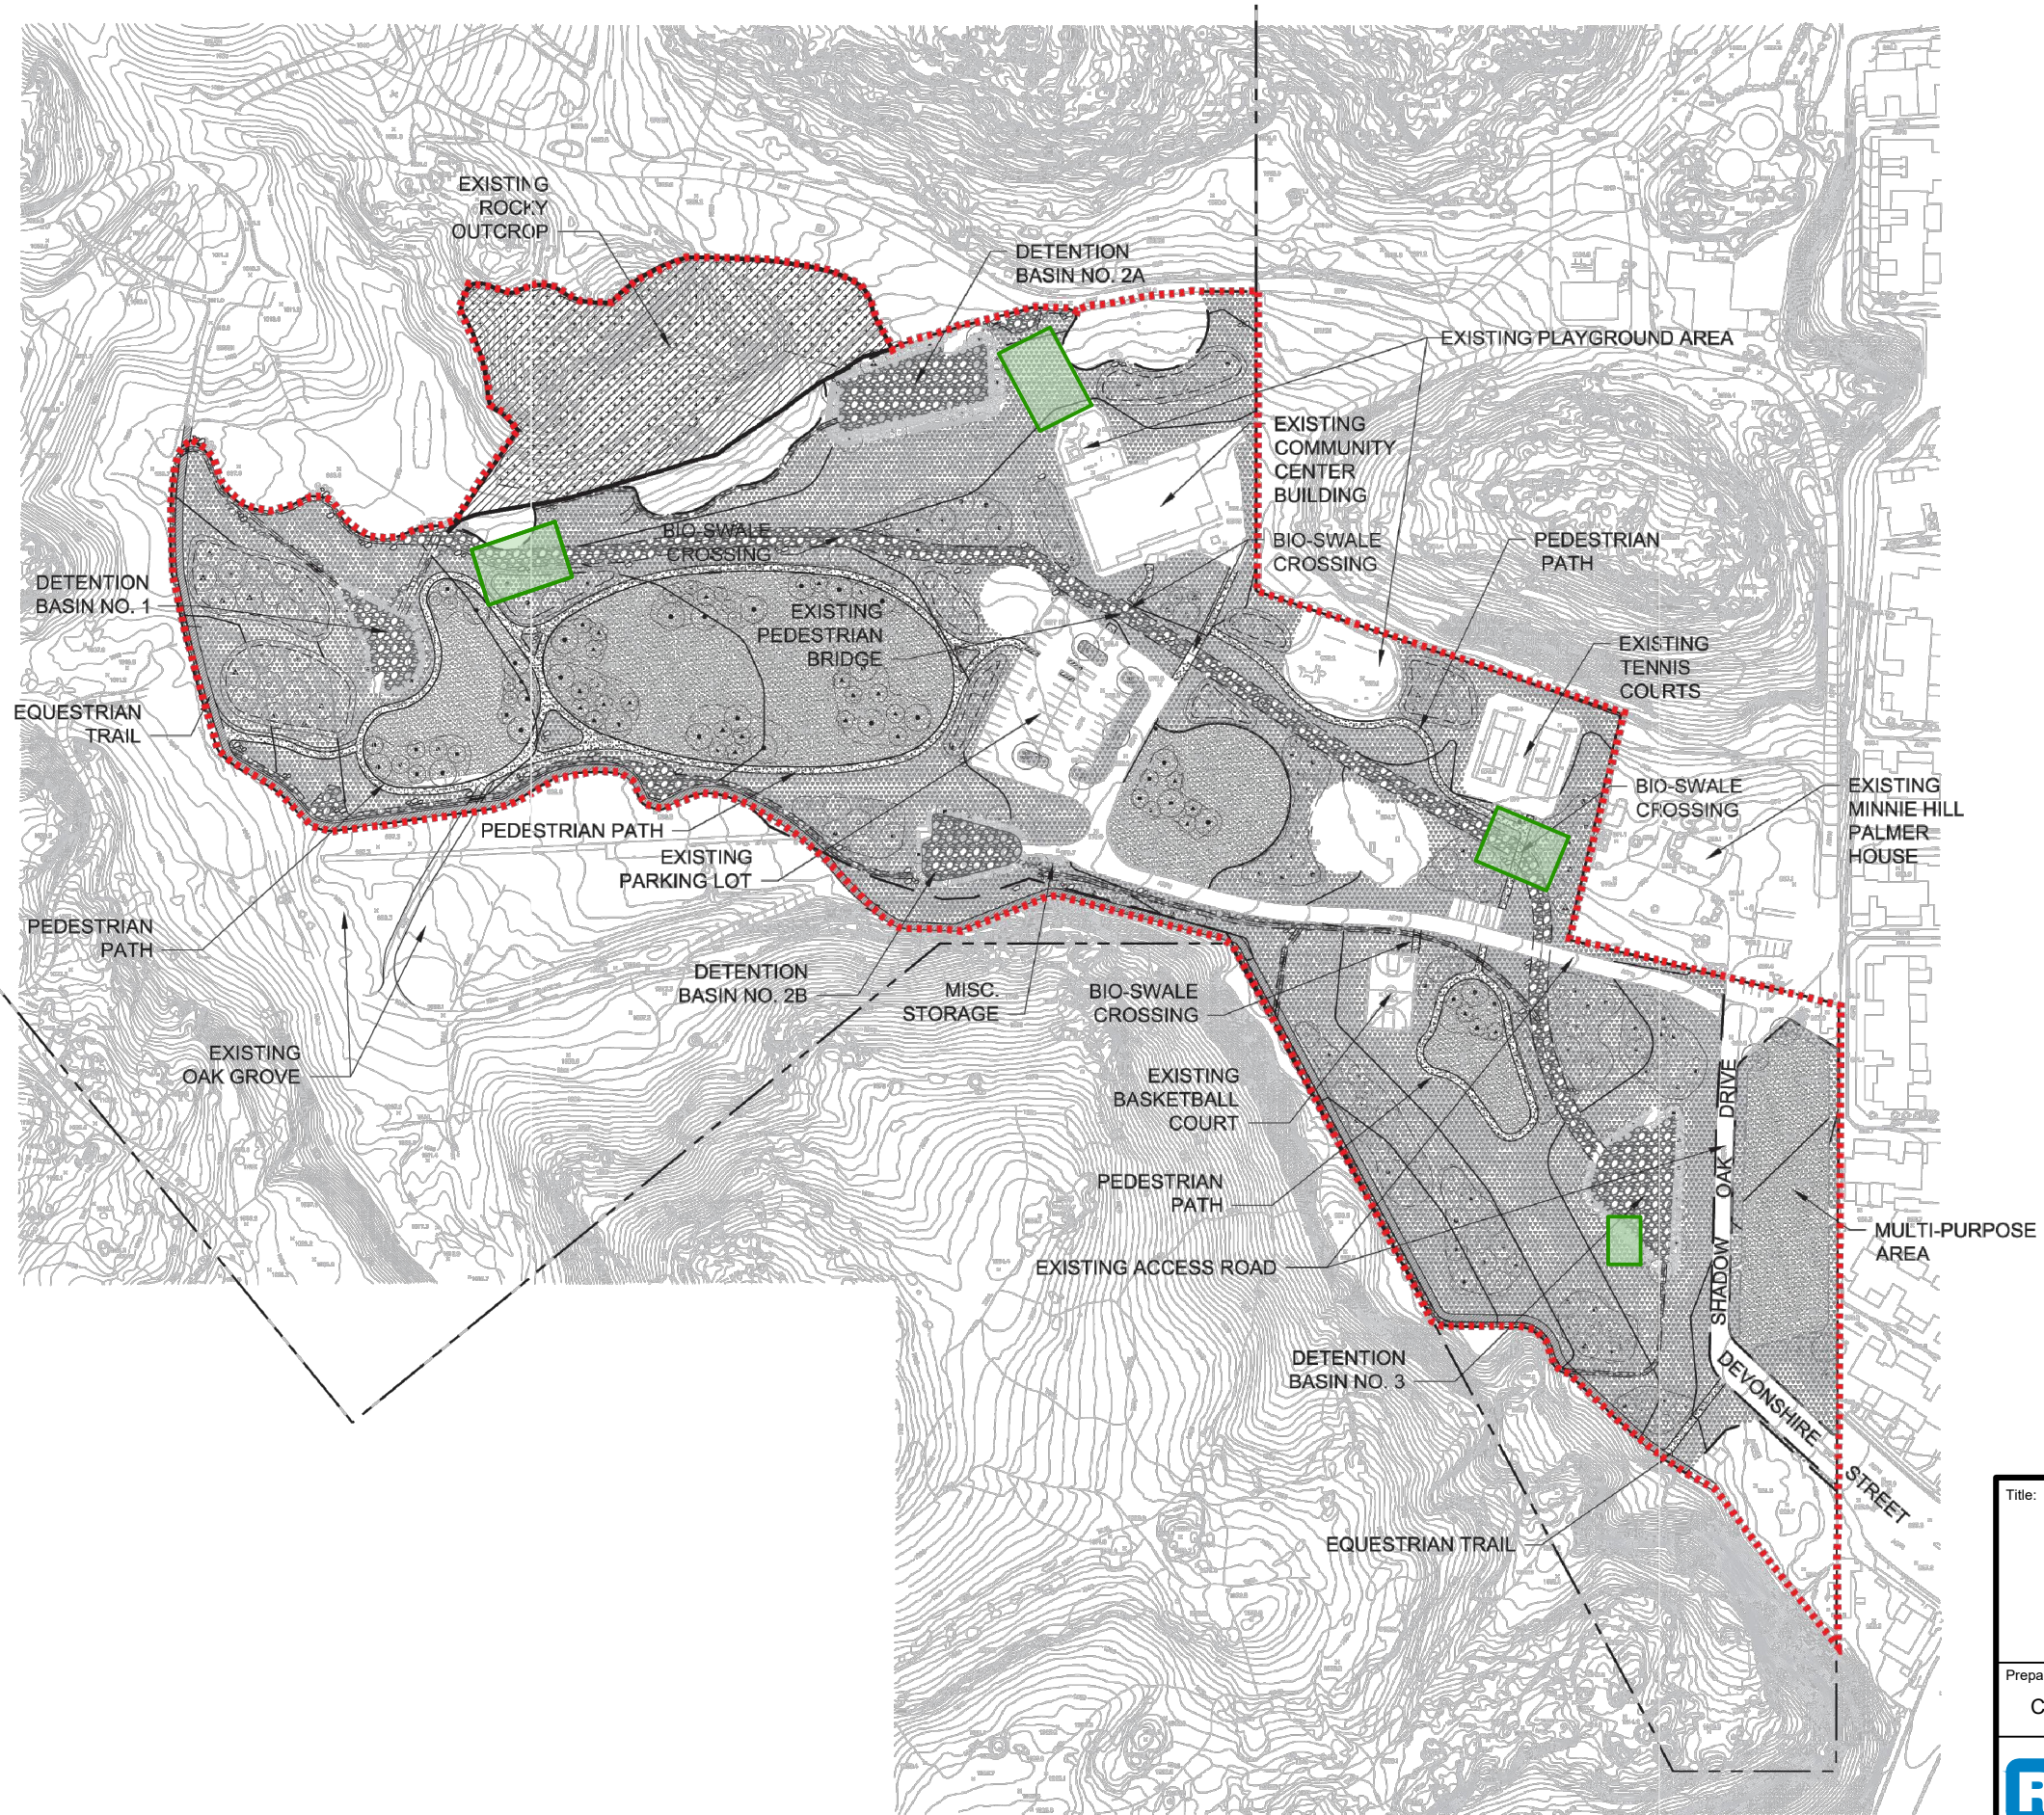
1. Erosion Areas

- Four areas of the cap were observed or reported to have eroded to the point of breaching the geo grid exposing the impacted soil beneath (Figure 1). There is inadequate O&M of physical remedial structures (Attachment 2 - Photographs 11 through 15, 20, and 21).

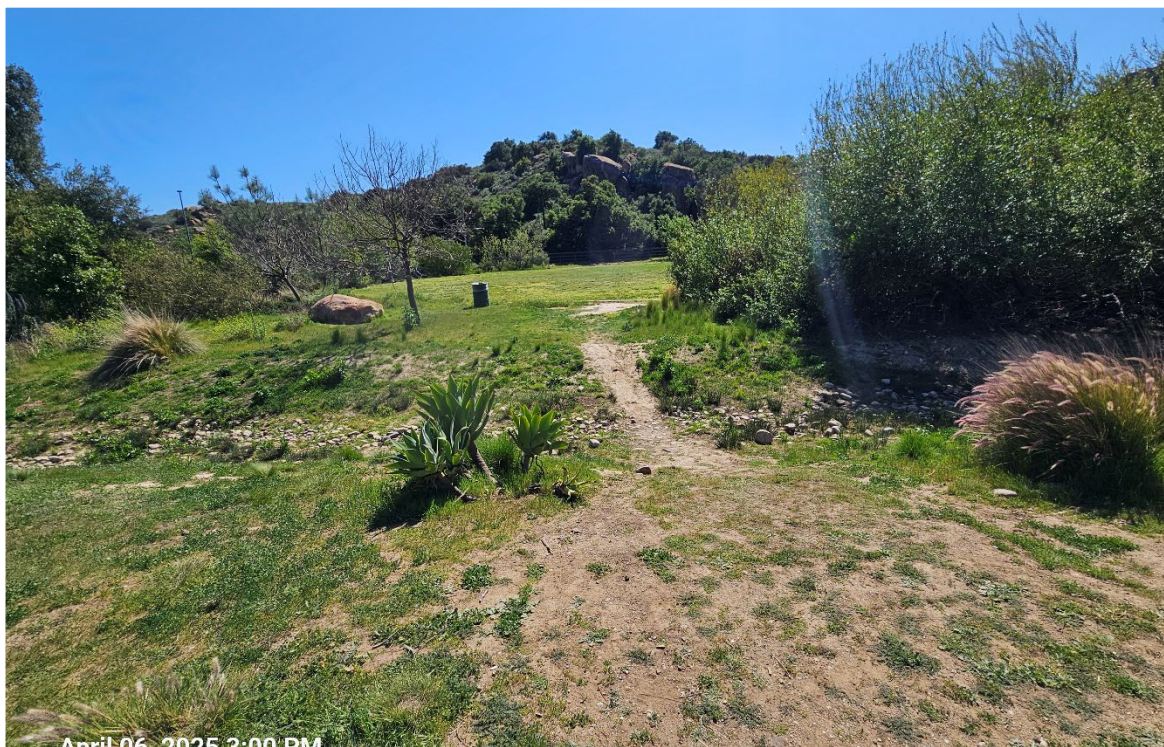
9. View of path being worn across swale between playground and picnic area

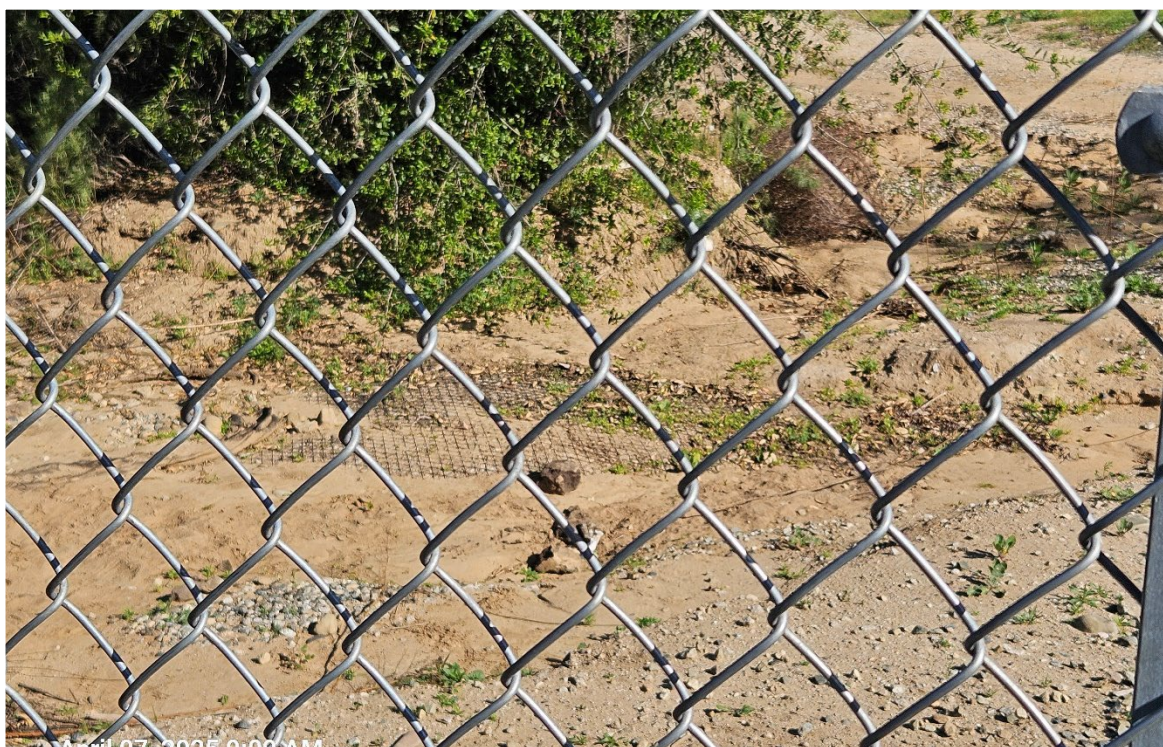
11. View of eroded area behind community center playground with exposed geo grid

- Immediate repairs are needed in the areas where the cap has been breached below the geo grid:
 - Retain the services of Hazardous Waste Operations and Emergency Response (HAZWOPER)-trained staff/contractor to repair the damage and restore the surface cap to its original condition.
 - Any soil excavated beneath the geo grid as part of the repair must be managed in accordance with the Soil Management Plan (Appendix C of the O&M Plan).
 - Notify the DTSC of the repairs in accordance with Section 4.4.1 of the O&M Plan.

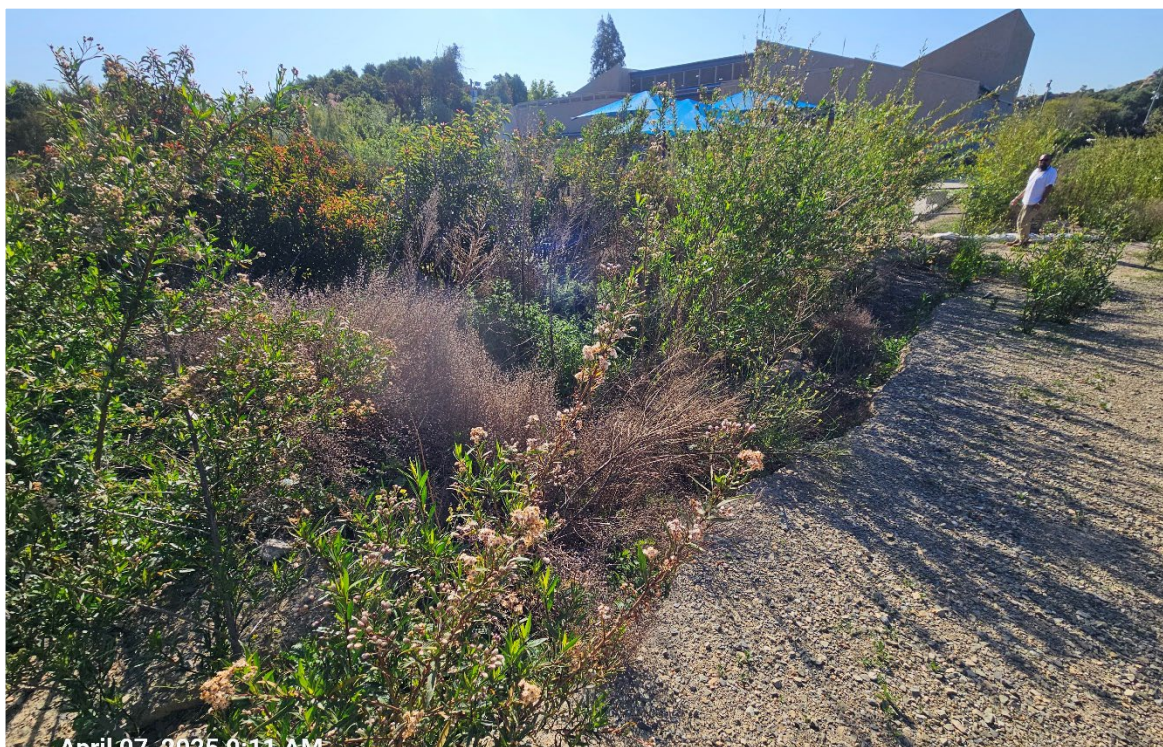
12. View of significant erosion beneath geo grid behind community center playground

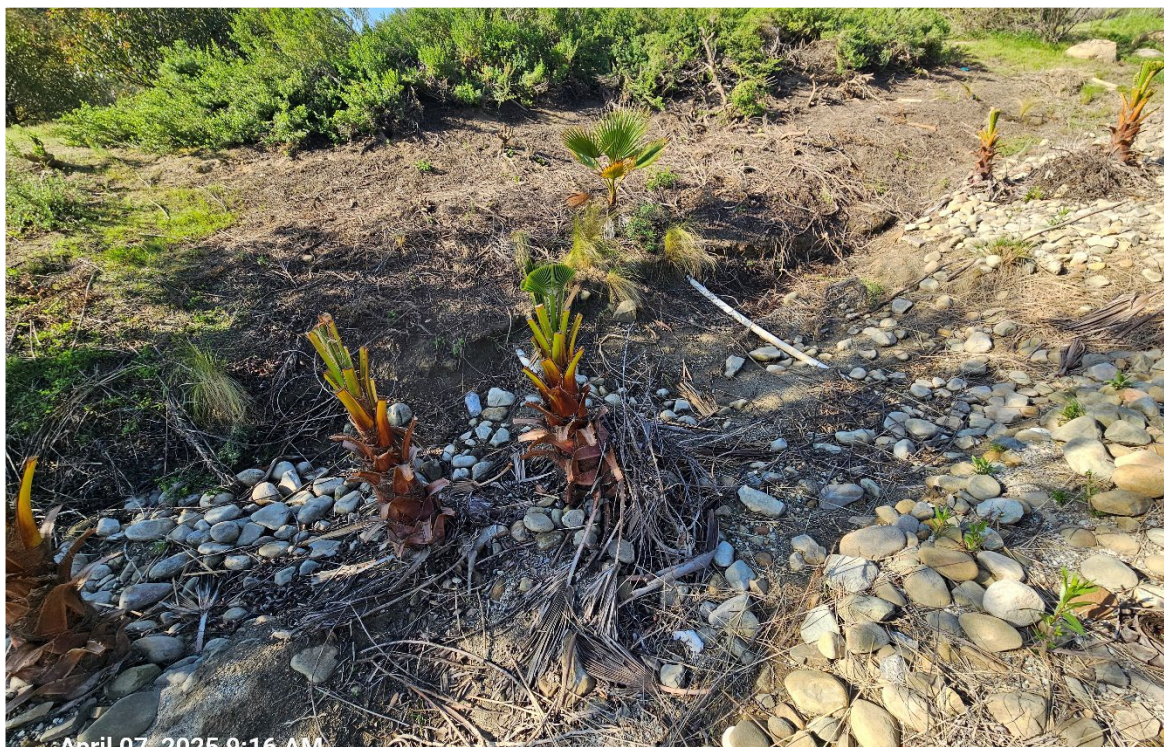
13. View of significant erosion beneath geo grid along swale near northwest end of Site

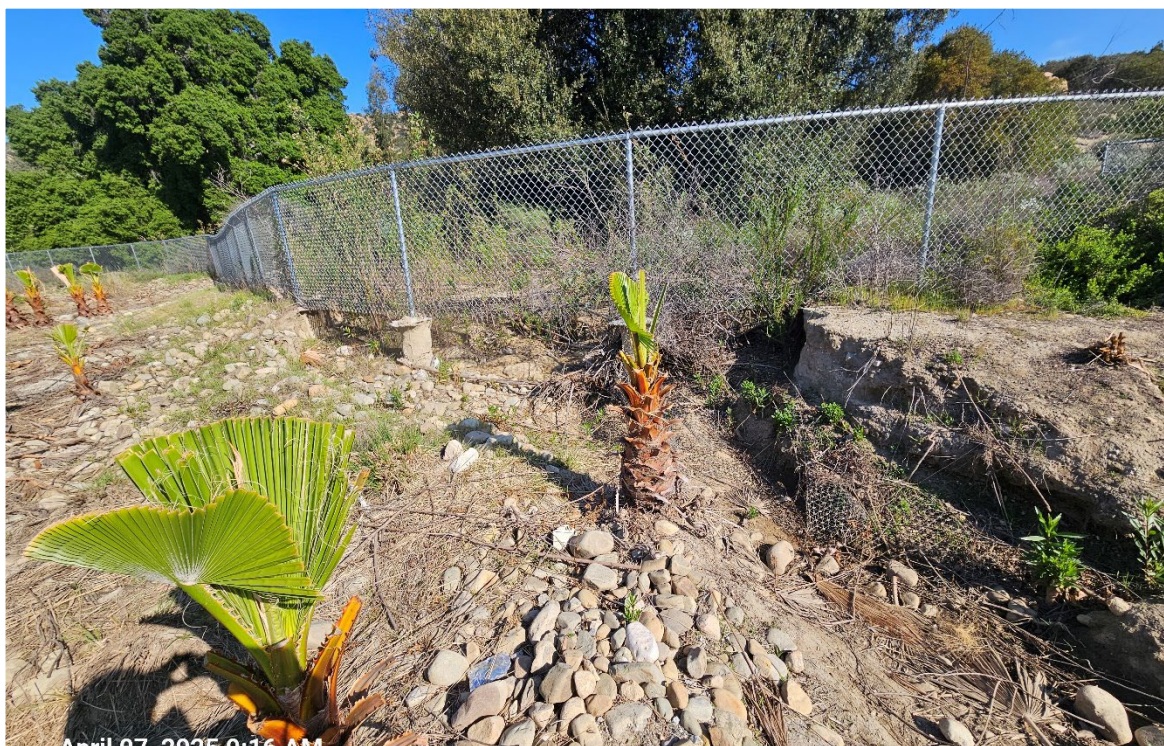
14. View of significant erosion beneath geo grid along swale near northwest end of Site

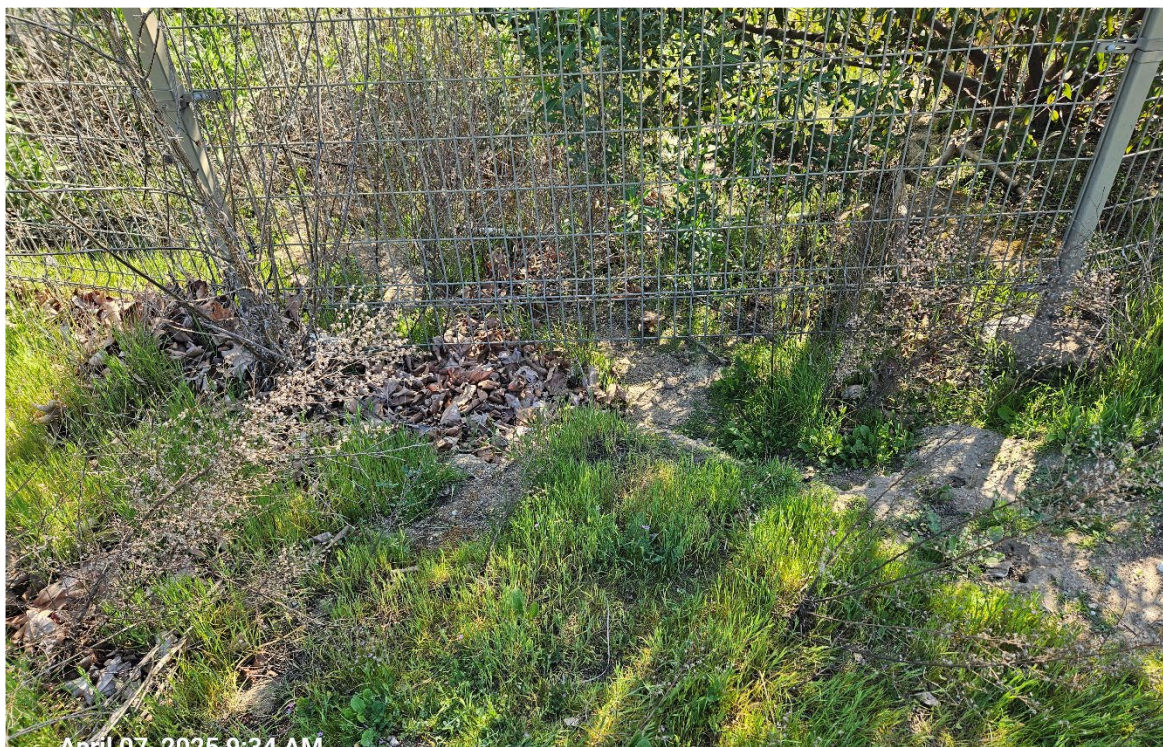
15. View of significant erosion on southeast side of detention basin number 3

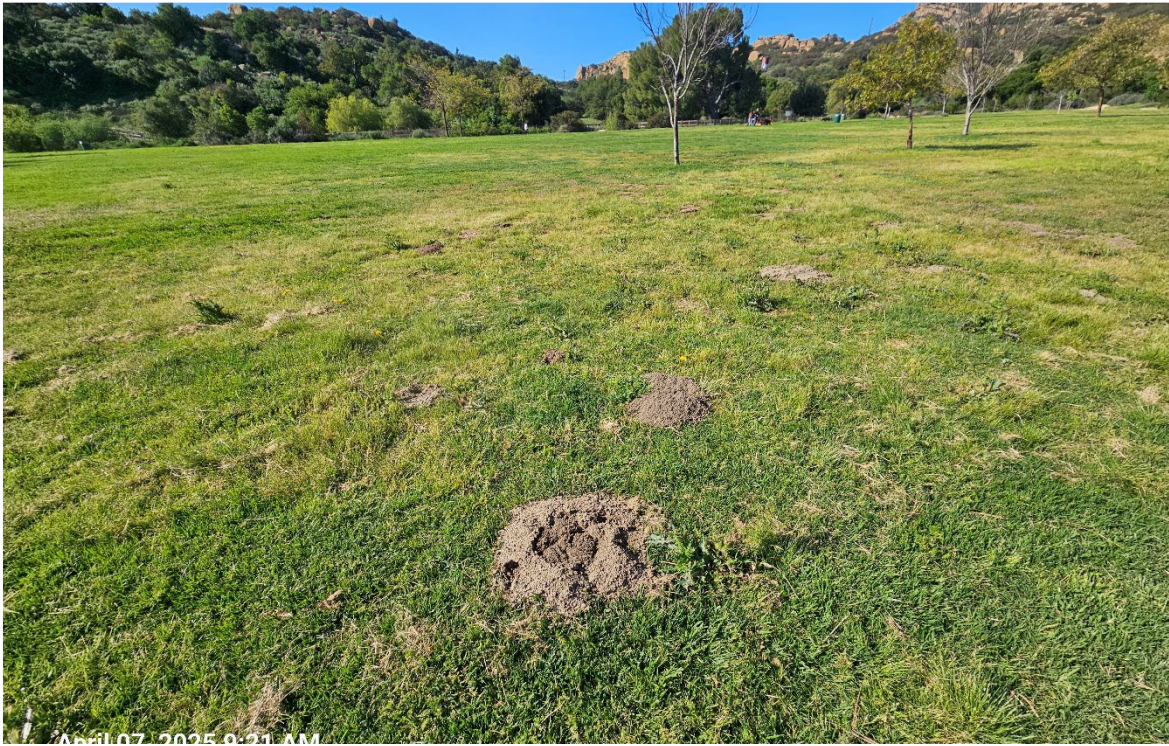
19. Typical burrowing animal hole visible throughout the cap area

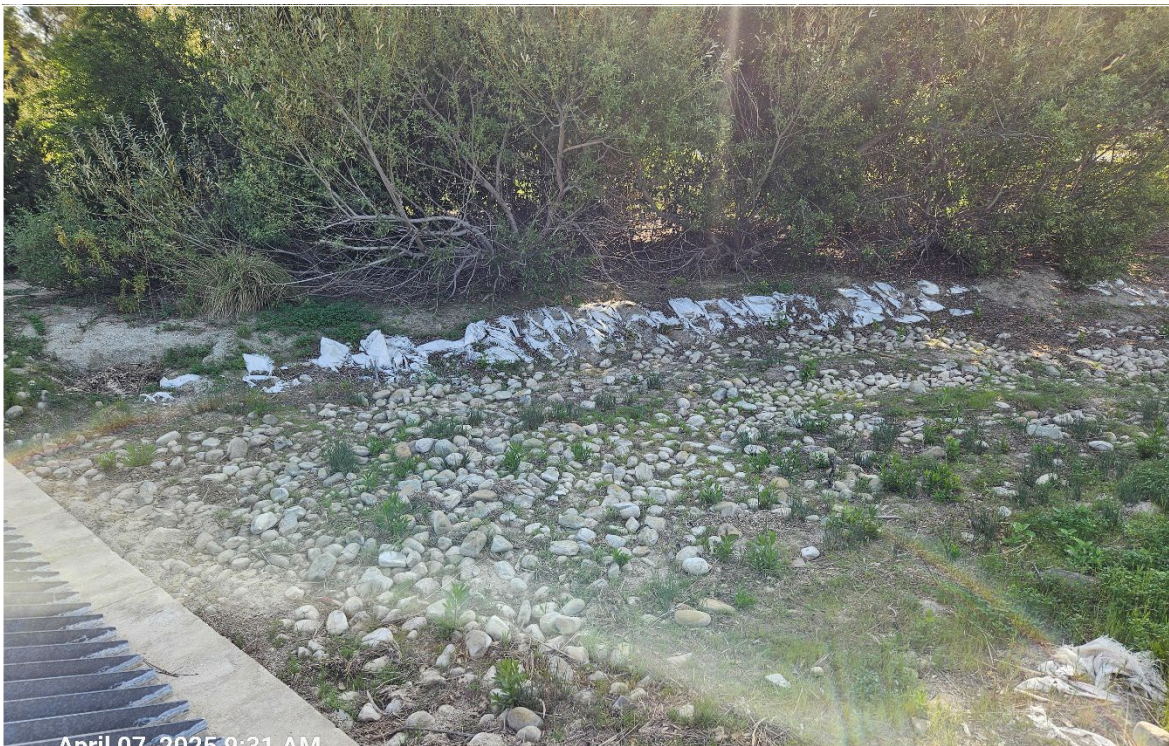
20. Significant swale erosion area near tennis courts showing repair and best management practices (BMP)

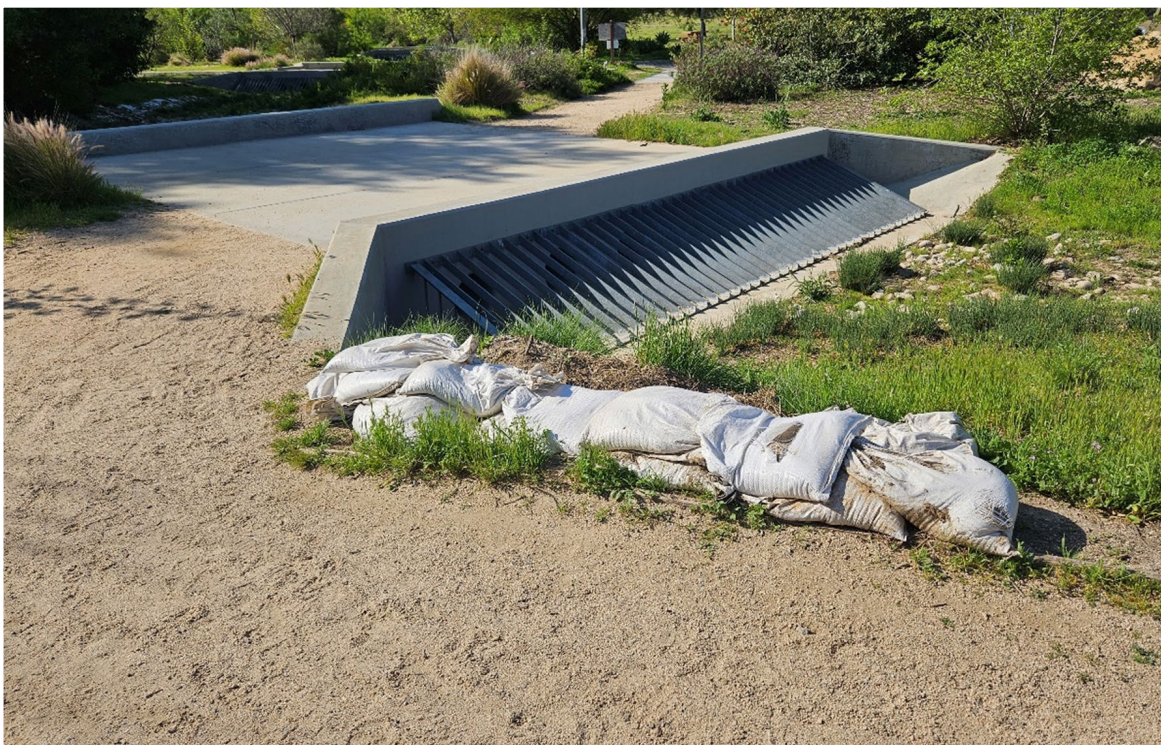
21. Significant swale erosion area near tennis courts showing repair and BMP

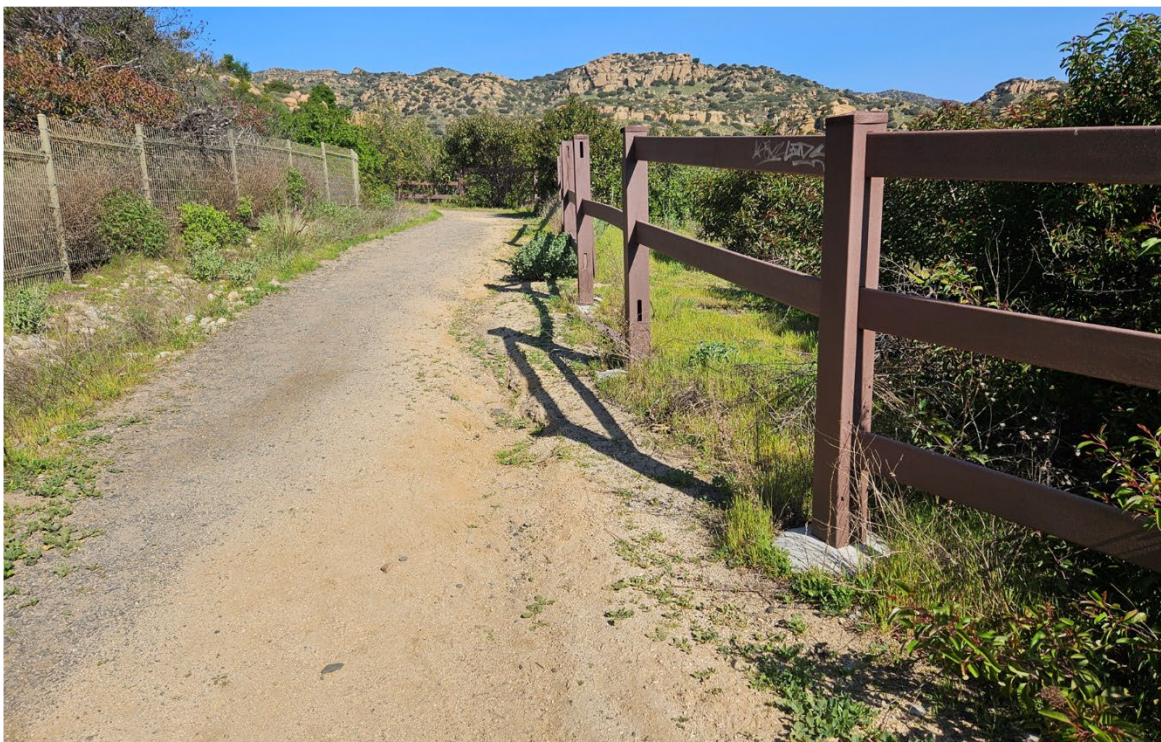
- Erosion has occurred in several locations down to the geo grid. The park maintenance team regularly makes repairs to these areas but in some locations, the cap cover appears to be less than the full one-foot depth. Typical repairs include replacing the washed out soil, if present, and filling voids with degraded granite (Attachment 2 - Photograph 22 shows a typical repair area). The degraded granite areas are more porous than the original cap material and become preferential pathways during subsequent rain events. This is resulting in excessive maintenance requirements for the cap.

22. Typical shallow erosion repair using degraded granite along pathways

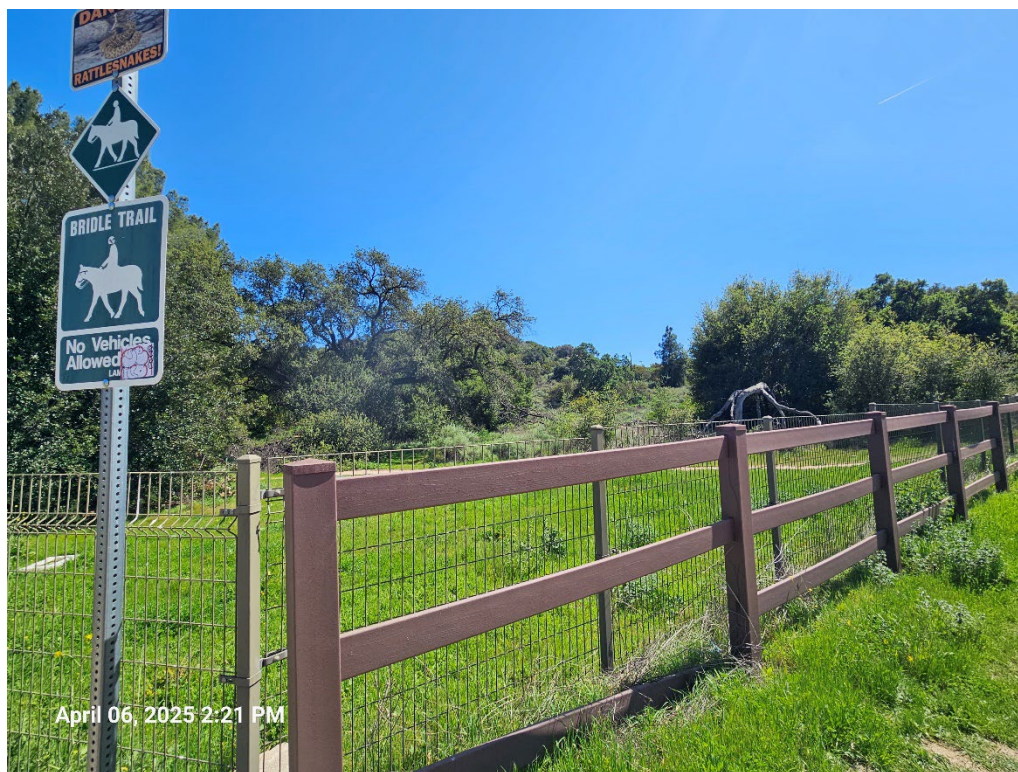
- There is evidence of regular foot traffic through some of the fenced areas. Mr. Cerezo indicated that the gate locks are regularly broken, and people access the areas to use like a dog park (Attachment 2 - Photographs 23 and 24). Current barriers/warnings are not adequate to restrict access.

23. Foot path visible in fenced area of southwest side of Site

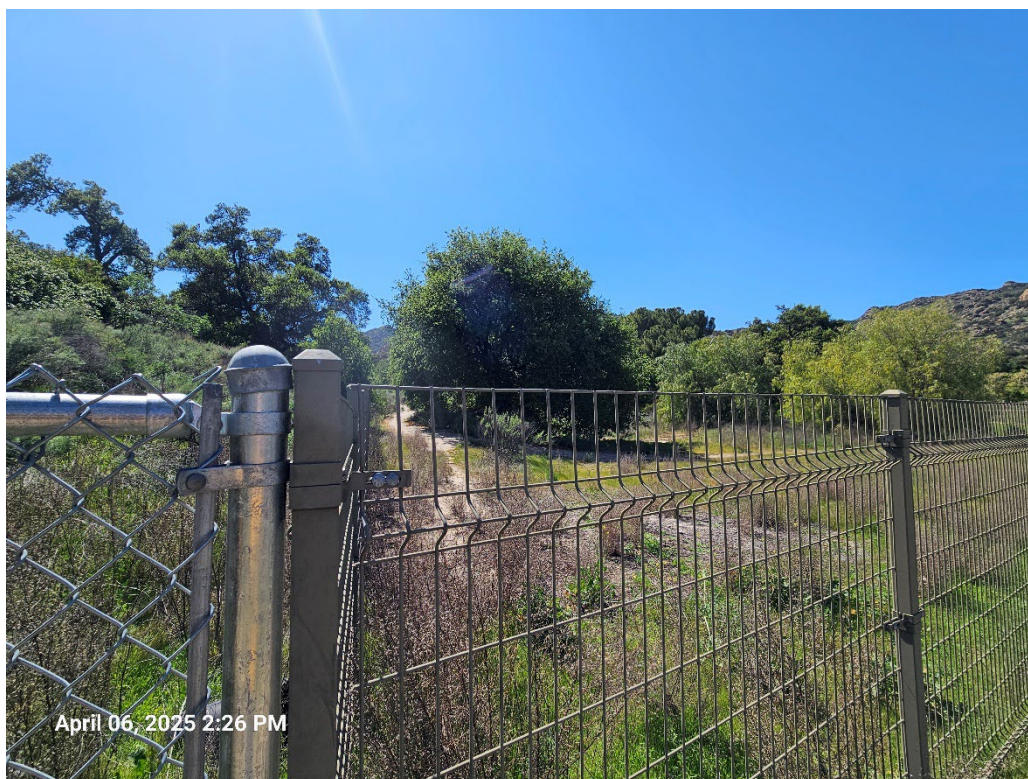
24. Foot path visible in fenced area of southwest side of Site
