NO. 25-166

SUBJECT: CHATSWORTH PARK SOUTH – OUTDOOR PARK IMPROVEMENTS (PRJ21885) PROJECT – COMMITMENT OF PARK FEES – CATEGORICALLY EXEMPT FROM THE PROVISIONS OF THE CALIFORNIA ENVIRONMENTAL QUALITY ACT (CEQA) PURSUANT TO ARTICLE 19, SECTION 15301(d) [RESTORATION OR REHABILITATION OF DETERIORATED OR DAMAGED STRUCTURES, FACILITIES, OR MECHANICAL EQUIPMENT TO MEET CURRENT STANDARDS OF PUBLIC HEALTH AND SAFETY] AND SECTION 15330 [MINOR CLEANUP ACTIONS TAKEN TO PREVENT, MINIMIZE, STABILIZE, MITIGATE, OR ELIMINATE THE RELEASE OR THREAT OF RELEASE OF A HAZARDOUS WASTE OR SUBSTANCE WHICH ARE SMALL OR MEDIUM REMOVAL ACTIONS COSTING \$1 MILLION OR LESS] OF CALIFORNIA CEQA GUIDELINES AS WELL AS ARTICLE III, SECTION 1, CLASS 1(4) OF CITY CEQA GUIDELINES

Roux conducted this Five-Year Review on behalf of the City of Los Angeles Department of Recreation and Parks (LARAP) pursuant to the Comprehensive Environmental Response, Compensation, and Liability Act (CERCLA) Section 121 (c), the National Oil and Hazardous Substances Pollution Contingency Plan (NCP) Section 300.400 (f) (11), and the Office of Solid Waste and Emergency Response (OSWER) directive 9355.7-03B-P.

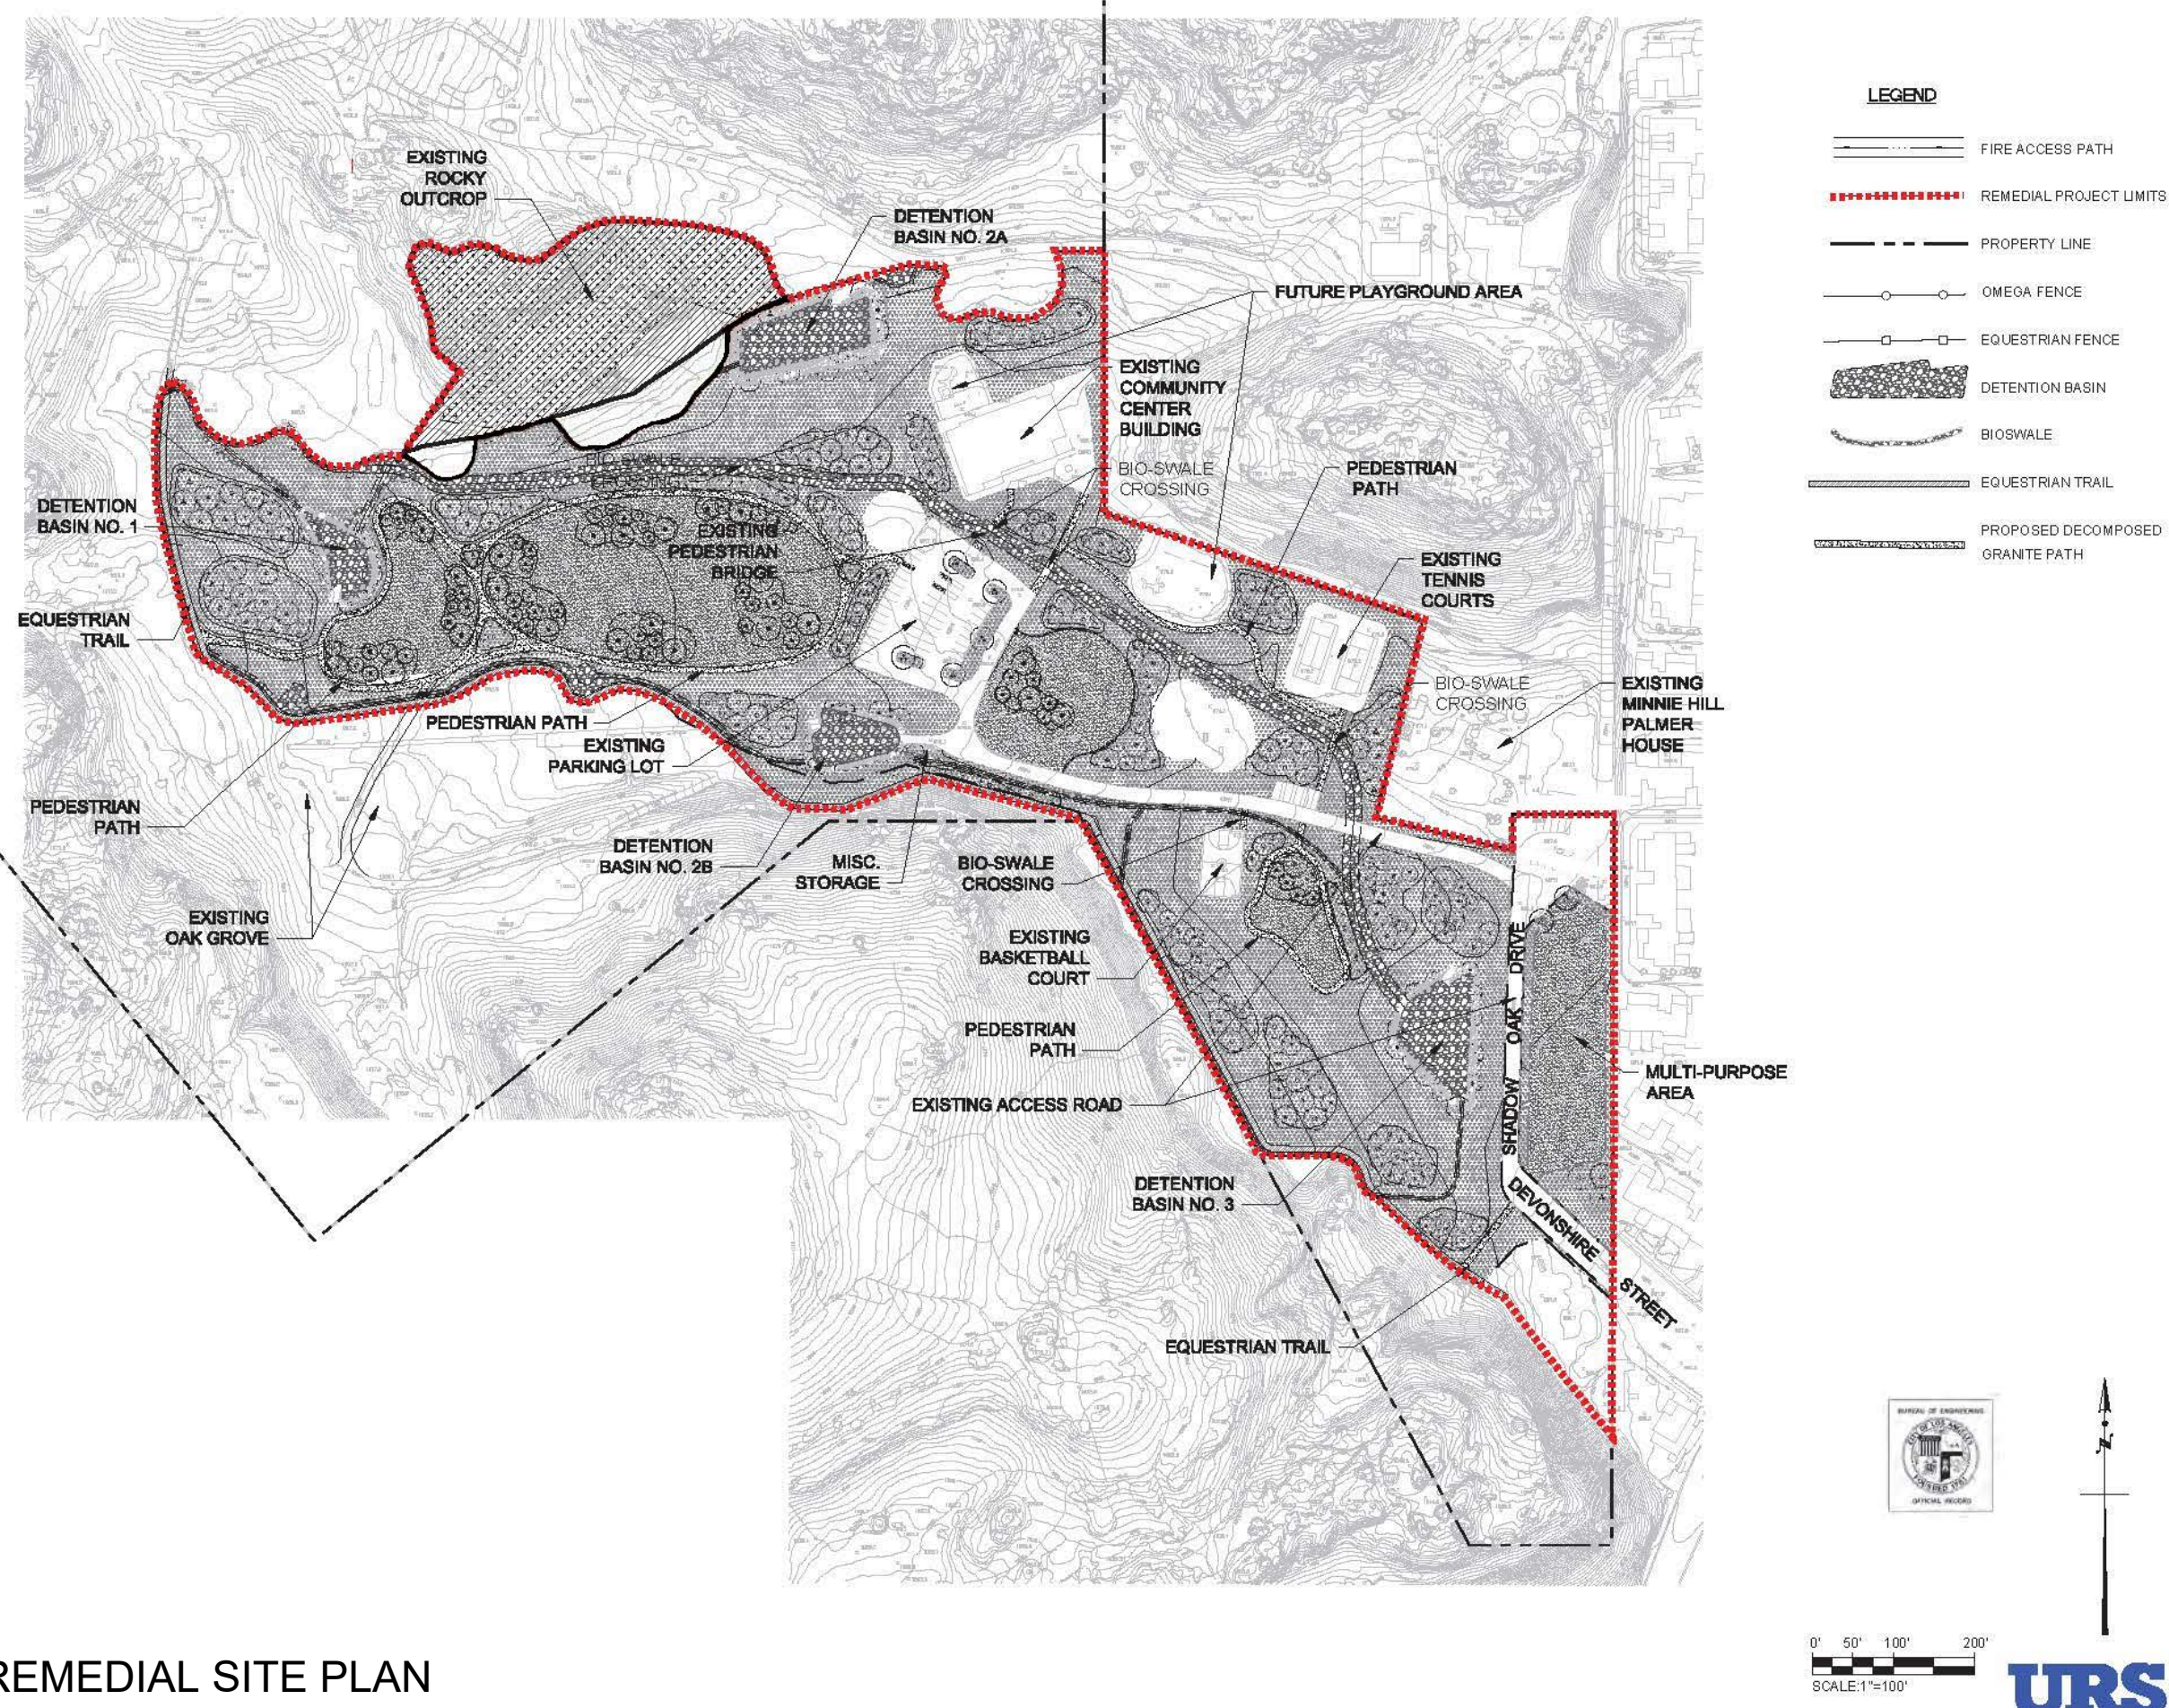
FIGURE 2 - REMEDIAL SITE PLAN

- Four areas of the cap were observed or reported to have eroded to the point of breaching the geo grid exposing the impacted soil beneath (Figure 1). There is inadequate O&M of physical remedial structures (Attachment 2 - Photographs 11 through 15, 20, and 21).

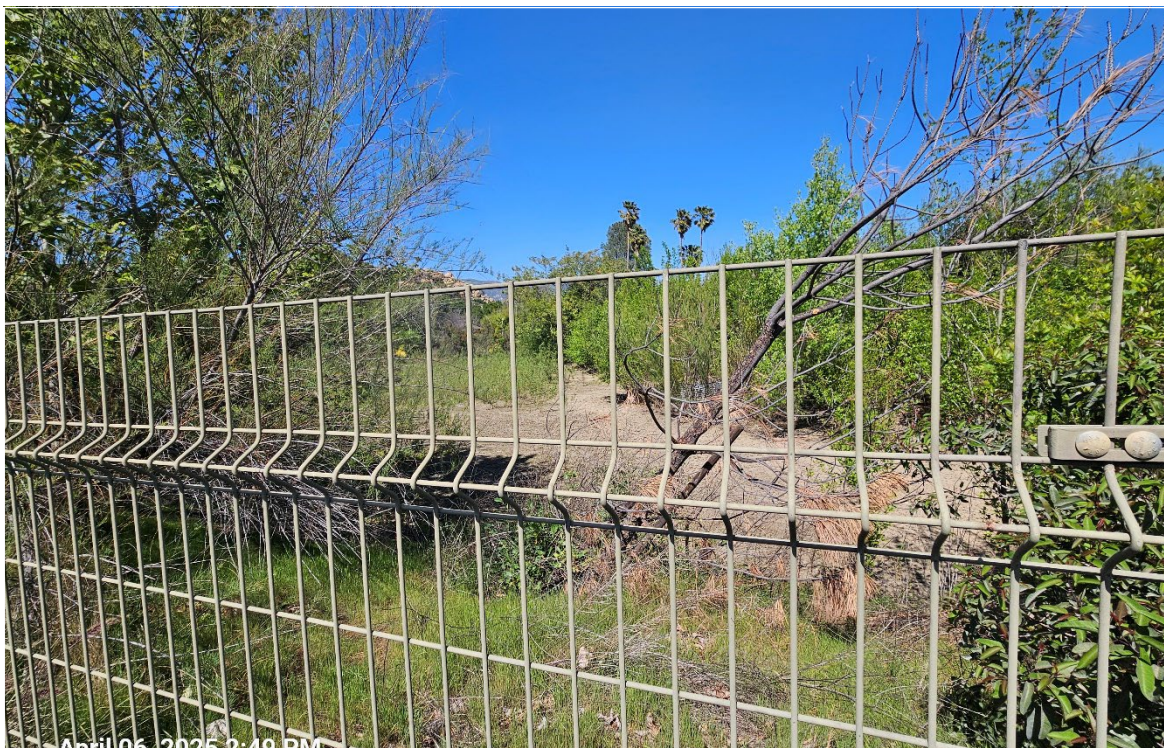
18. View into detention basin number 3

- The detention basins have become overgrown to the point that inspection was difficult.
- There is evidence of burrowing animals throughout the cap.
- There is evidence of regular foot traffic through some of the fenced areas. Mr. Cerezo indicated that the gate locks are regularly broken, and people access the areas to use like a dog park.

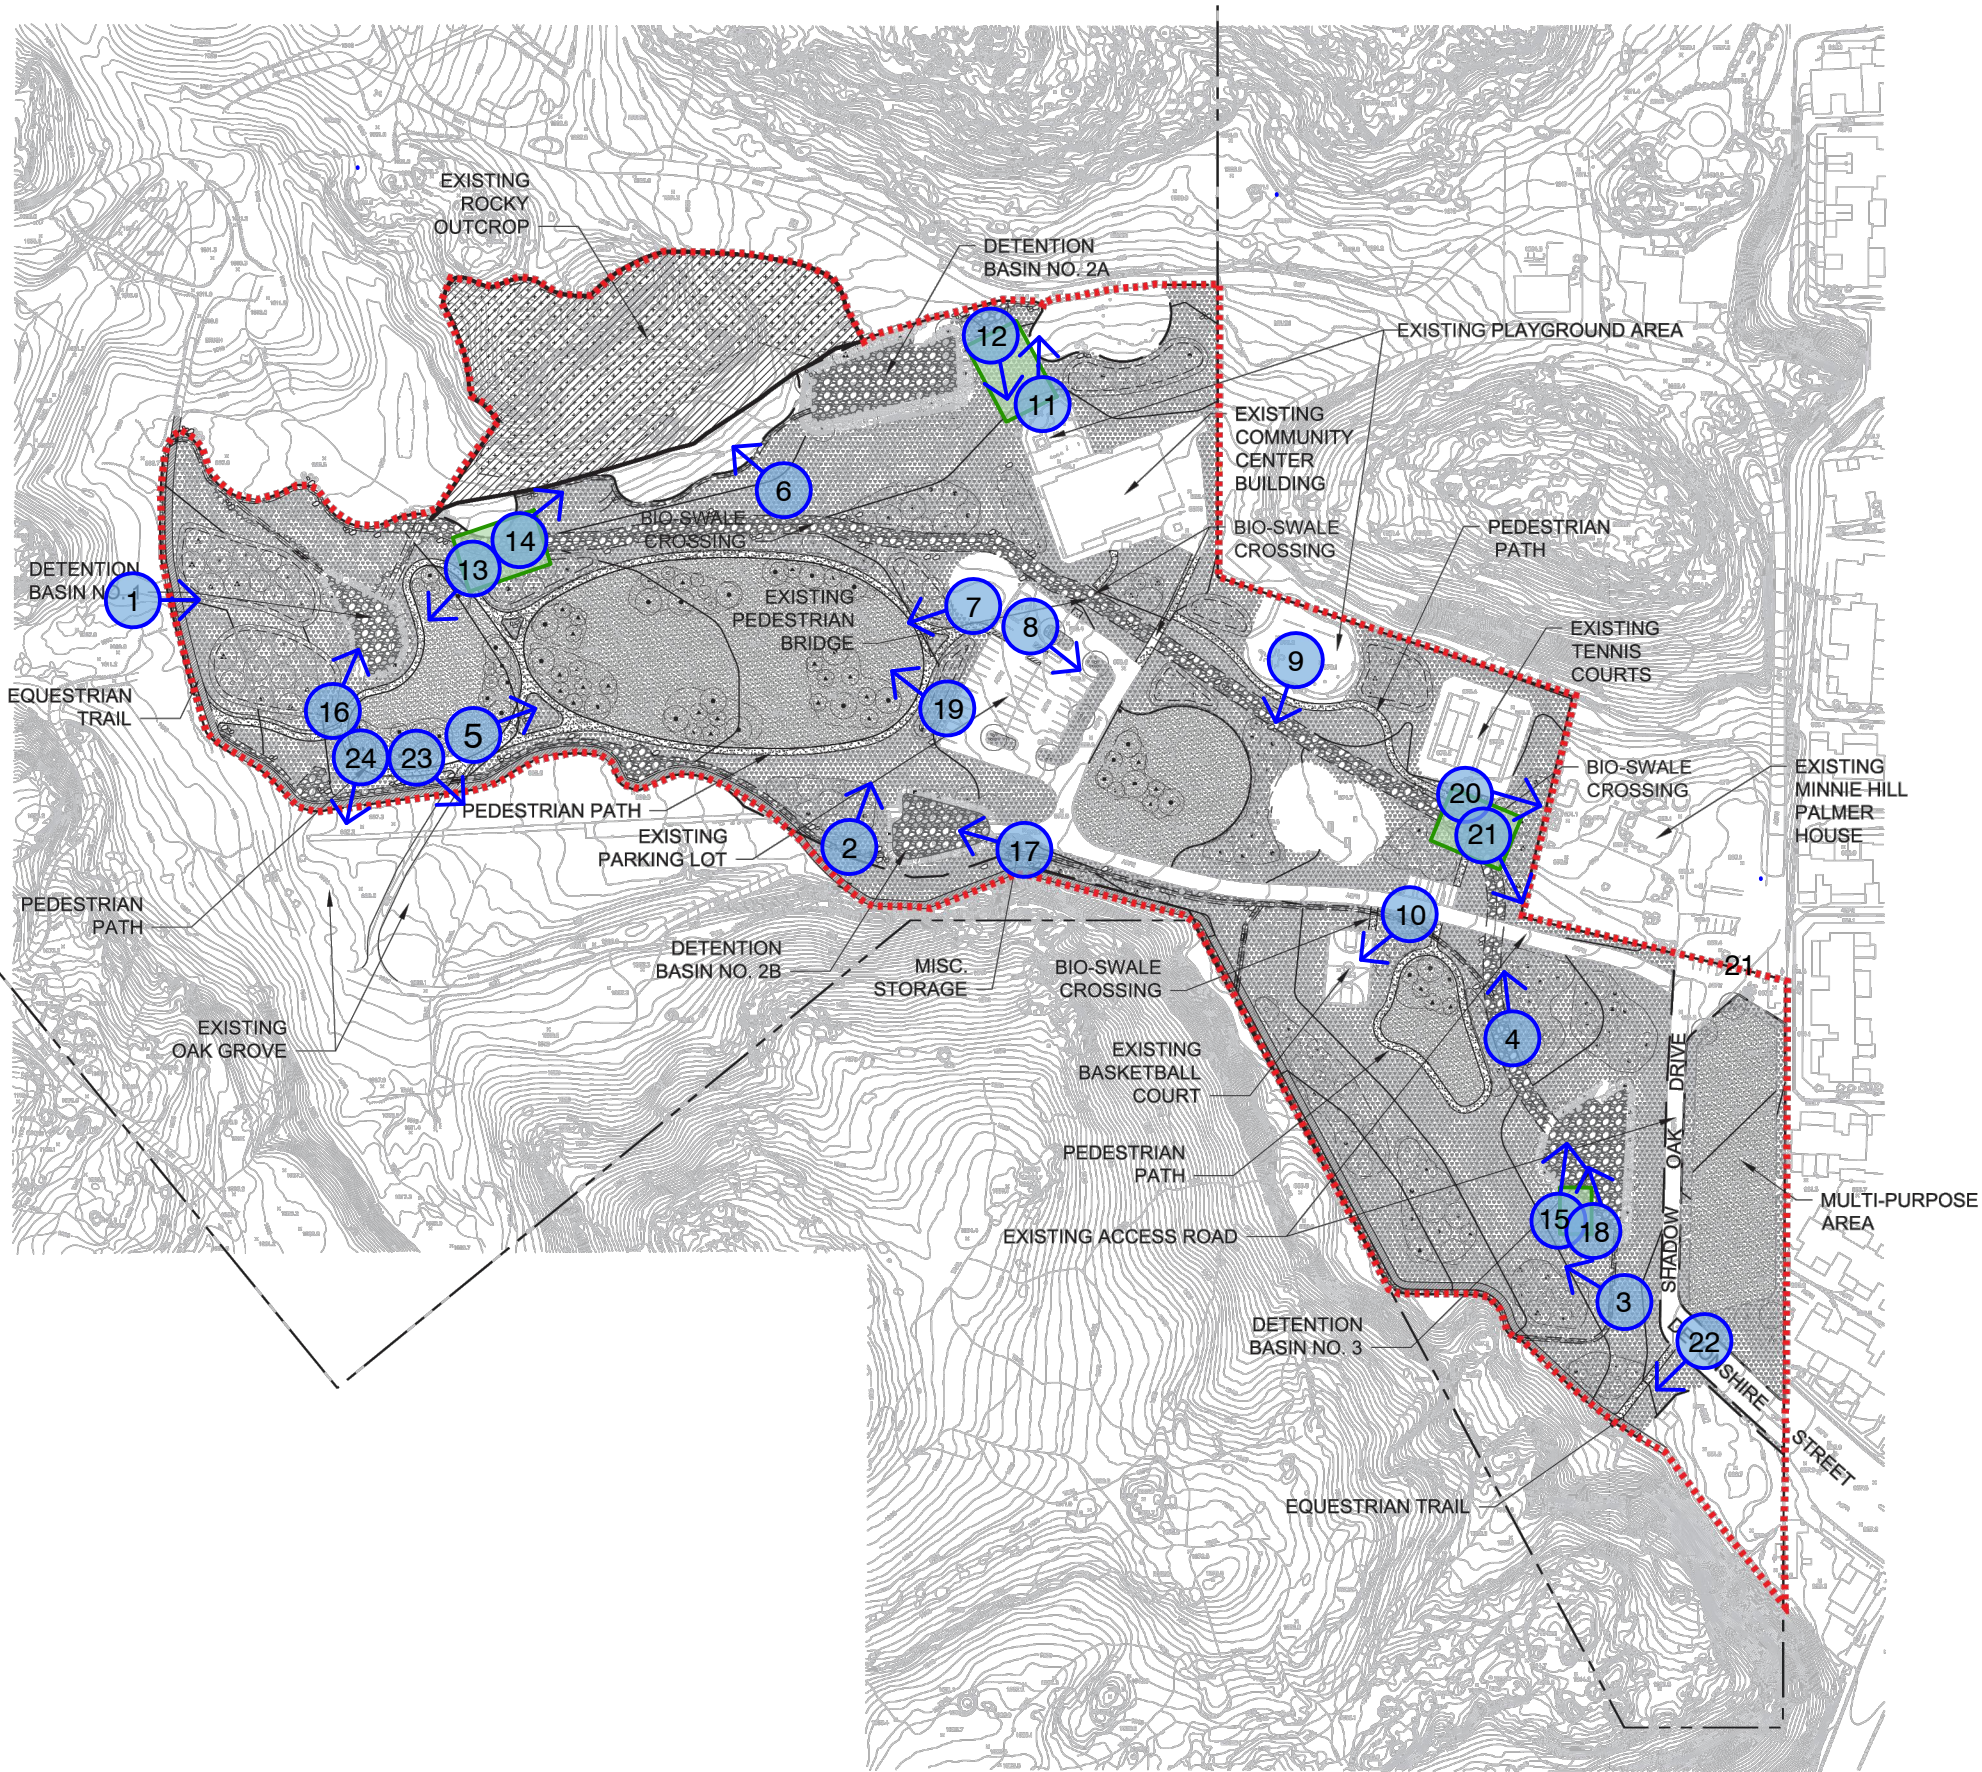
- Erosion has occurred in several locations down to the geo grid. The park maintenance team regularly makes repairs to these areas but in some locations, the cap cover appears to be less than the full one-foot depth. Typical repairs include replacing the washed out soil, if present, and filling voids with degraded granite (Attachment 2 - Photograph 22 shows a typical repair area). The degraded granite areas are more porous than the original cap material and become preferential pathways during subsequent rain events. This is resulting in excessive maintenance requirements for the cap.

- Four areas of the cap were observed or reported to have eroded to the point of breaching the geo grid exposing the impacted soil beneath.
- Erosion has occurred in several locations down to the geo grid. The park maintenance team regularly makes repairs to these areas but in some locations, the cap cover appears to be less than the full one-foot depth. Typical repairs include replacing the washed out soil, if present, and filling voids with degraded granite. The degraded granite areas are more porous than the original cap material and become preferential pathways during subsequent rain events. This is resulting in excessive maintenance requirements for the cap.

- Immediate repairs are needed in the areas where the cap has been breached below the geo grid:
 - Retain the services of Hazardous Waste Operations and Emergency Response (HAZWOPER)-trained staff/contractor to repair the damage and restore the surface cap to its original condition.
 - Any soil excavated beneath the geo grid as part of the repair must be managed in accordance with the Soil Management Plan (Appendix C of the O&M Plan).
 - Notify the DTSC of the repairs in accordance with Section 4.4.1 of the O&M Plan.

- Evaluate for potential migration of impacted soil in the areas where the cap and associated geogrid have been breached.
- Evaluate all areas where erosion regularly occurs and provide a more rigorous repair. The repair contractor should evaluate these areas with Mr. Cerezo as he has historical familiarity with the areas that regularly erode.
- Clear the detention basins of debris and excess growth so an inspection can be performed.
- Evaluate if the geo grid is successfully preventing burrowing animals from breaching through into the contamination zone.
- Add signage to the fenced areas where regular foot traffic is occurring to discourage entry.
- Update the O&M Plan and provide training to the site maintenance team regarding the requirements of the O&M Plan, including when to notify of issues and when HAZWOPER-trained staff/contractor repairs are necessary.
