SUBJECT: GLASSELL PARK SYNTHETIC SOCCER FIELD (PRJ20760) (W.O. #E170187F) PROJECT – APPROVAL OF FINAL PLANS; CATEGORICAL EXEMPTION FROM THE PROVISIONS OF THE CALIFORNIA ENVIRONMENTAL QUALITY ACT (CEQA) PURSUANT TO ARTICLE III, SECTION 1, CLASS 1(1) [MINOR EXTERIOR ALTERATION OF EXISTING PUBLIC STRUCTURES INVOLVING MINOR CONSTRUCTION] AND CLASS 1(4) [REHABILITATION OF DETERIORATED STRUCTURES TO MEET CURRENT STANDARDS OF PUBLIC SAFETY] OF CITY CEQA GUIDELINES AND ARTICLE 19, SECTION 15301(d) OF CALIFORNIA CEQA GUIDELINES

**GEOTECHNICAL ENGINEERING REPORT
GLASSELL PARK - SYNTHETIC SOCCER FIELD
3650 VERDUGO ROAD
TRACT: SUBDIVISION OF THE HUNTER HIGHLAND VIEW TRACT,
BLOCK: - LOT: 56
LOS ANGELES, CALIFORNIA**

**W.O. # E170187B
GEO FILE # 13-096
DATE: MAY 13, 2014**

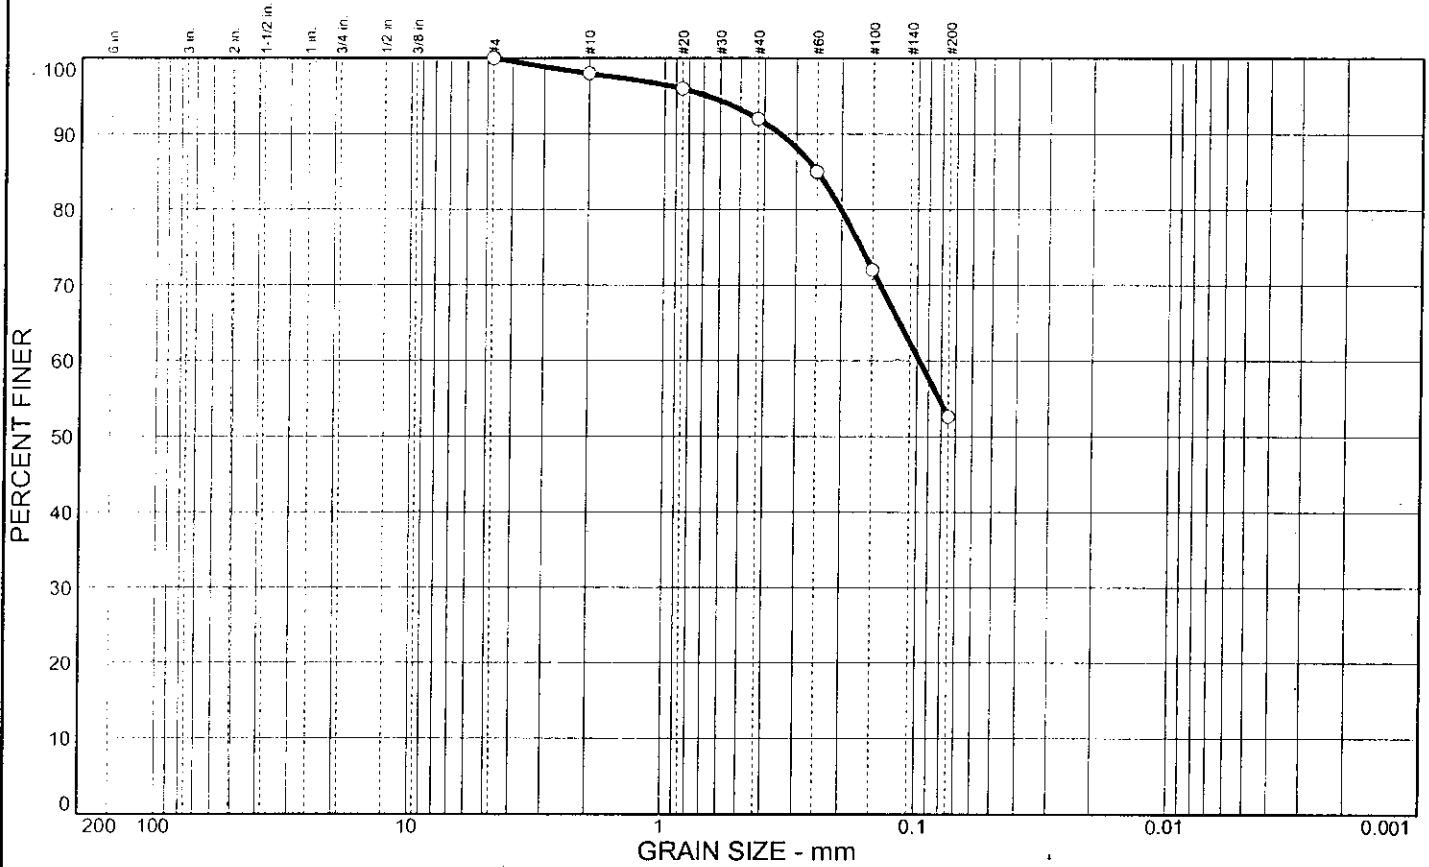
STANDARDS DIVISION: Particle Size Distribution Report

% COBBLES	% GRAVEL	% SAND	% SILT	% CLAY	USCS	AASHTO	PL	LL
		47.4	52.6		CL		14	25

SIEVE inches size	PERCENT FINER		
○			
X	GRAIN SIZE		
D ₆₀	0.0978		
D ₃₀			
D ₁₀			
X	COEFFICIENTS		
C _c			
C _u
